RE: Submission of 2019 Geotechnical Inspection Report No. 1 (July 2019)

Annual Geotechnical Inspections – 2019 Report 1. Mary River Iron Mine Complex – Nunavut

Annual Geotechnical Inspections – 2019 Report 2. Mary River Iron Mine – Nunavut

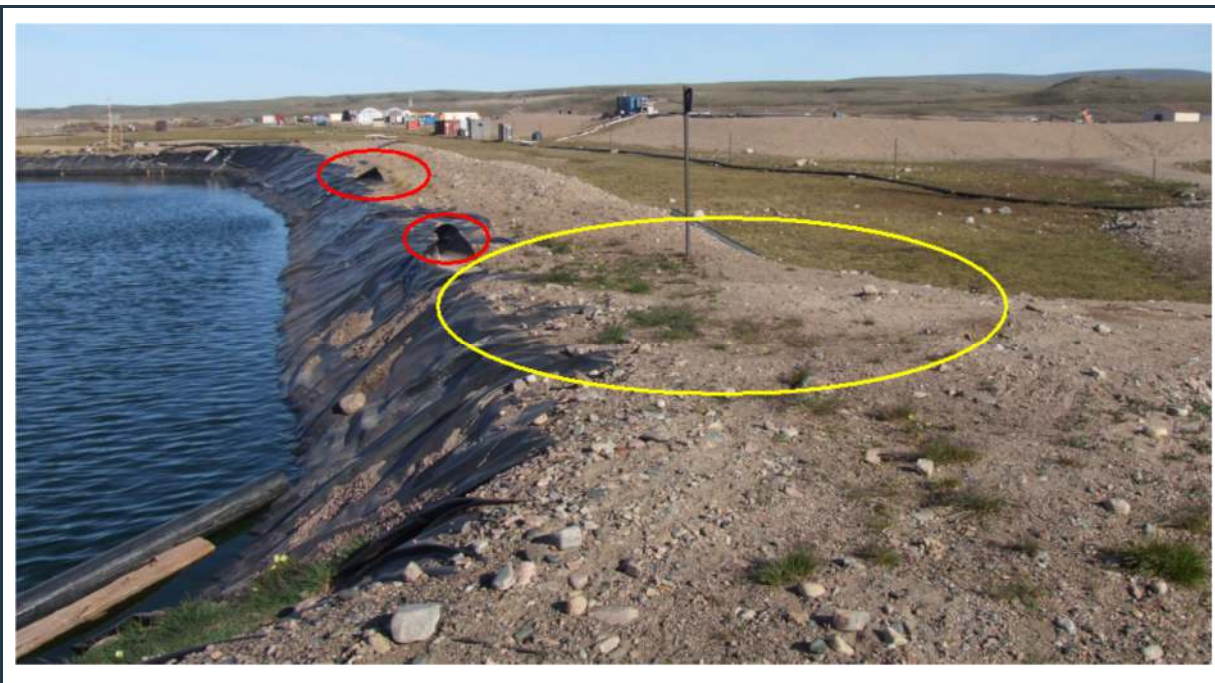
Figure 7: PWS pond #1 – Lower crest elevation (yellow circle) and damages to the liner (red circles)

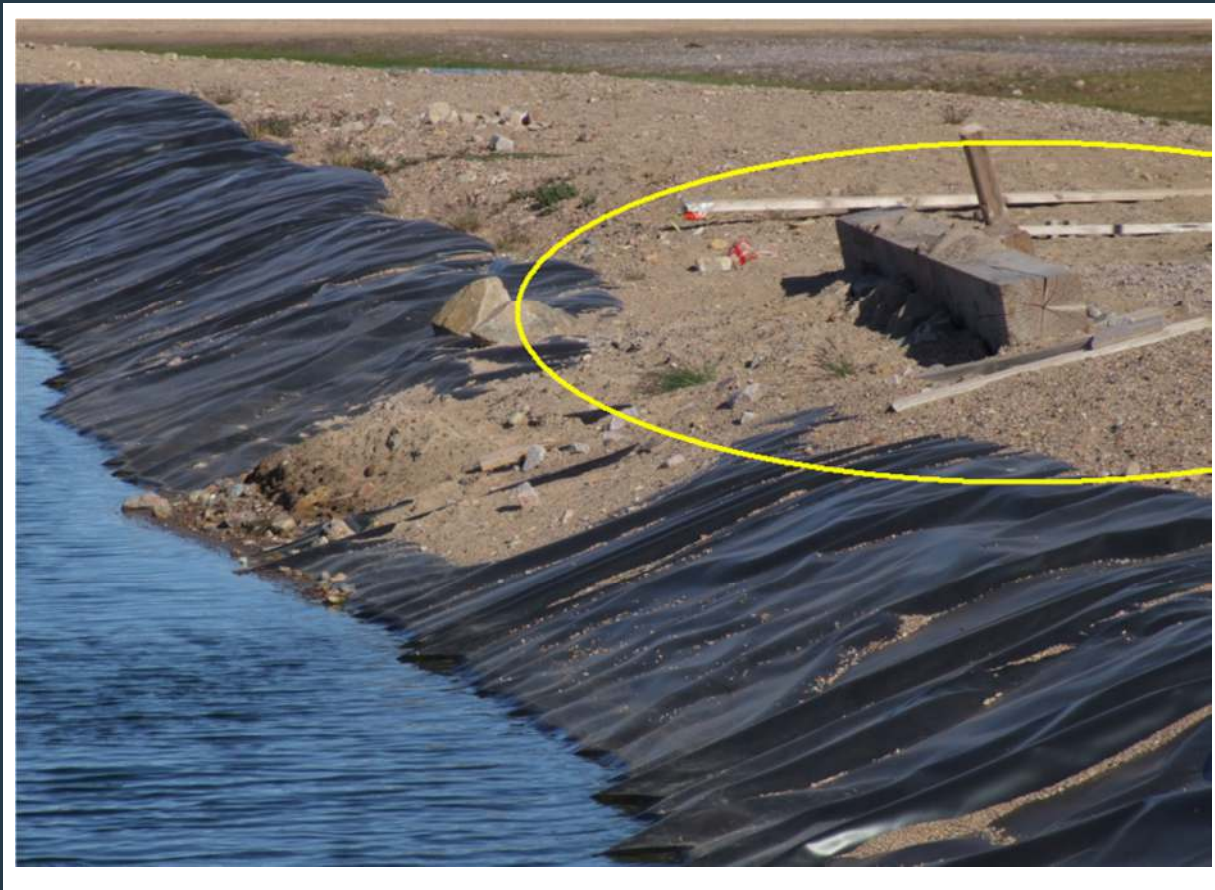
Figure 8: PWS pond #2 – Lower crest elevation caused by truck traffic at the water discharge point (yellow circle)

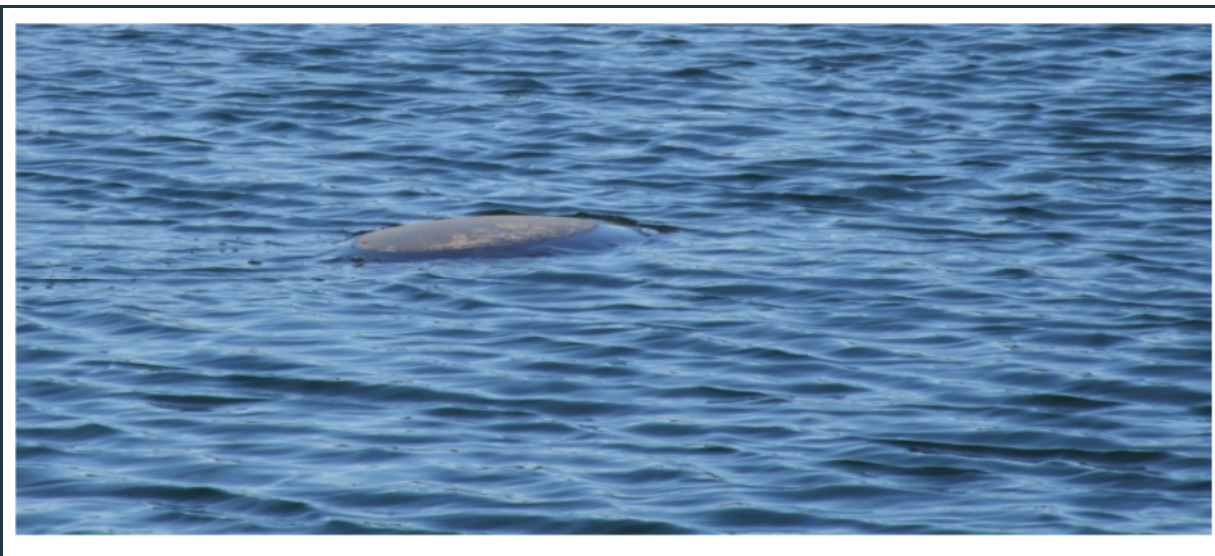
A relatively common issue in water lagoons is the appearance of "whales" within the ponds. Whales are sections of the liners which have risen above the surface of the water, particularly in shallow ponds where the weight of water above the liner is minimal. Such a "whale" was visible during the inspection at PWS pond #3, as shown in Figure 9. The presence of whales ("liner bubbles") is usually attributed to suspected to potential gas generation beneath the liners due to decomposition of organics in topsoil layer that may have been left in place beneath the liner away from berm foundation during construction, resulting in the formation of whales. Such whales had been recorded in the past in some of the ponds at the subject mine site. However, no damage to the liners or seepage from the ponds has been reported, including the current survey/inspection. Should the affected pond be drained in the near future, it is recommended that the gas from beneath the liner be released by poking holes and repairing the liner in the next step.

Figure 9: PWS pond #3 – A "whale" is visible in pond #3.

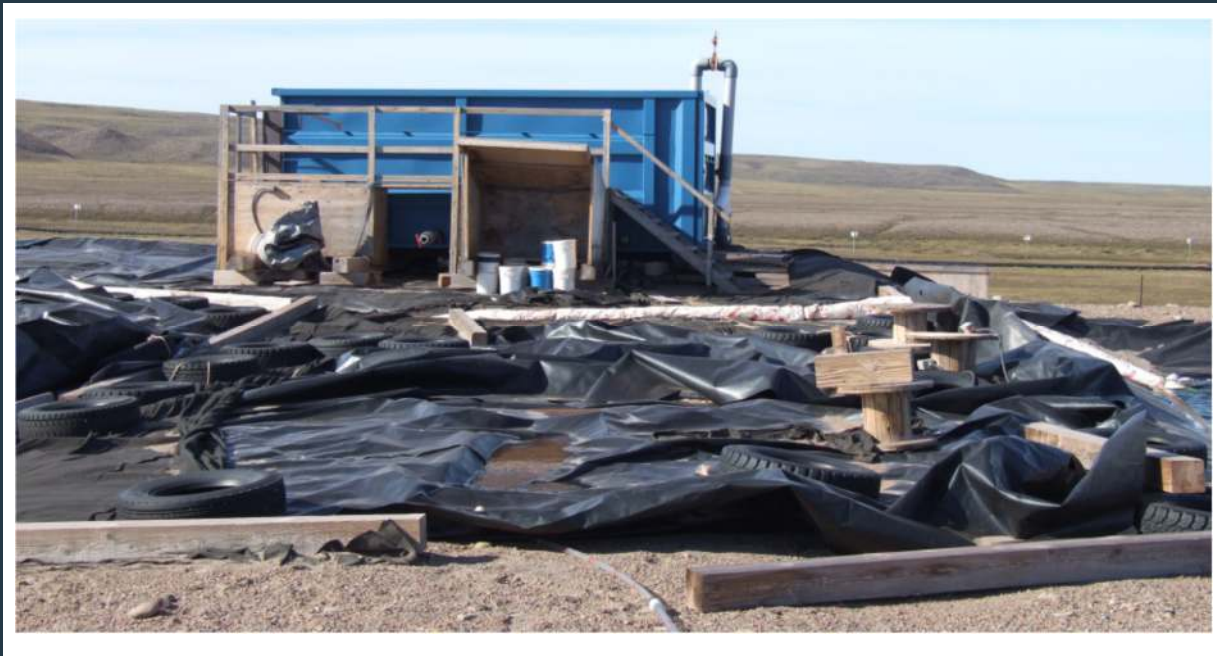
As pointed out above, the berms appear to be structurally stable, and no visible wet downstream slopes and toe seepage was noted. However, as shown in Figure 10, the surface appearance was not found to be orderly at the front of the water discharge pipes at the middle of the south-western perimeter berm at its juncture with the central berm between Ponds #2 and #3. Namely, heavily wrinkled surficial liner was observed to cover the crest at this location and at the junction. It is suspected that this may have been water discharge point for further conveyance of the discharged water into the two adjacent ponds.

Figure 10: PWSP #2 and #3 – Untidy conditions at the water discharge point between ponds #2 and #3

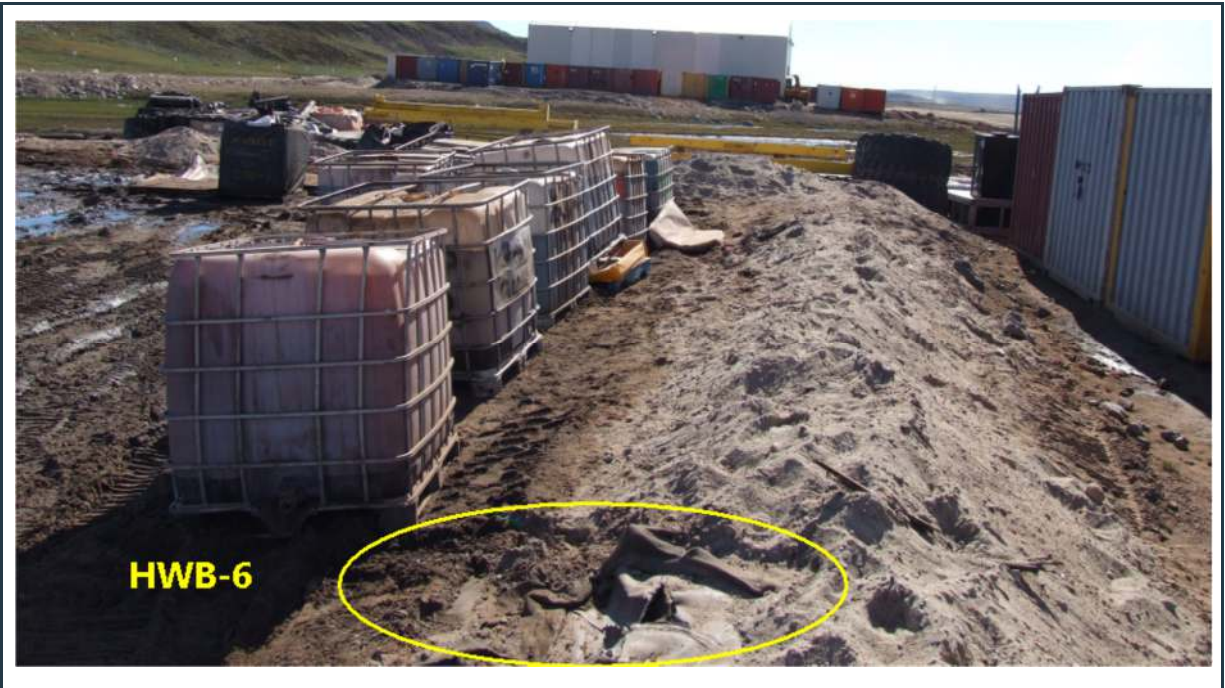
The berms have been extensively disturbed by truck and foot traffic, particularly at the northern section of the berm. Cracking and tearing of the liner are also visible at several locations on the upstream face and crest of the berm.

Figure 16: View of HWB-6. Note the damaged liner at the yellow circle.

Baffinland Action: Baffinland is aware HWB-6 will require repairs to continue receiving waste materials in the future. A repair of both the berm structure and the liner is scheduled to be completed.

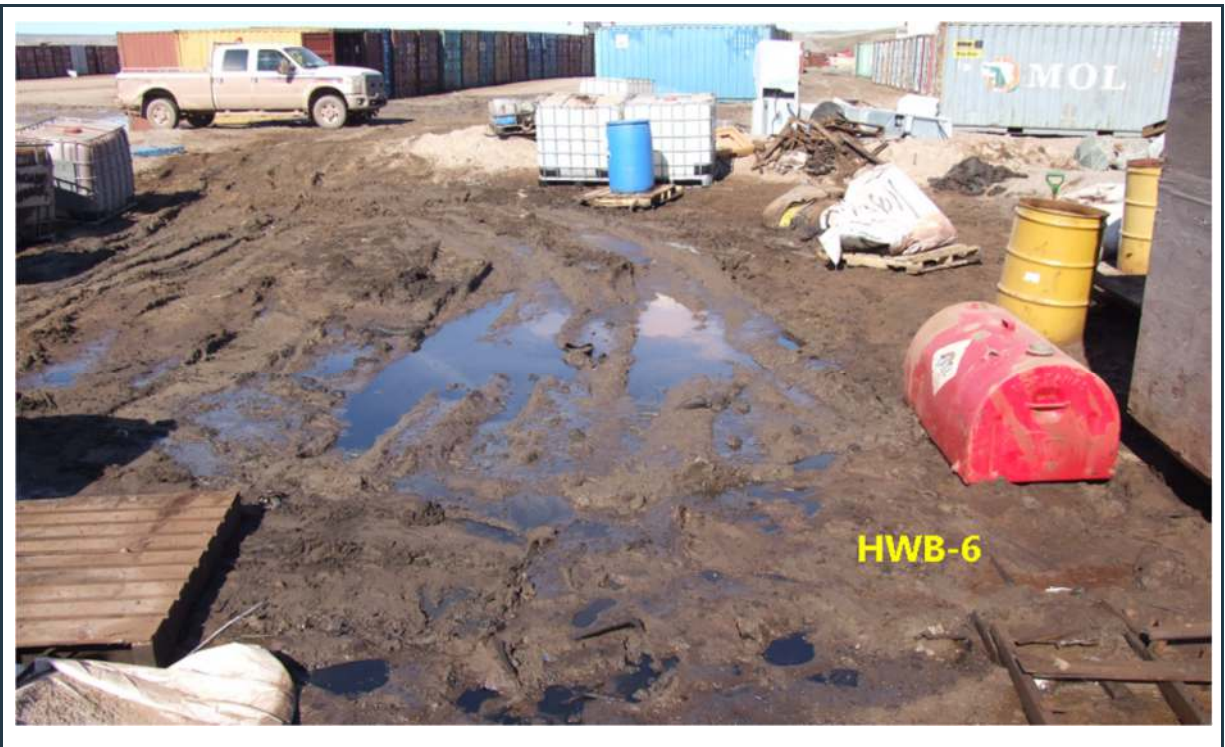
Figure 17: View of HWB-6. Note the shallow berm near the pickup truck.

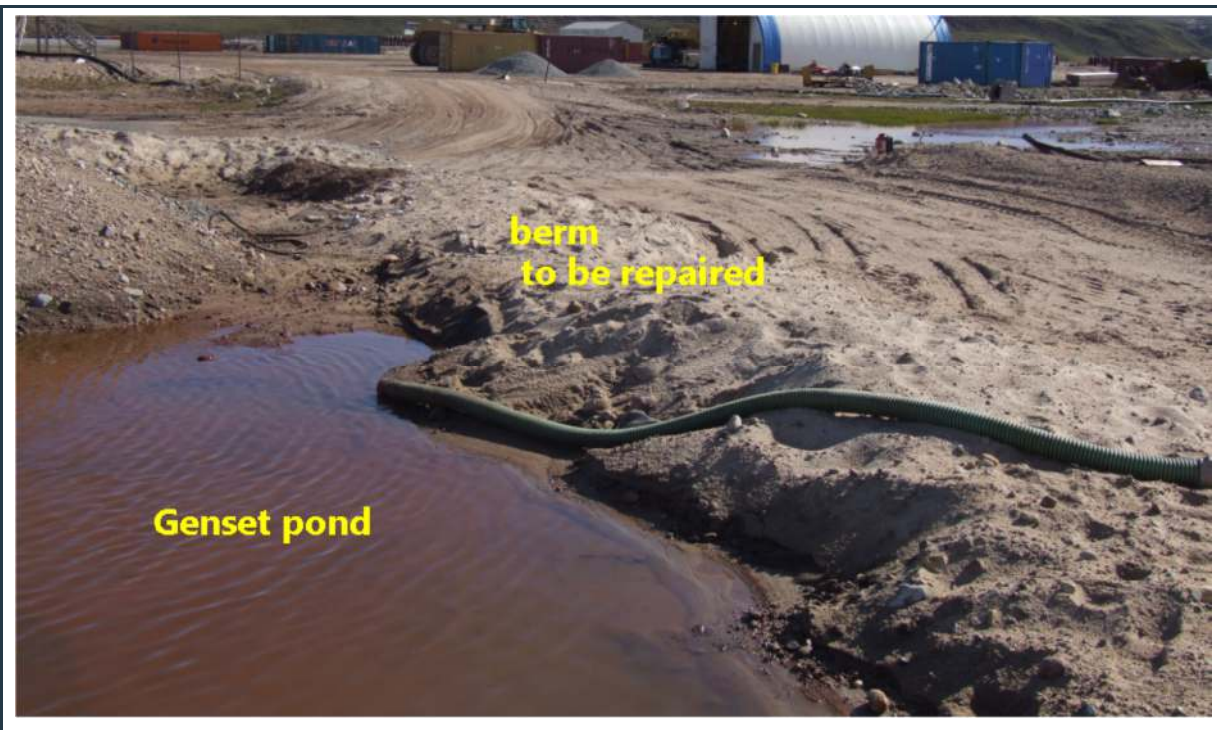
Figure 31: View of the south section of the berm that needs to be repaired (raised and regraded)

Baffinland Action: Baffinland commits to bringing granular fill to this location to re-fill the slope and regrade the area. In addition to the repair work on the slope, the southern, lower section of the berm will be reconstructed to its original geometry.

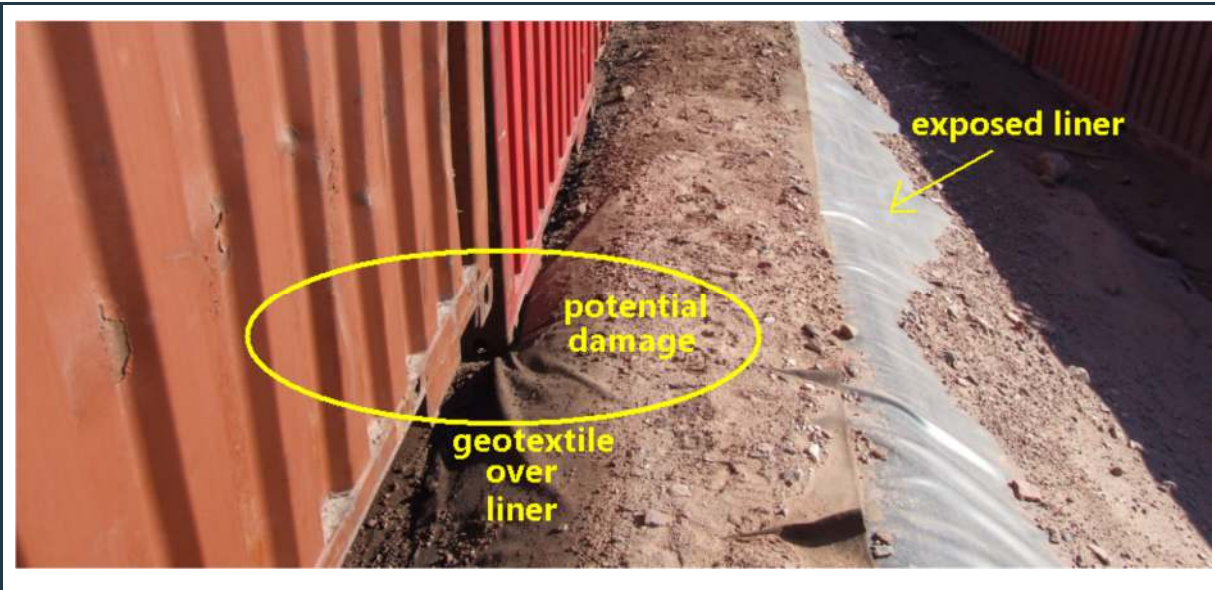
Figure 48: Exposed geotextile and liner at the HWB-4 pond, with location of potential damage to liner

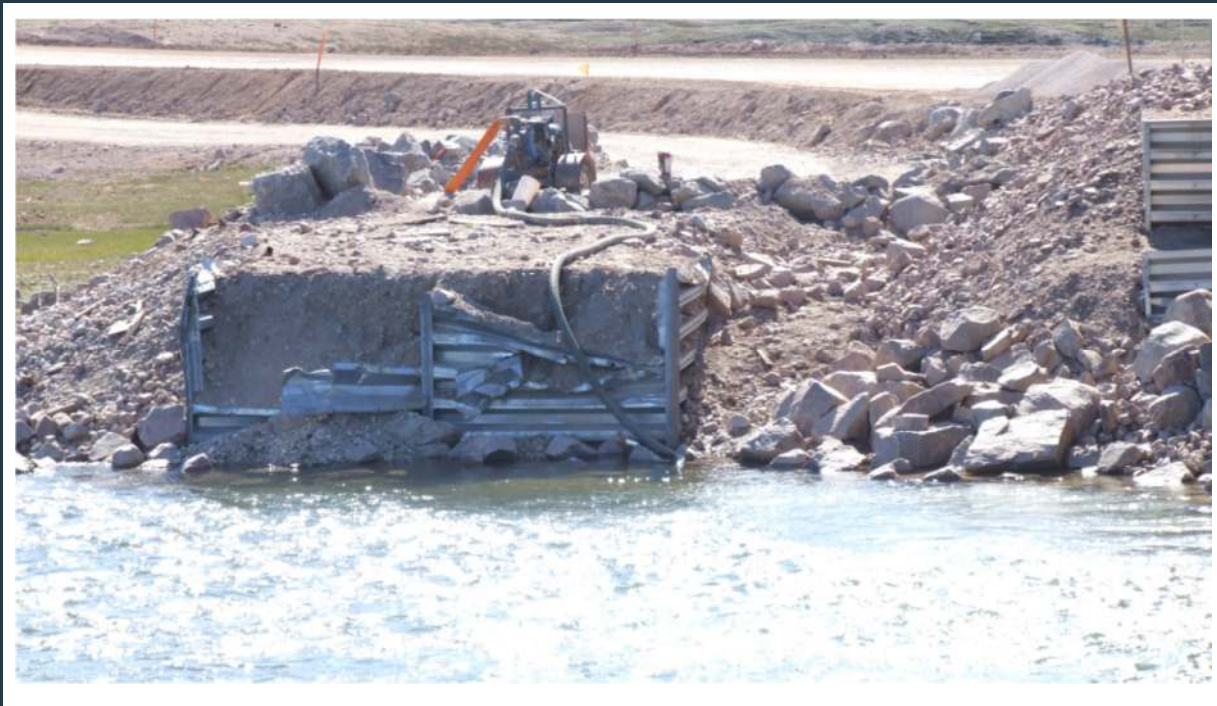
There are two historic abutments, located immediately adjacent to the “new” ones. The metal front and wing walls of both “old” abutments have suffered damages in the past, particularly the south abutment.

Figure 74: The “old” south-east abutment at bridge 17

Baffinland Action: To maintain the stability of the currently used bridge abutments, Baffinland will keep the two old abutments in place since they provide support to the adjacent new structures. Baffinland will schedule repairs to the damaged sections of the abutments identified during the inspection. Additional rip-rap on the regraded granular fill slopes will also be placed to prevent erosion.

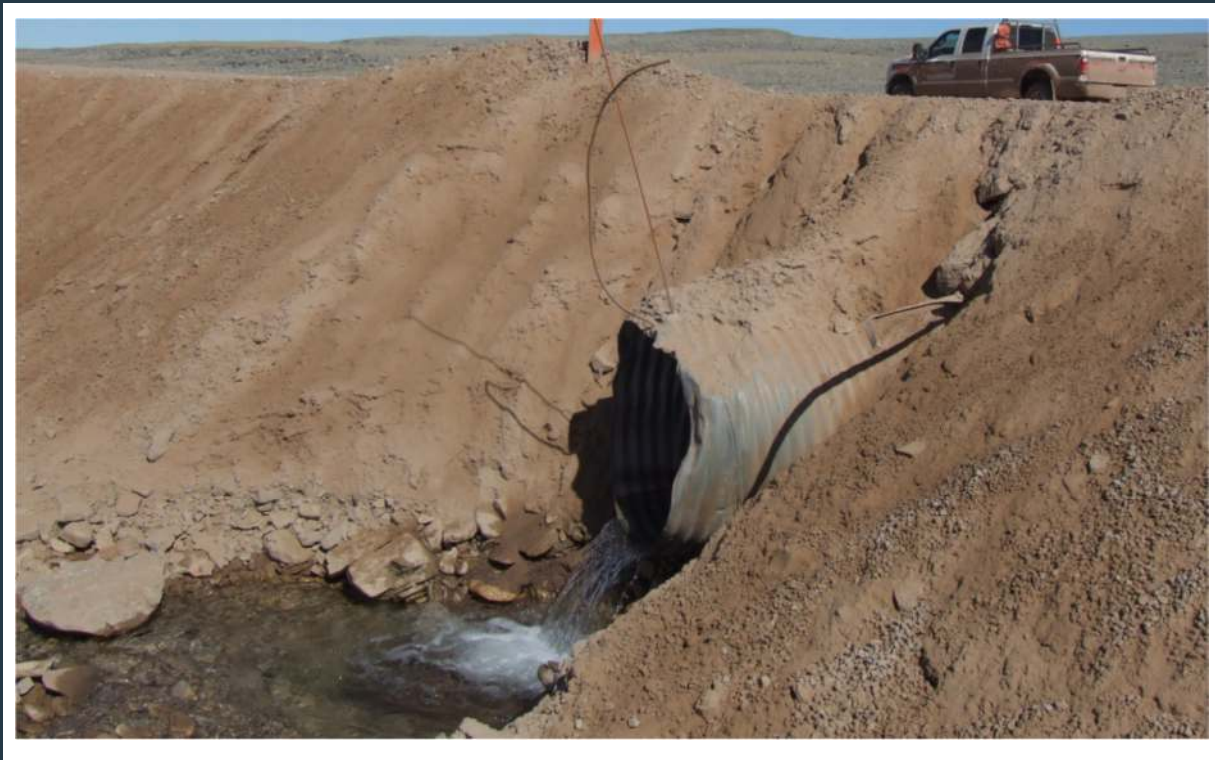
Figure 86: View of culvert 083 (outlet) with some slope erosion

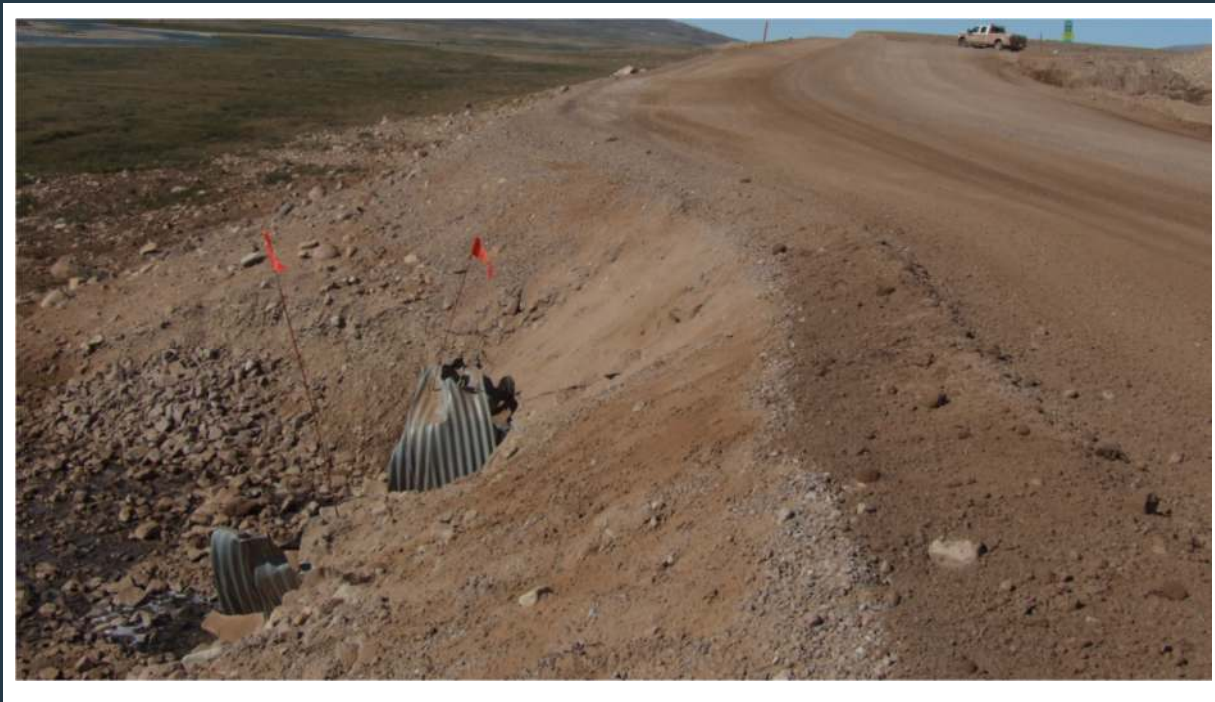
Both ends of this double-barrel culvert are damaged and too short, particularly at the outlet end.

Figure 100: View of culvert(s) 114D (somewhat damaged outlet). Repair and extension is required.

Baffinland Action: Baffinland commits to further inspecting this culvert to determine if replacement with a longer, larger pipe is required. If replaced, both pipes will be repaired and extended. Once the pipes are repaired and extended, the road embankment may be widened.

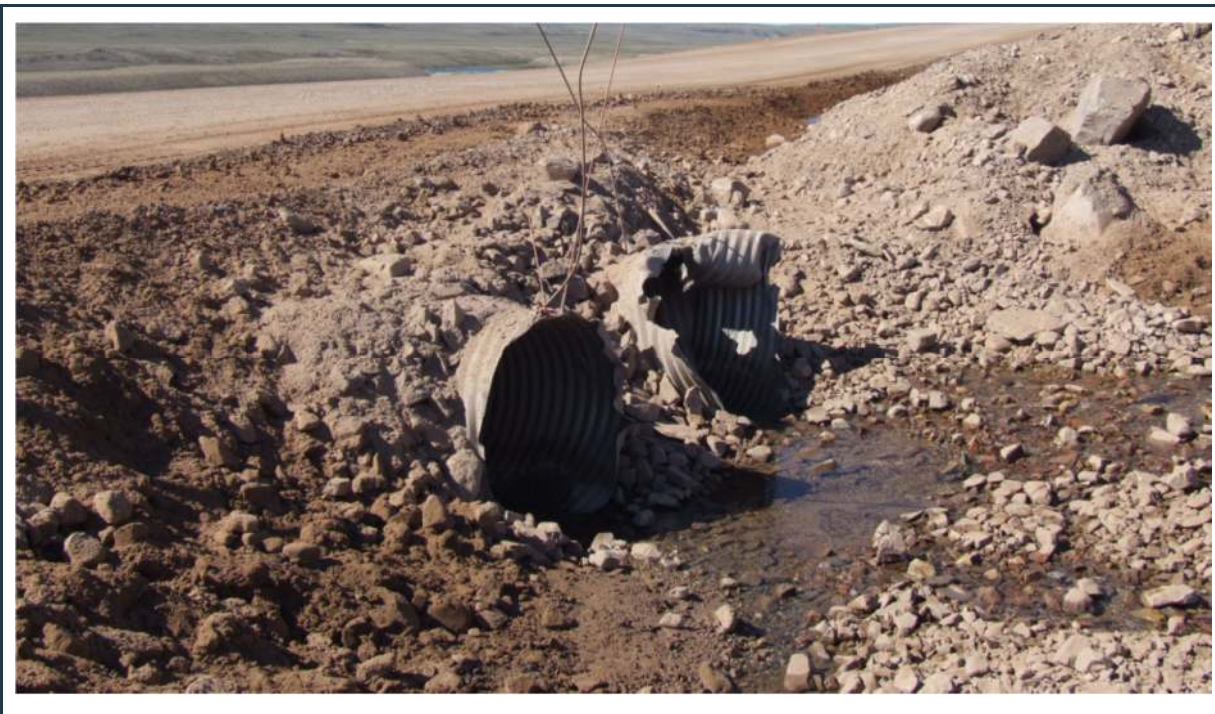
Figure 101: View of culvert(s) 114D (somewhat damaged inlet). Repair is required.

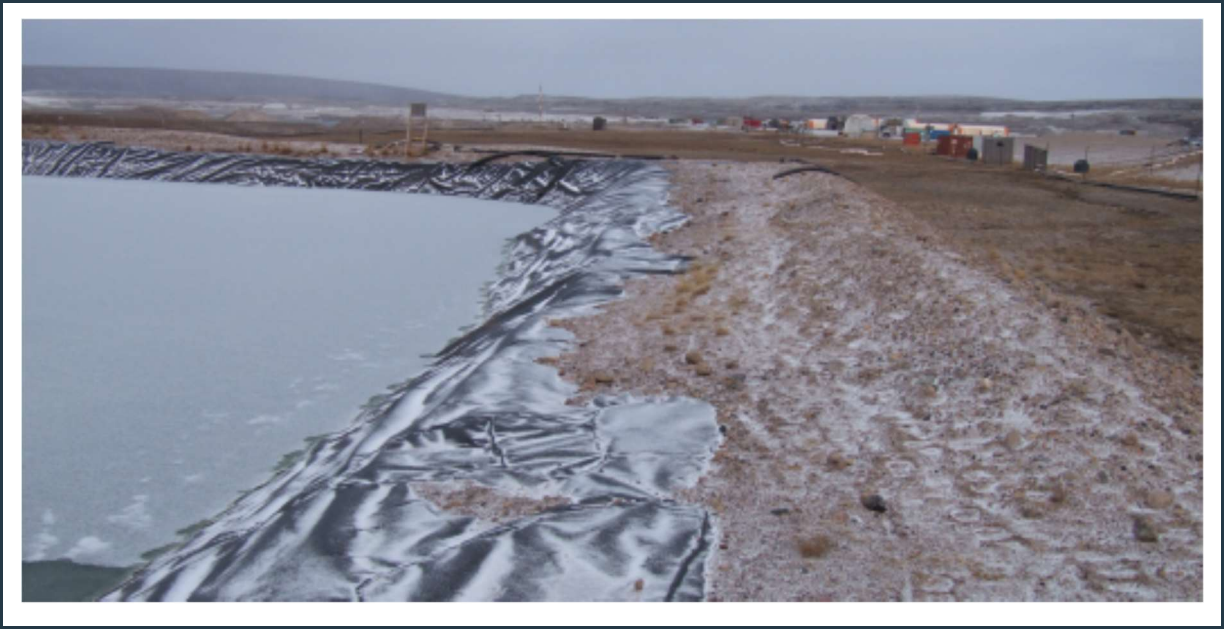
Figure 5: PWS pond #1 – View of repaired liner and additional fill on the berm's crest.

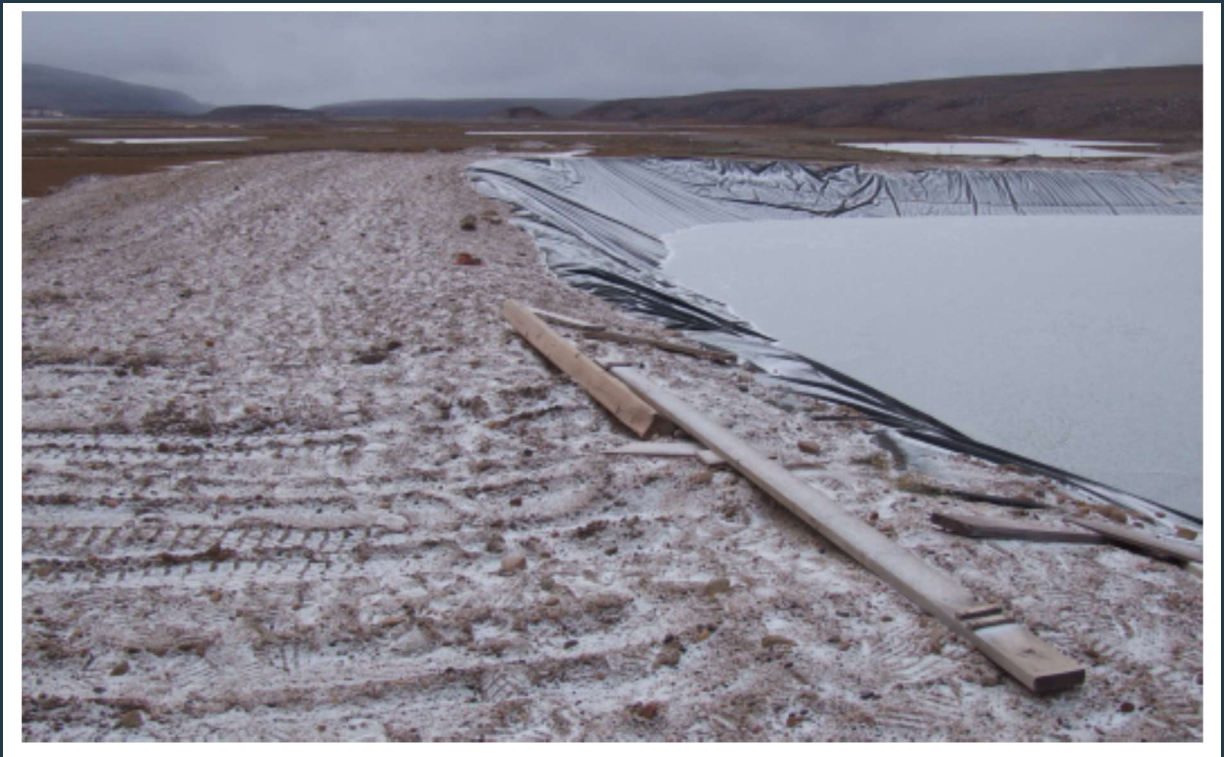
Figure 7: PWS pond #3 – Timber/lumber debris visible on the crest that should be removed.

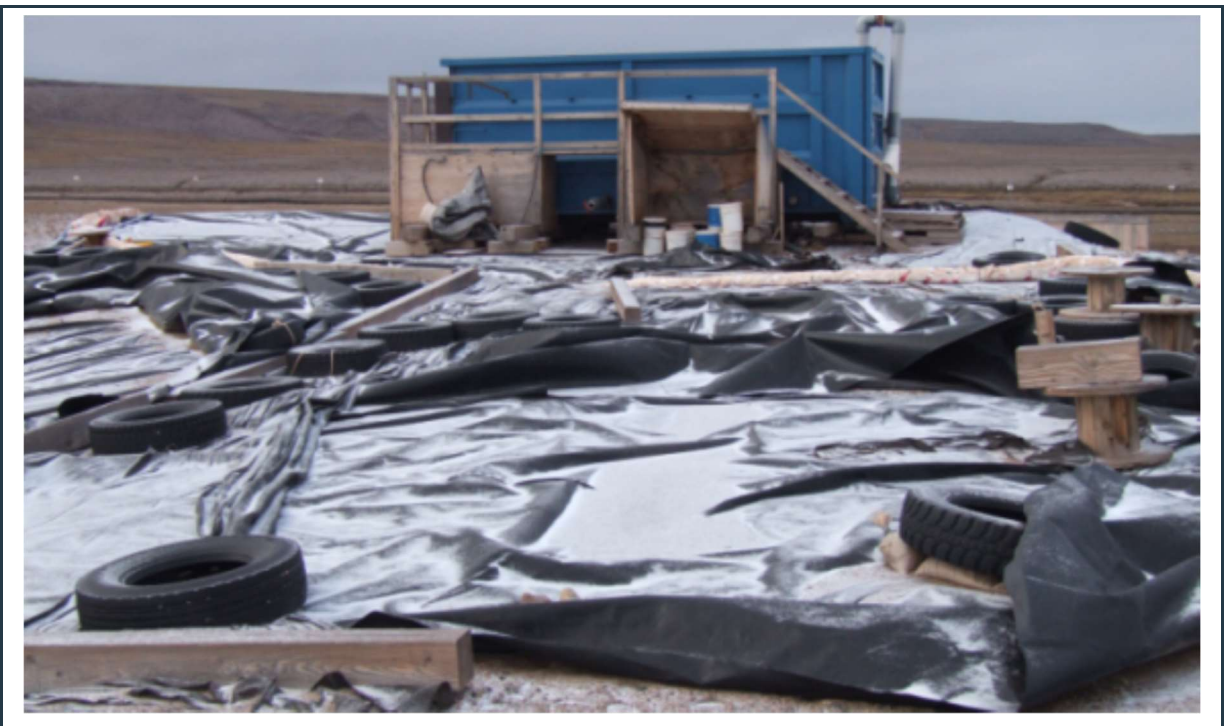
Figure 8: PWSP #2 and #3 – Untidy conditions at the water discharge point between ponds #2 and #3.

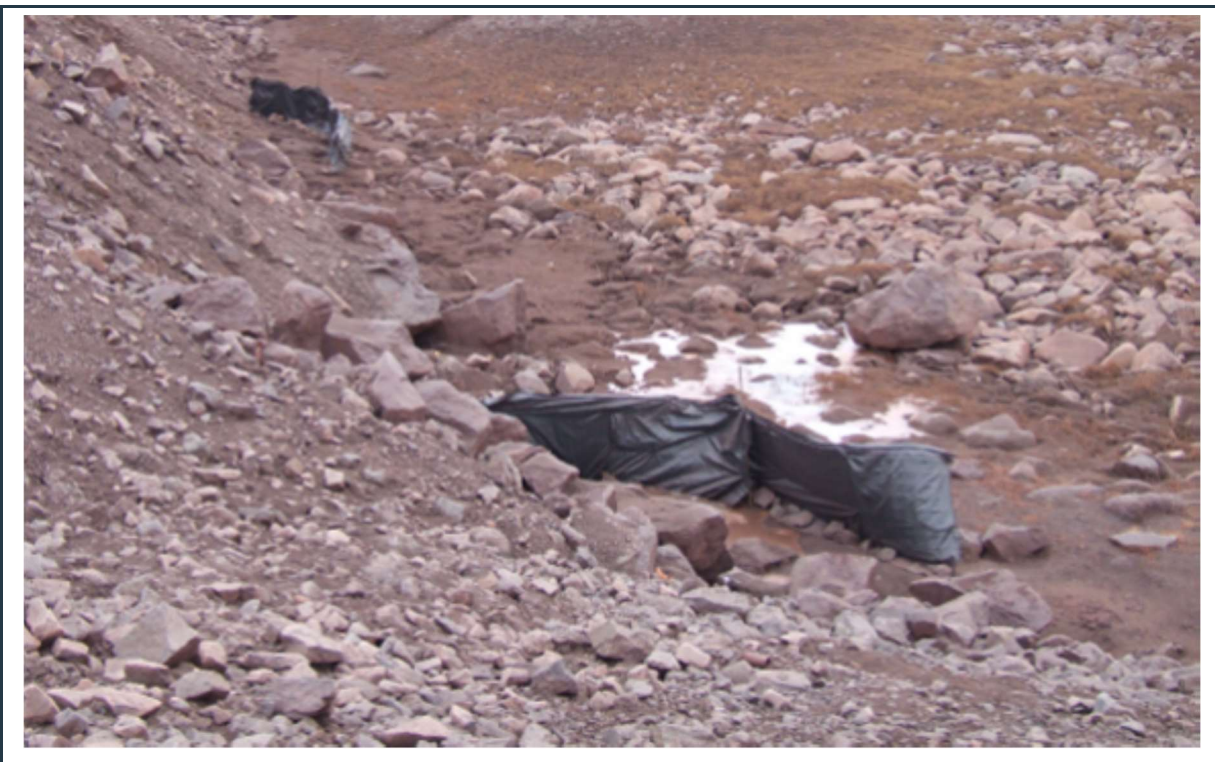
Figure 20: Minor water seepage as ice mount at the toe of the embankment where the crusher pad ditch embankment fill meets the tundra.
