**BAFFINLAND IRON MINES CORPORATION  
MARY RIVER PROJECT**

**FISH HABITAT MONITORING  
2019 ANNUAL REPORT  
EARLY REVENUE PHASE - TOTE ROAD UPGRADES**

2019-12-31	0

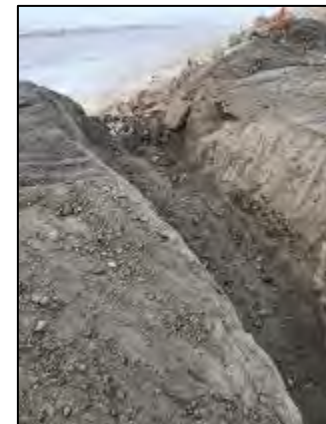
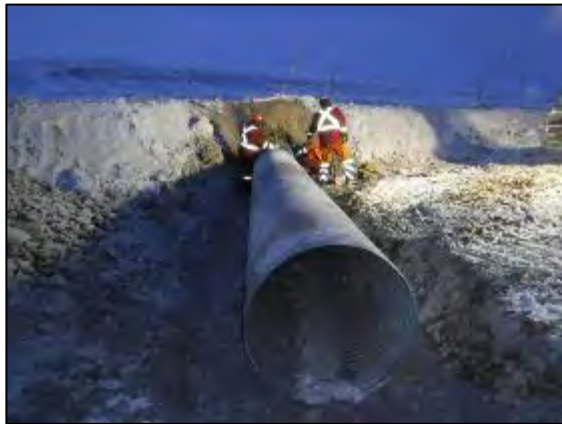
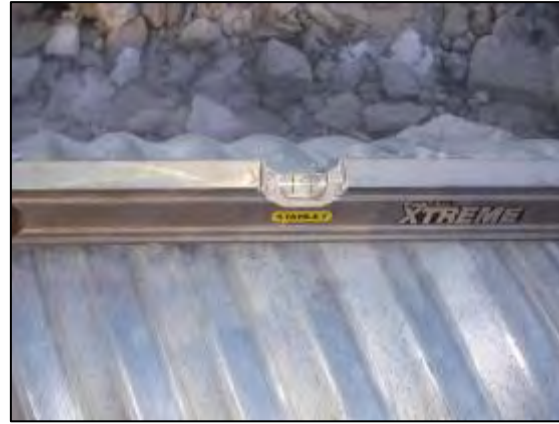
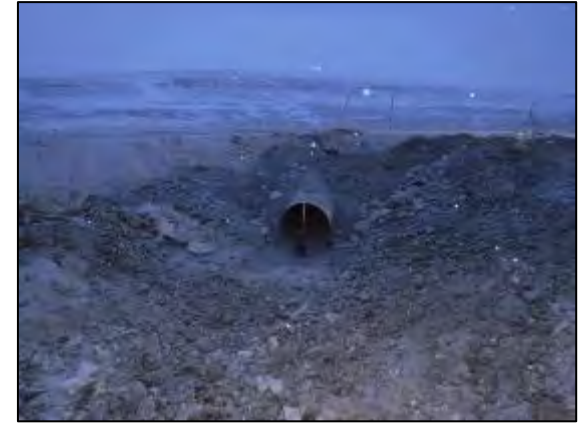
**Photos 1:** Photographs of the culvert crossing at CV-111 (KM 32) (A-C) before, (D-H) during, and (I-L) after construction works to replace existing culverts with a single new culvert. Work was completed on 19 February 2019.

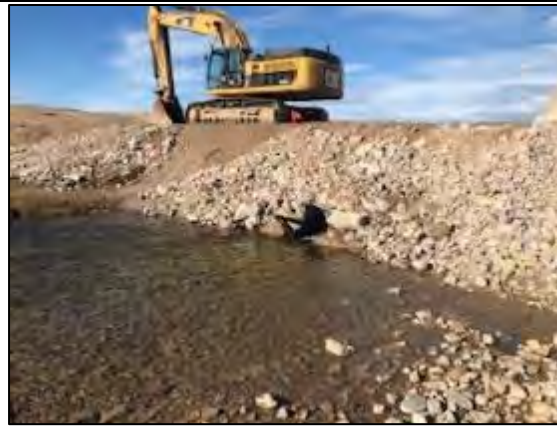
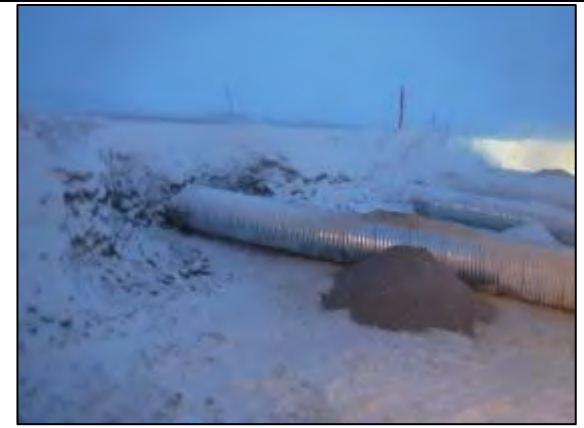
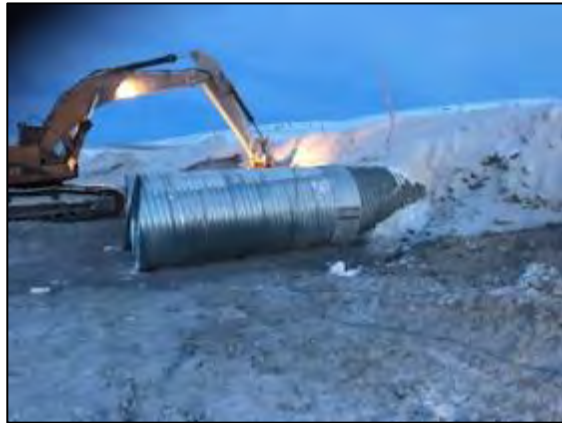
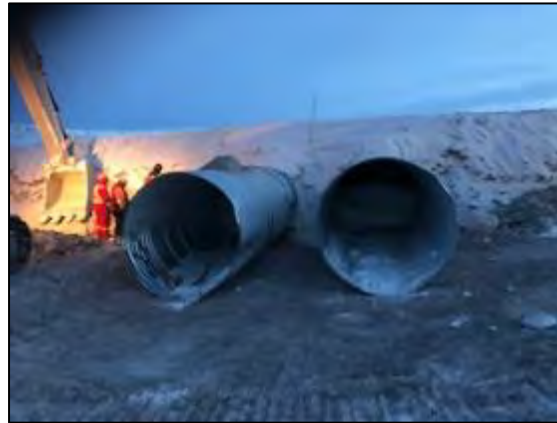
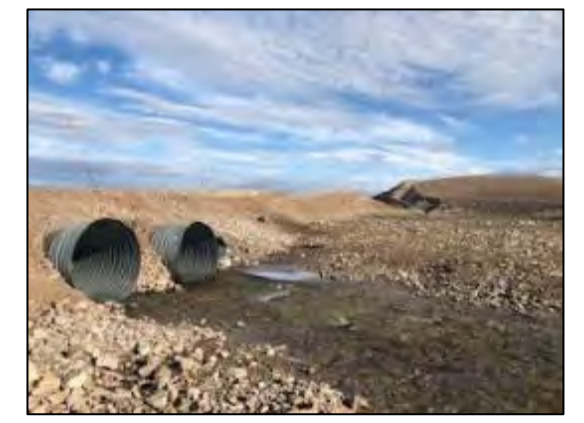
**Photos 2:** Photographs of the culvert crossing at CV-078 (KM 51) (A-E) during and (F) after construction works to add extensions to existing culverts. Work was completed on 7 January 2019.

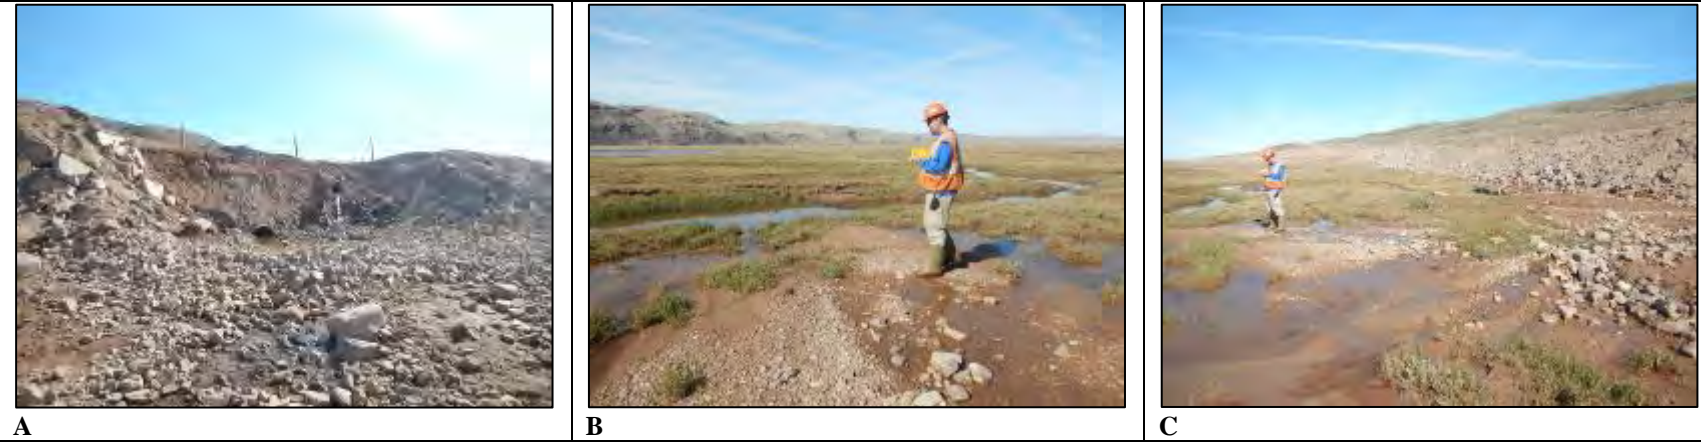
**Summary:** Anadromous juvenile Arctic Char occasionally use habitat downstream of the Tote Road, but a steep gradient at the crossing and a rocky barrier immediately downstream prevent access to the crossing and upstream habitat.

**Photos 1.** Photographs downstream of the Tote Road crossing CV-166: (A) looking upstream; (B) looking downstream; and (C) looking across.

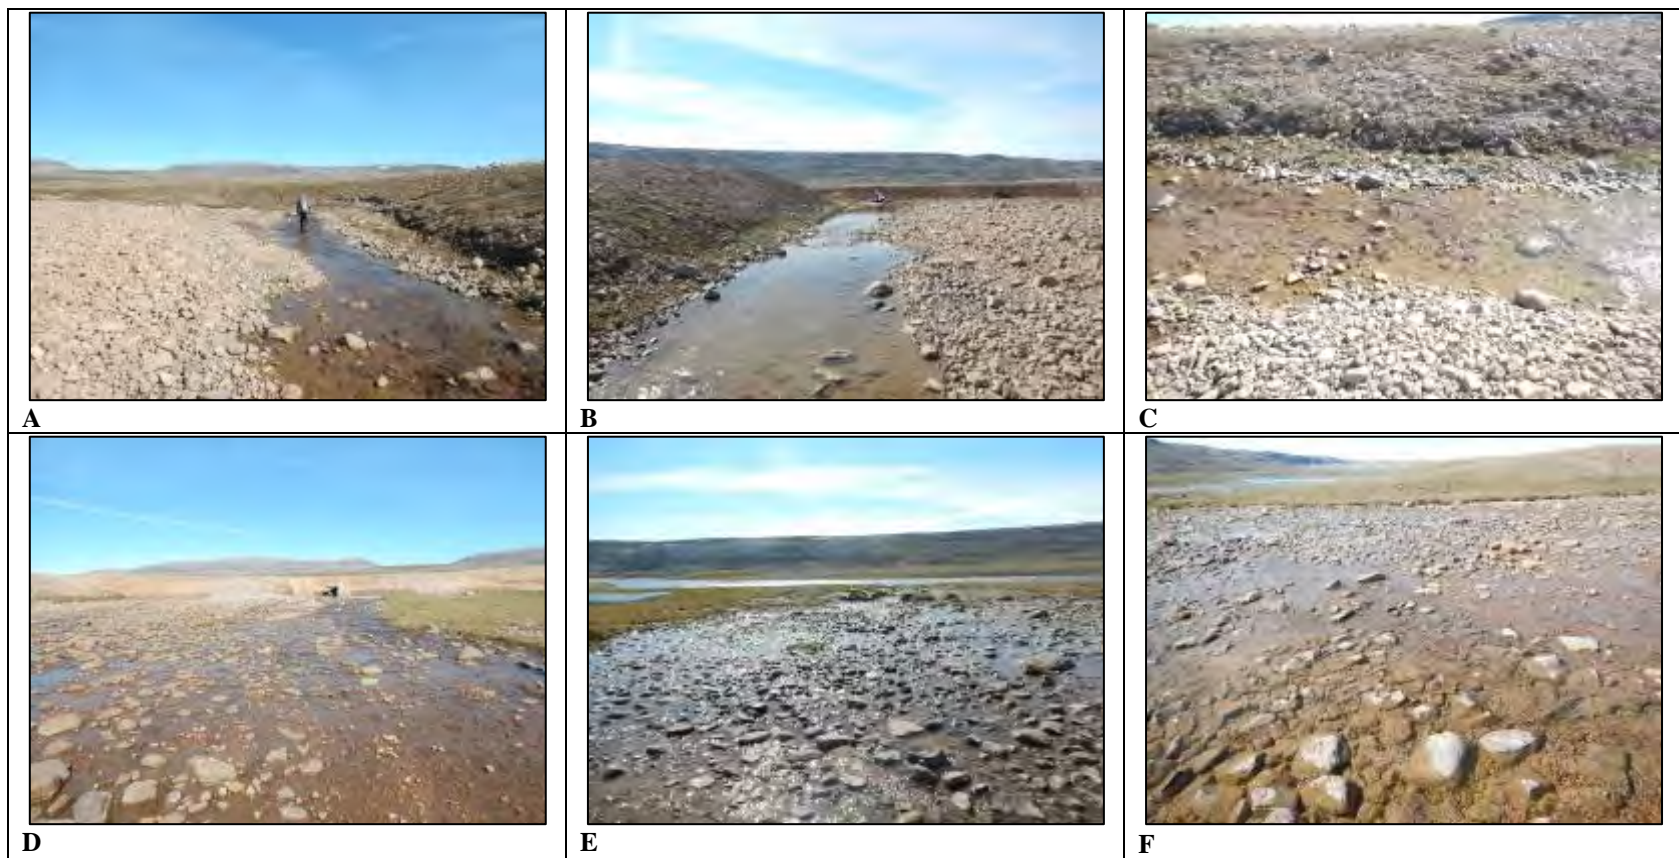
**Summary:** This site has consistently provided good quality summer rearing habitat for juvenile Arctic Char and is the first large stream upstream of the impassable falls on Phillips Creek (i.e., fish use is restricted to land-locked Arctic Char). Small culvert perch was remediated in fall 2019. Upstream overwintering lake provides additional habitat, so fall upstream movements could be as important as downstream, requiring full culvert access.

**Photos 1.** Photographs upstream of the Tote Road crossing CV-129: (A) looking upstream; (B) looking downstream; (C) looking across; and photographs downstream of the Tote Road: (D) looking upstream; (E) looking downstream; and (F) looking across.

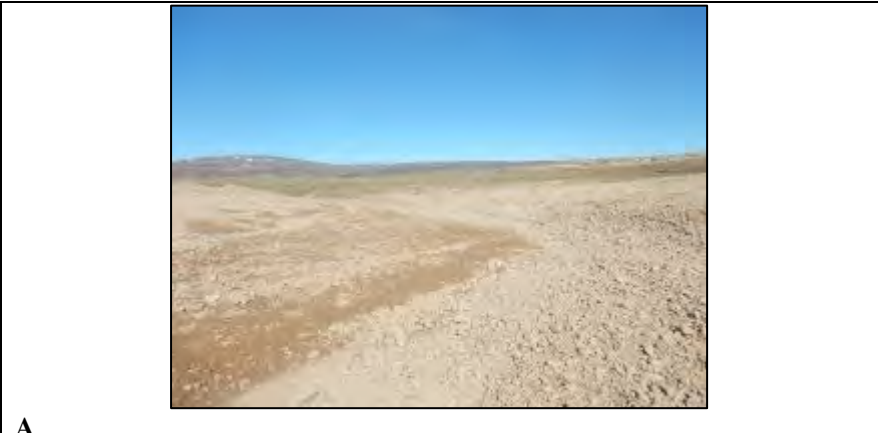
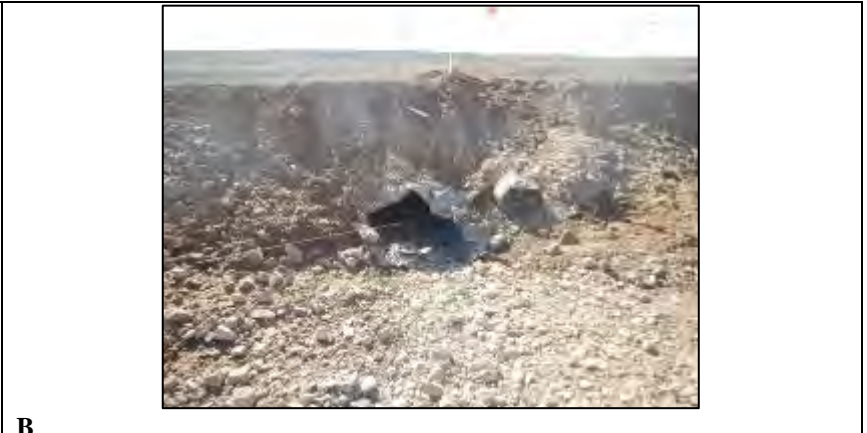
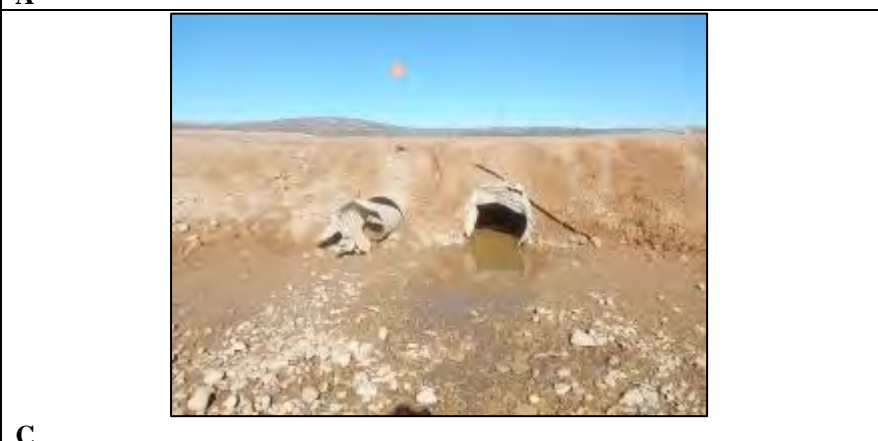
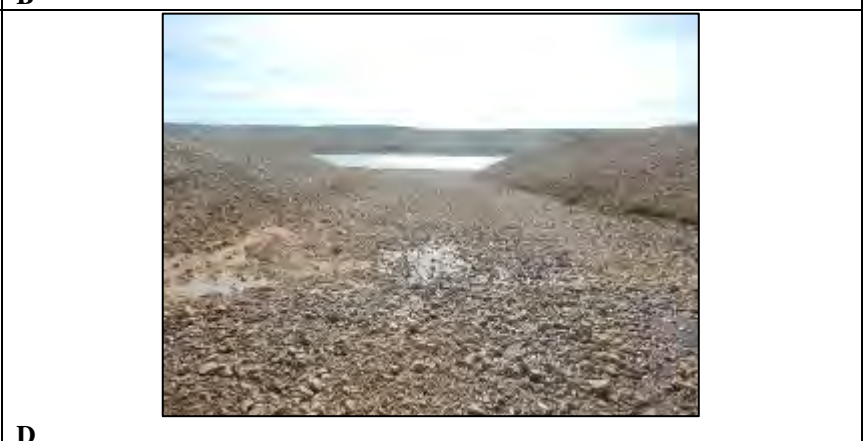
**Summary:** Stream has been regularly surveyed and is dry most years, including 2019. When wetted, small numbers of fish have been observed at the crossing.

**Photos 1.** Photographs upstream of the Tote Road crossing CV-115: (A) looking upstream; (B) looking downstream; and photographs downstream of the Tote Road: (C) looking upstream; and (D) looking downstream.

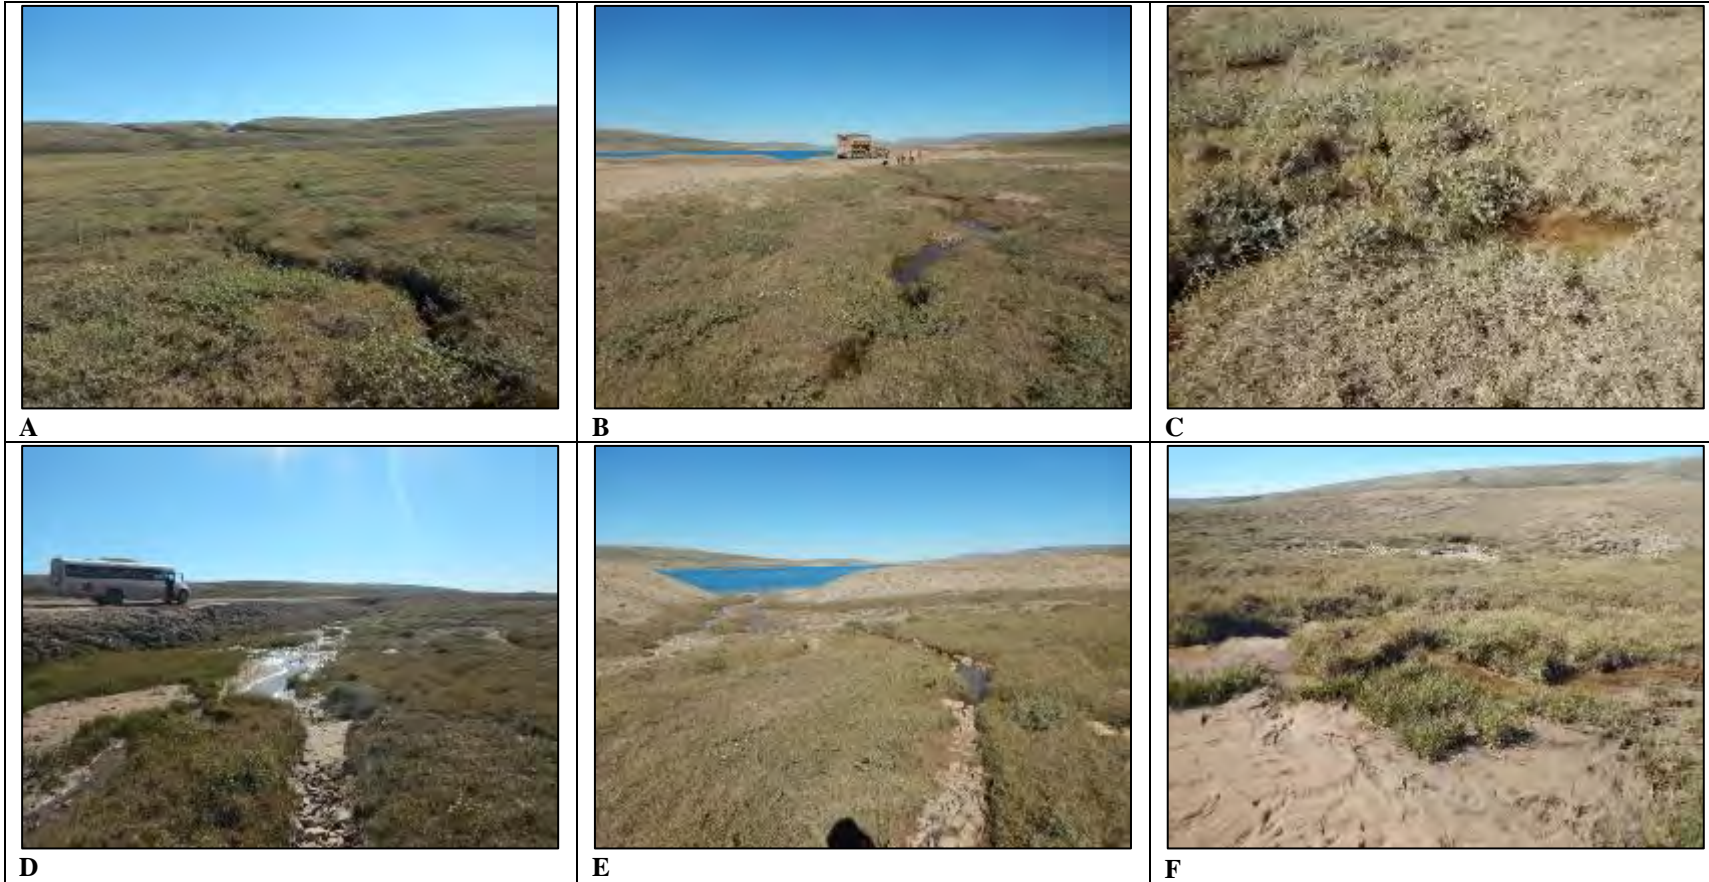
**Summary:** Stream provides summer rearing habitat for juvenile Arctic Char, though it dries up downstream of the culvert during periods of low water, as was observed in early summer 2019. An existing ramp (2018) designed to improve access received additional modifications in 2019.

**Photos 1.** Photographs upstream of the Tote Road crossing CV-106: (A) looking upstream; (B) looking downstream; (C) looking across; and photographs downstream of the Tote Road: (D) looking upstream; (E) looking downstream; and (F) looking across.

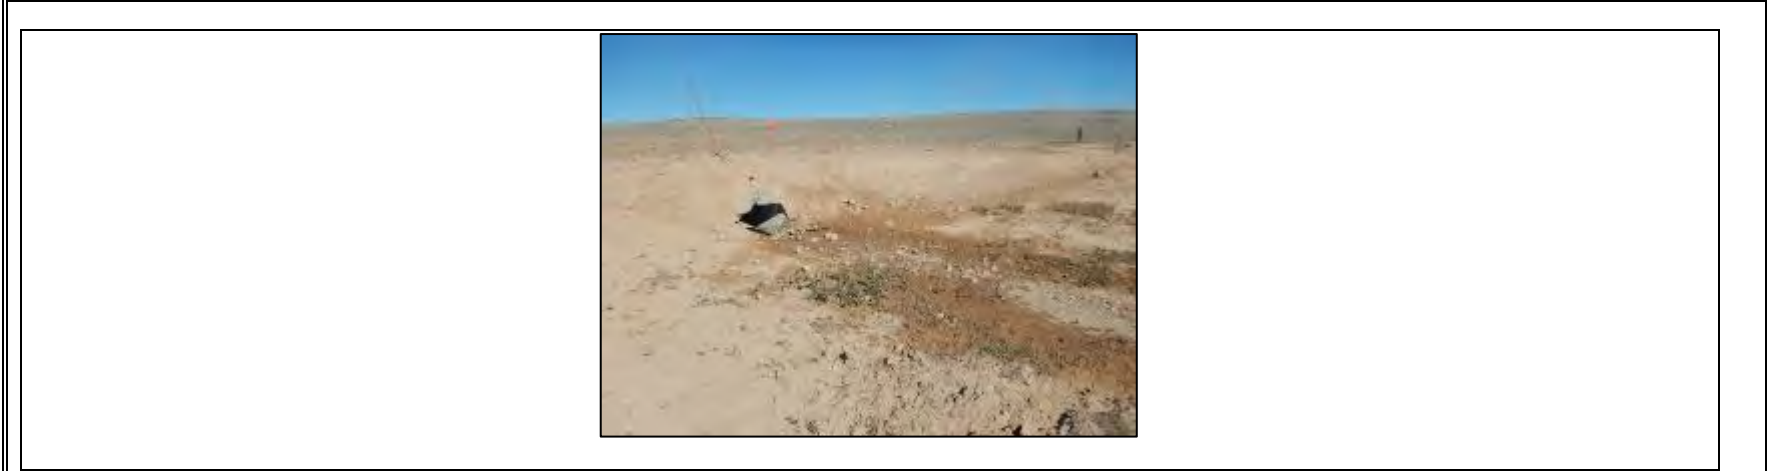
**Summary:** No natural channel or surface water and not connected to overwintering habitat.

**Photos 1.** Photograph of the Tote Road crossing CV-086 from downstream looking upstream.

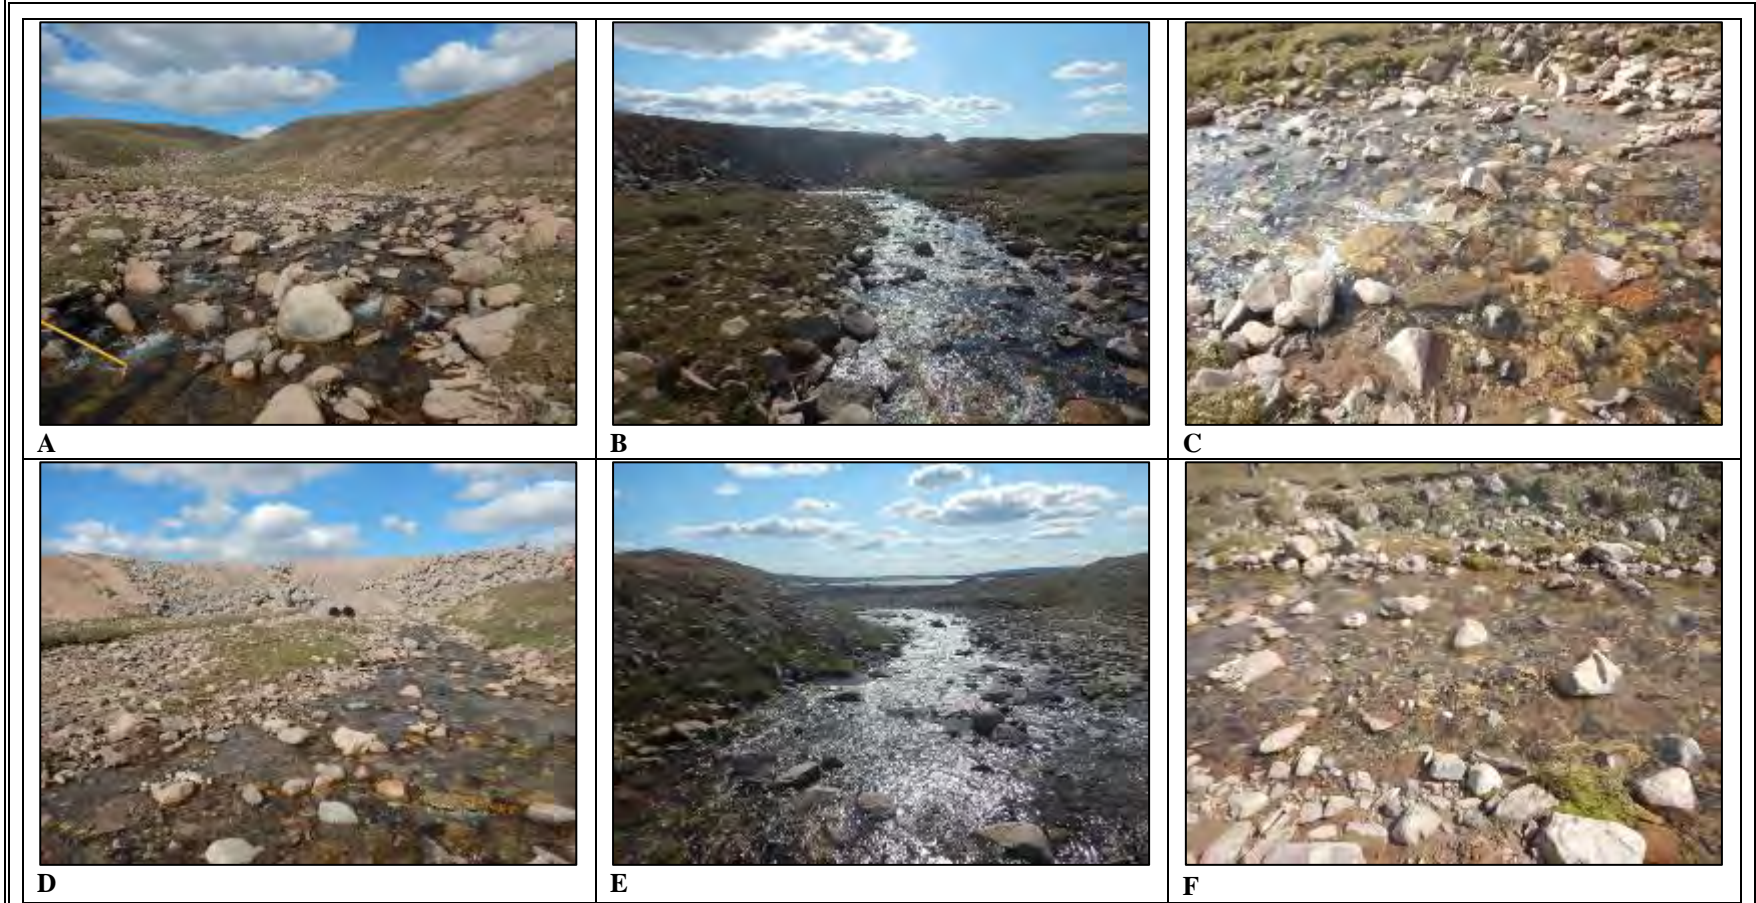
**Summary:** Site provides summer rearing habitat for both species. The culverts were slightly perched and measured velocities were too high for smaller fish at the downstream end of the culverts (0.91-1.42 m/s). Remediation has not yet been completed at this site.

**Photos 1.** Photographs upstream of the Tote Road crossing CV-225: (A) looking upstream; (B) looking downstream; (C) looking across; and photographs downstream of the Tote Road: (D) looking upstream; (E) looking downstream; and (F) looking across.

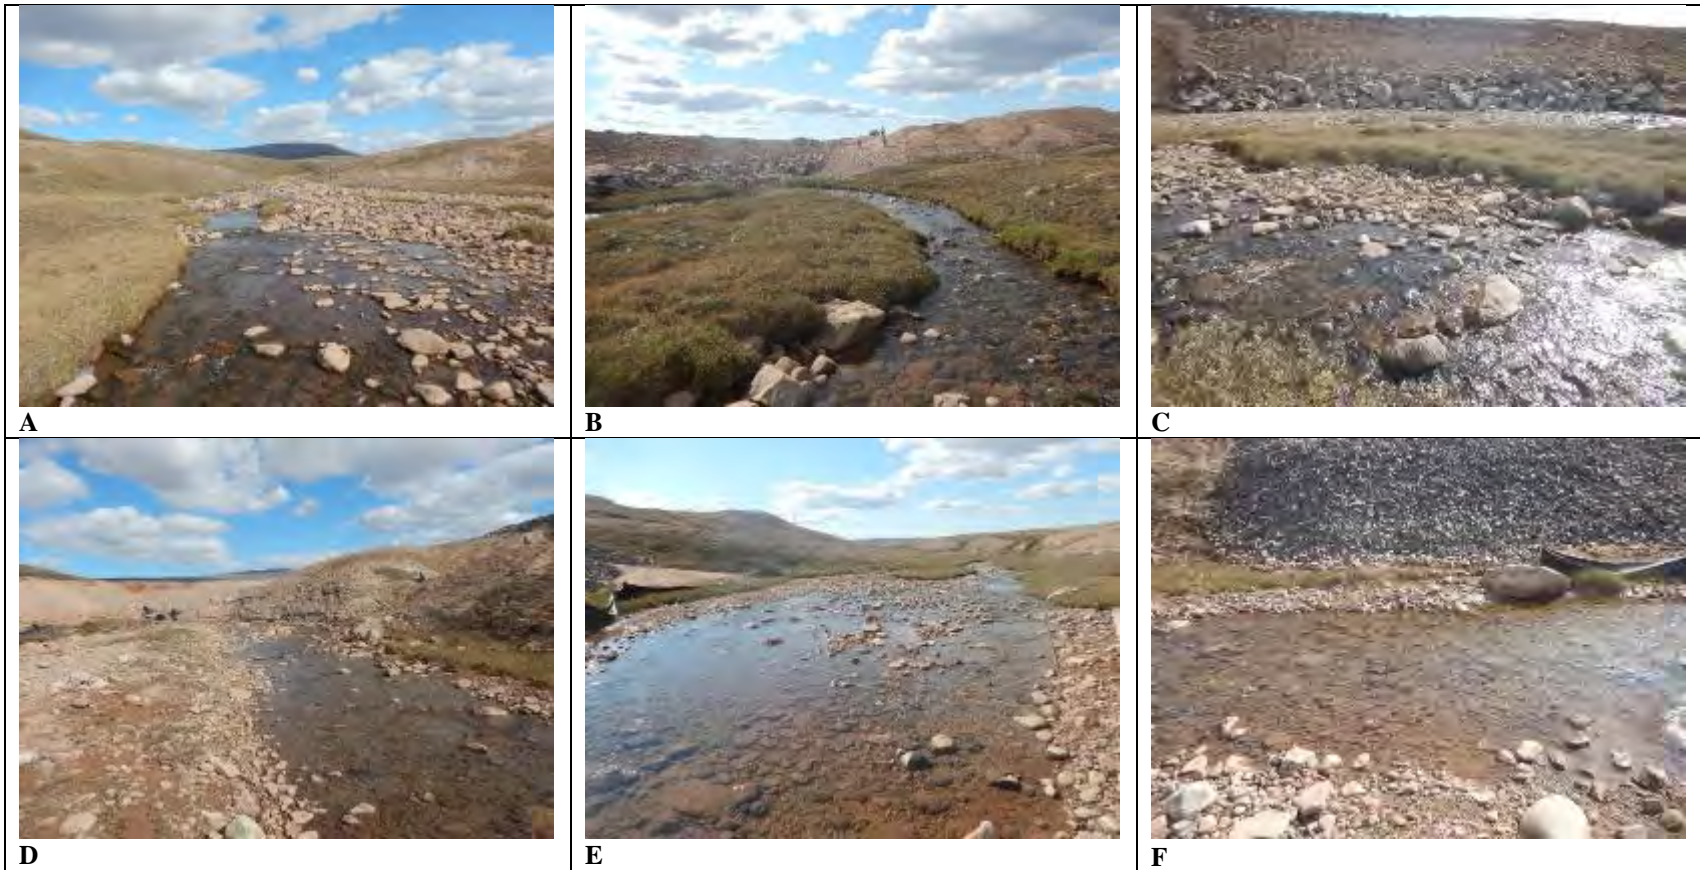
**Summary:** This stream provides summer rearing habitat for both species. Upstream of the road, rip rap had blocked fish access to a smaller tributary stream. Rip rap was removed and access restored in fall 2019.

**Photos 1.** Photographs upstream of the Tote Road crossing BG-01: (A) looking upstream; (B) looking downstream; (C) looking across; and photographs downstream of the Tote Road: (D) looking upstream; (E) looking downstream; and (F) looking across.

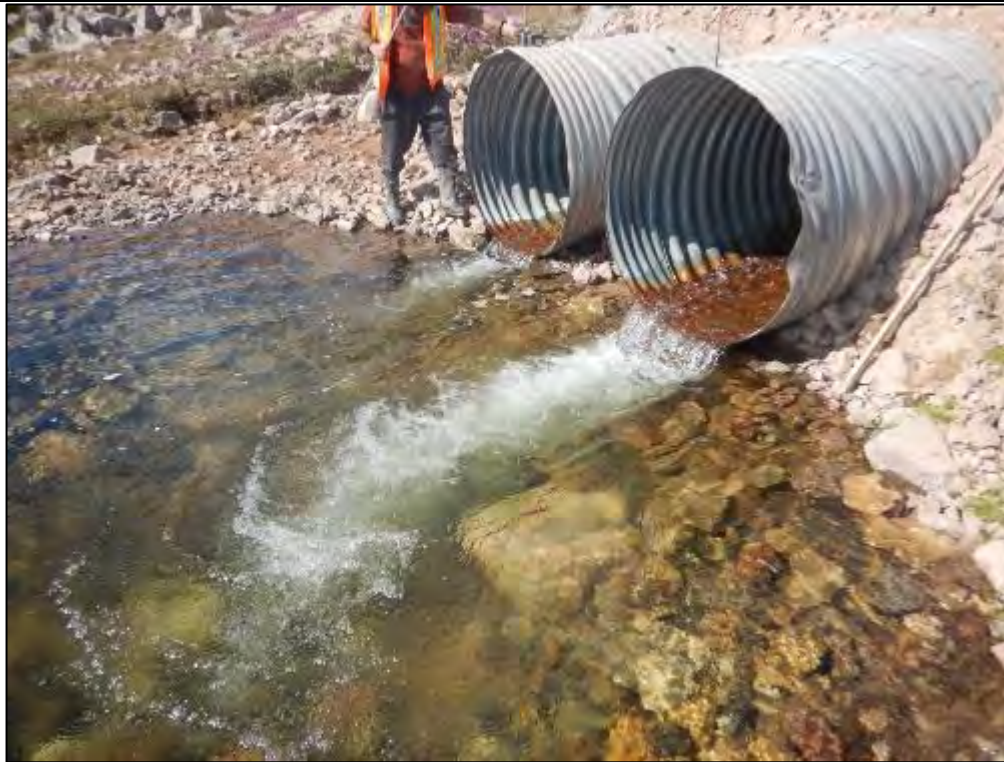
**Photos 8:** Photograph of the downstream end the perched culvert before remediation at CV-225. Remediation could not be completed in 2019.
