**BAFFINLAND IRON MINES CORPORATION
MARY RIVER PROJECT**

**FISH HABITAT MONITORING
2017 ANNUAL REPORT
EARLY REVENUE PHASE - TOTE ROAD UPGRADES**

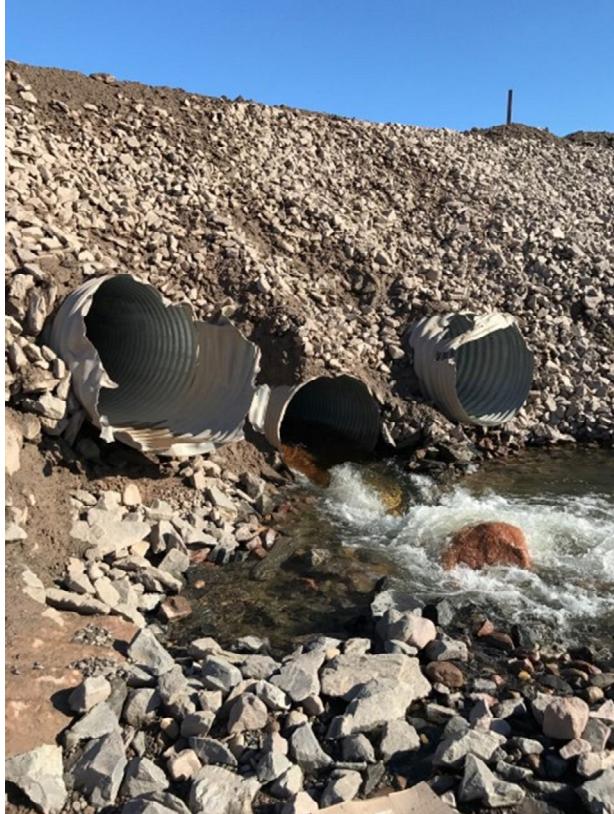
Figure 1. BG01 DS pre-construction 17-09-02

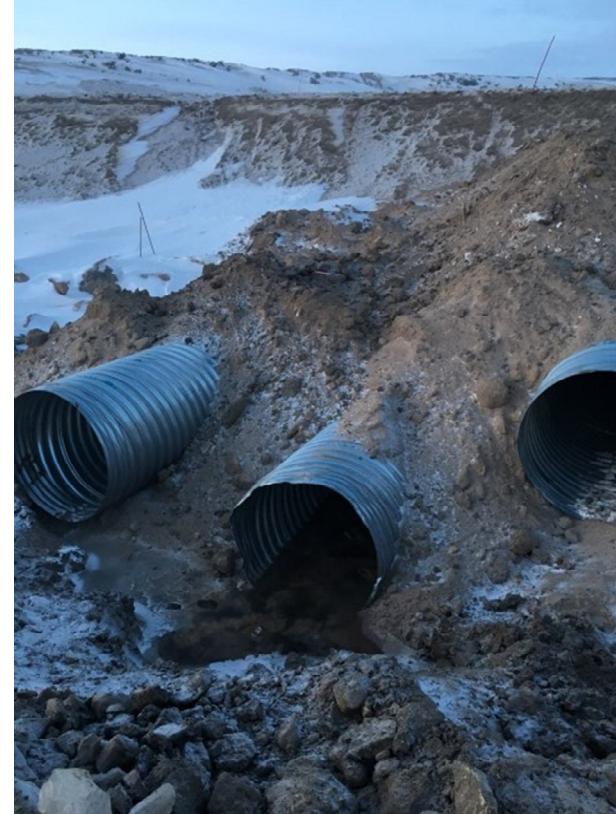
Figure 2. BG01 US mid-installation 17-10-05

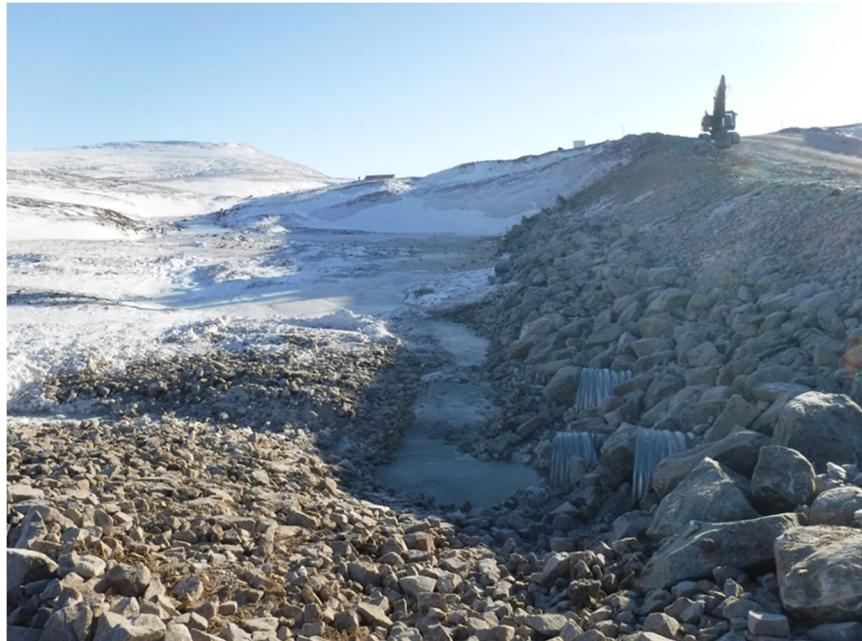
Figure 3. BG01 US installed 17-10-09

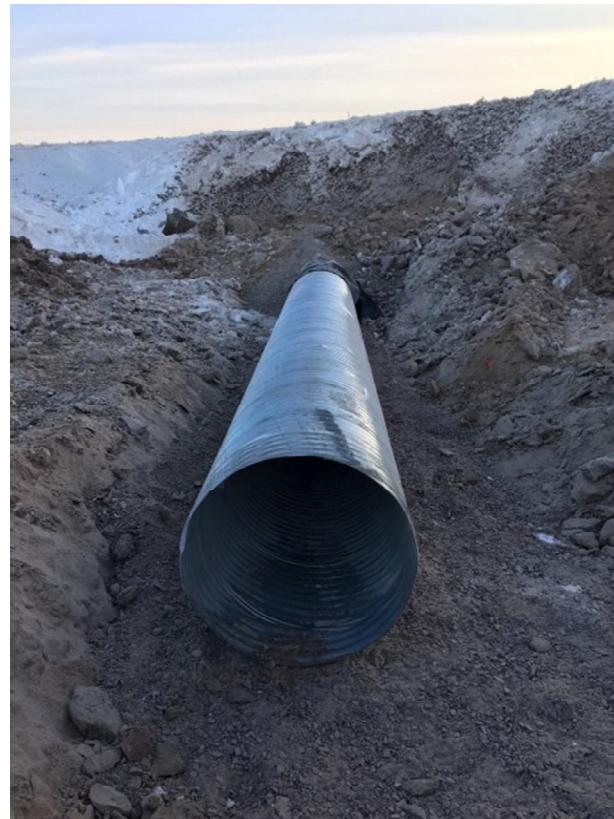
Figure 5. BG29 DS culvert extension
installation 17-11-07

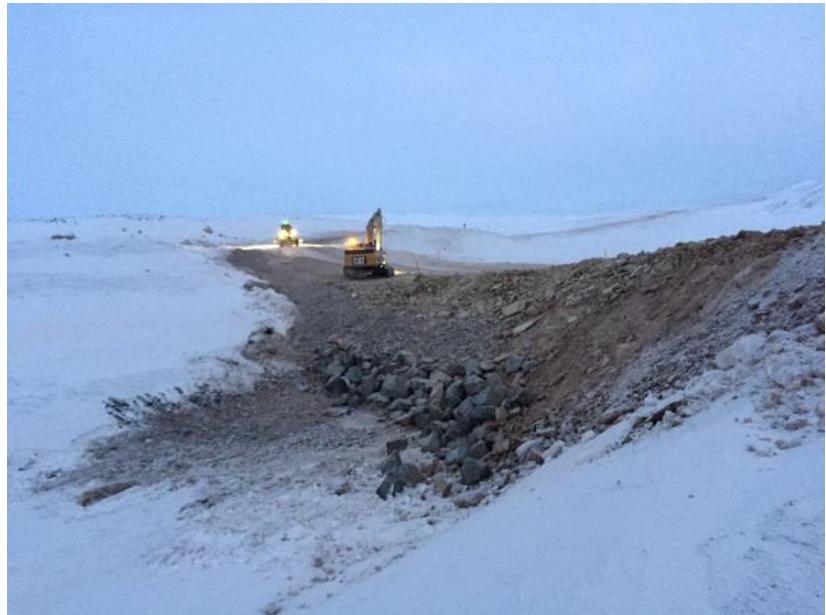
Figure 6. BG29 DS culvert extension installed
17-11-09

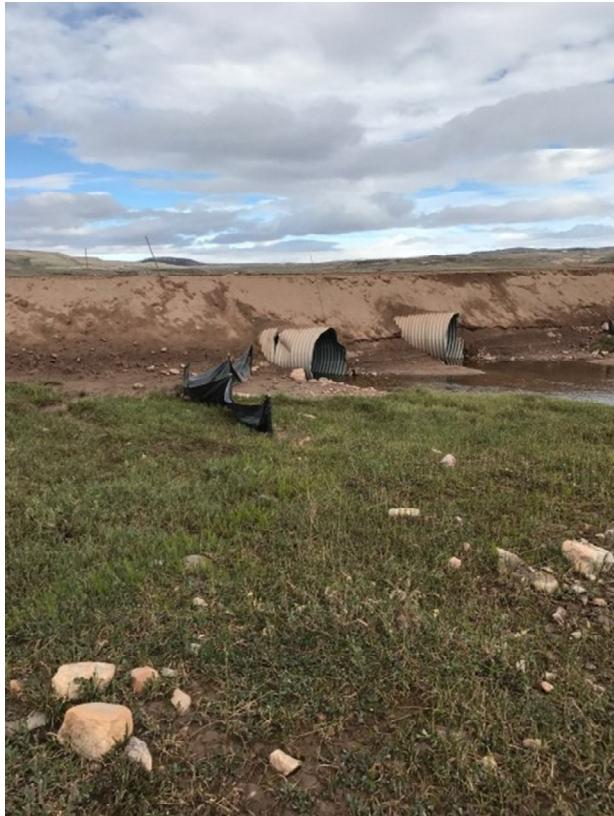
Figure 7. BG32 DS pre-culvert extension
17-07-24

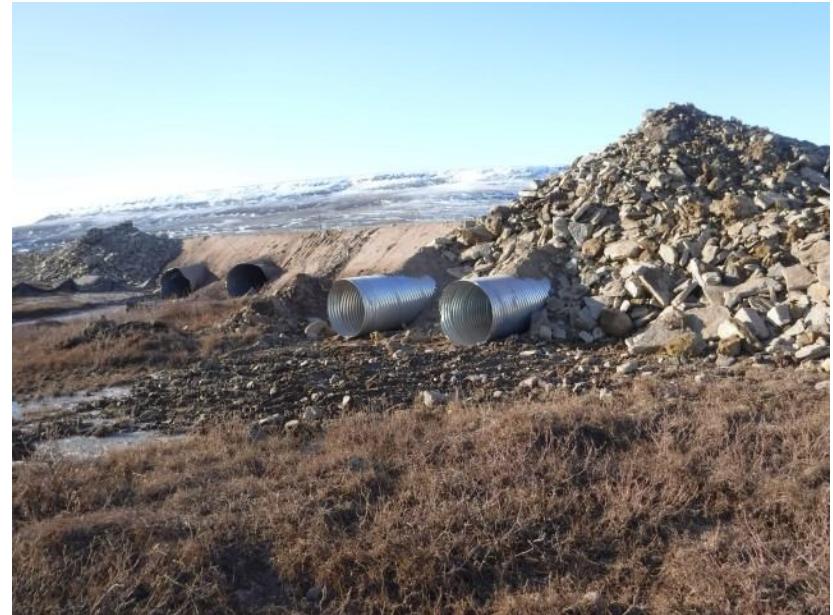
Figure 8. BG32 DS mid-culvert extension
installation 17-09-22

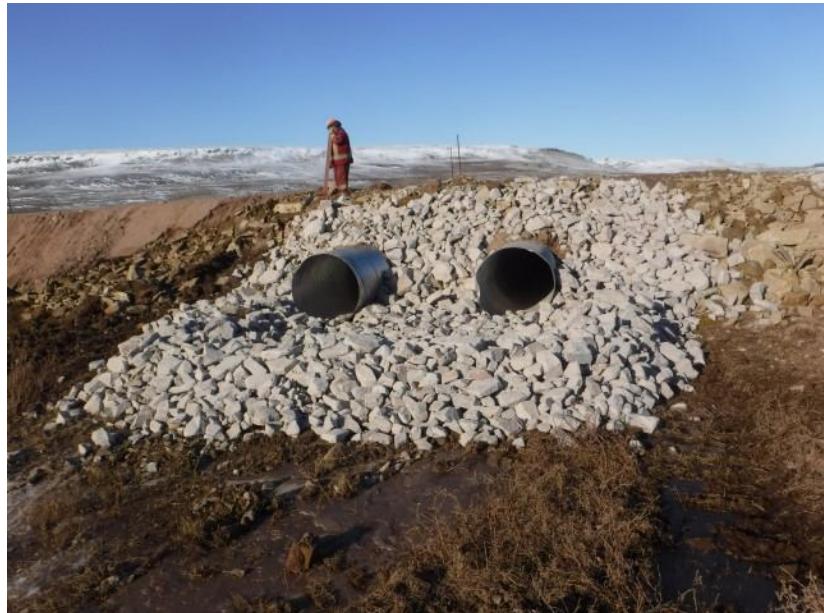
Figure 9. BG 32 DS culvert extension
completed 17-09-23

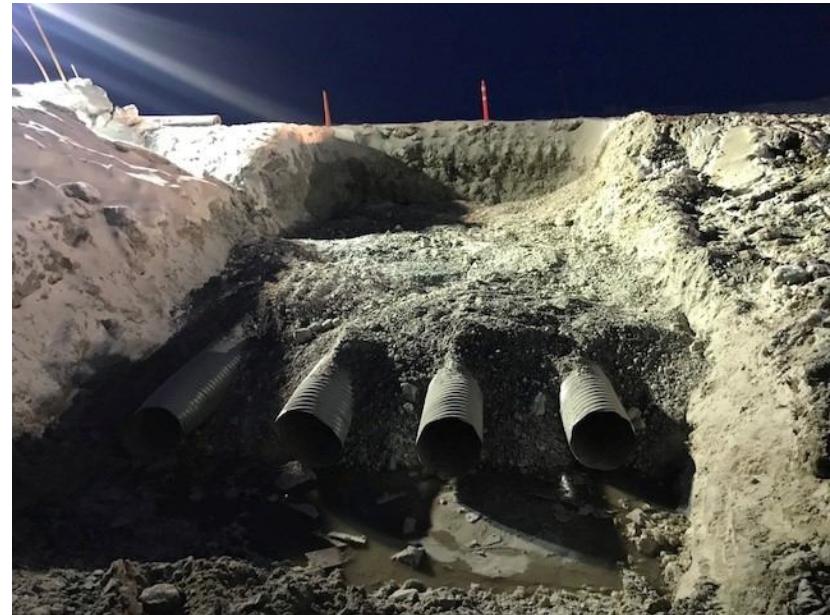
Figure 11. CV059 DS during culvert replacement 17-12-18

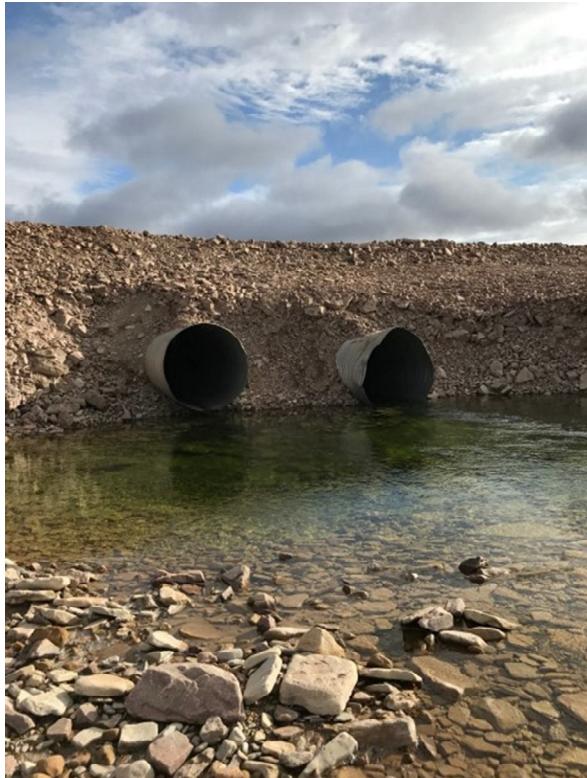
CV099	A37+343	Existing culverts were reinforced	17-12-03	1 x 1.2m diameter 1 x 2.0m diameter	Fish were observed upstream of the crossing. No fish passage or habitat issues identified.

Figure 12. CV099 DS pre slope embankment reinforcement 17-09-11

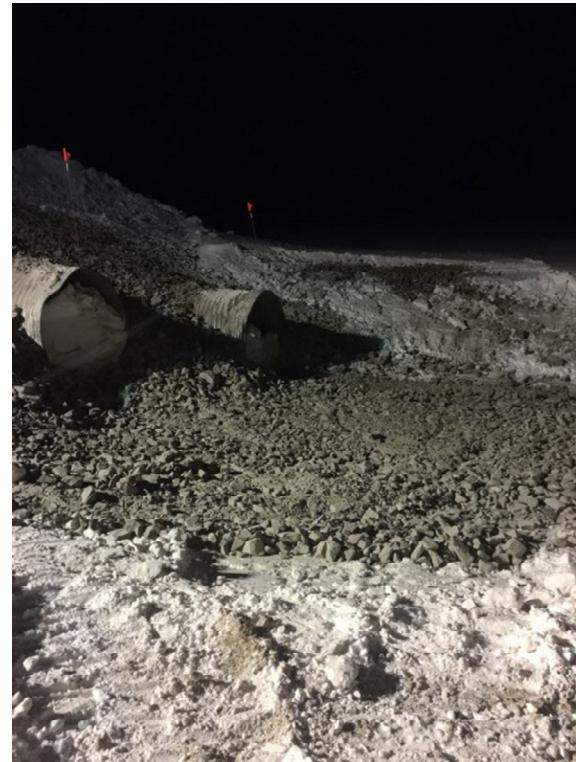
Figure 13. CV099 DS post slope embankment reinforcement 17-12-03

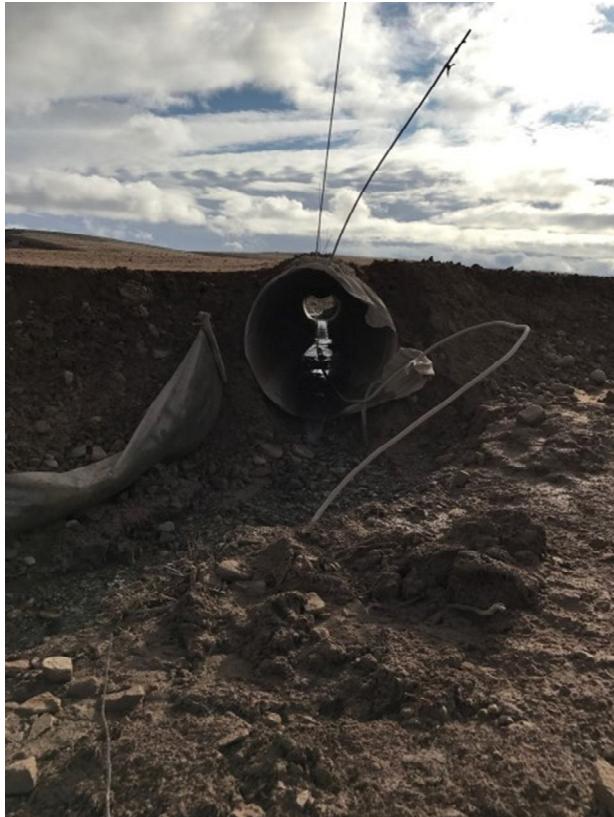
CV111	IMP	Y	Y	None	Fish observed upstream and downstream. No passage issues.	
CV106	MAR	Y	N	Yes	Vertical drop at upstream end of culvert has increased since 2016. Fish passage blocked	Culverts were extended in December 2017 after habitat assessment. Continue to monitor in 2018.
CV104	MAR	Y	Y	Yes	Right culvert in good condition and providing fish passage. Upstream end of left culvert is perched (culvert was damaged, but not perched in 2016) and passage in left channel is fully impeded	Repair culvert to prevent culvert becoming problem for fish passage. This culvert was replaced during the Fall 2016.

Figure 14. CV106 DS pre-culvert extension
17-09-11

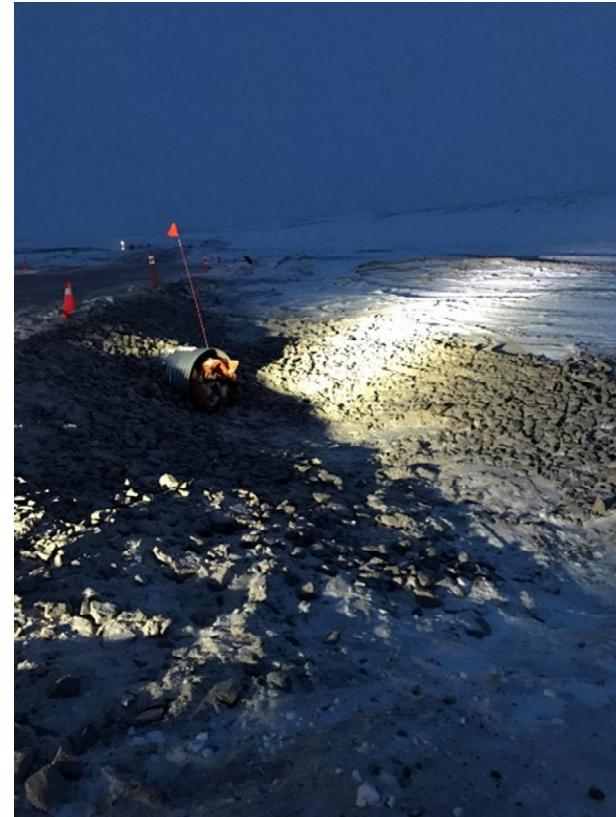
Figure 15. CV106 DS post-culvert extension
17-12-03

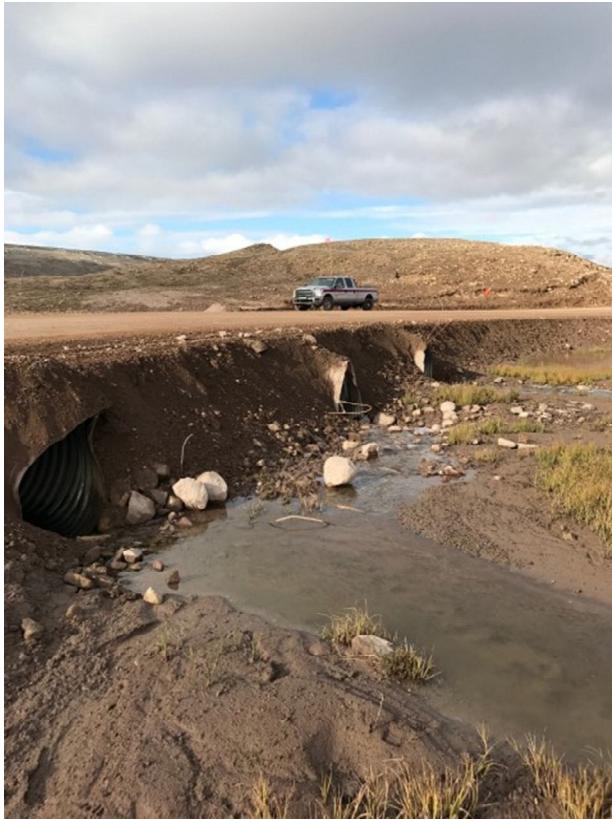
Crossing	Road Chainage (km.m)	Completed Work	Date Completed	Current Crossing Configuration	Fisheries Survey Conducted July 2017 ¹
CV112	A30+947	Existing culverts were extended	17-11-04	3 x 1.2m diameter	Fish were observed both upstream and downstream of the crossing. While movement through the left culvert is fine, the right culvert is badly damaged and may be blocking passage.
CV106	A32+681	Existing culverts were extended	17-12-01	1 x 1m diameter	Fish were observed downstream of the crossing. The culvert is perched too high for fish passage, with the vertical drop increasing since 2016.
CV059	A59+217	Existing culverts were replaced	17-12-18	4 x 0.5m diameter	Fish were observed downstream of the crossing. The culverts were submerged and damaged, with the potential for them to become blocked with substrate.
CV216	A80+951	Existing culverts were extended	17-10-05	3 x 1.2m diameter	Fish were observed downstream of the crossing. The culvert is perched too high for passage of young-of-the-year Arctic Char, which typically use this stream to access upstream habitat.

Figure 16. CV112 DS pre-culvert extension
17-09-11

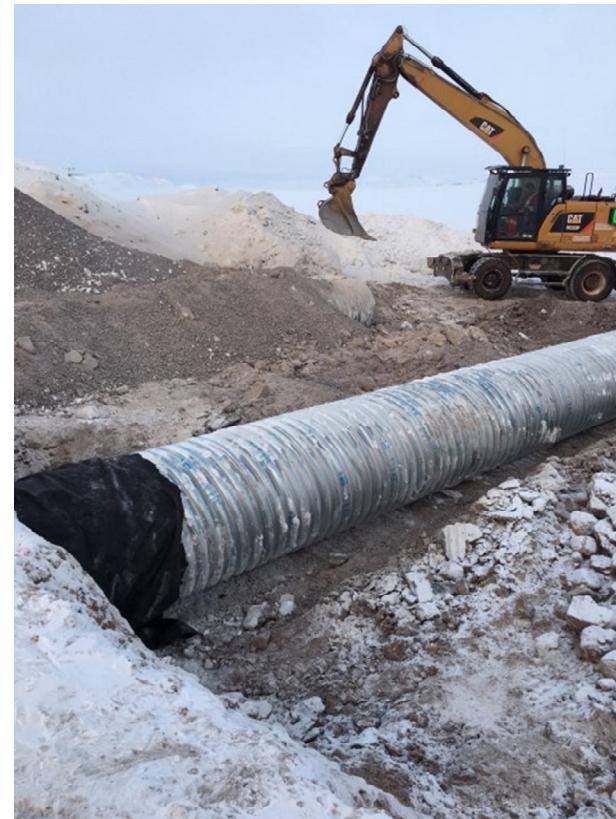
Figure 17. CV112 DS culvert extension
installation 17-11-04

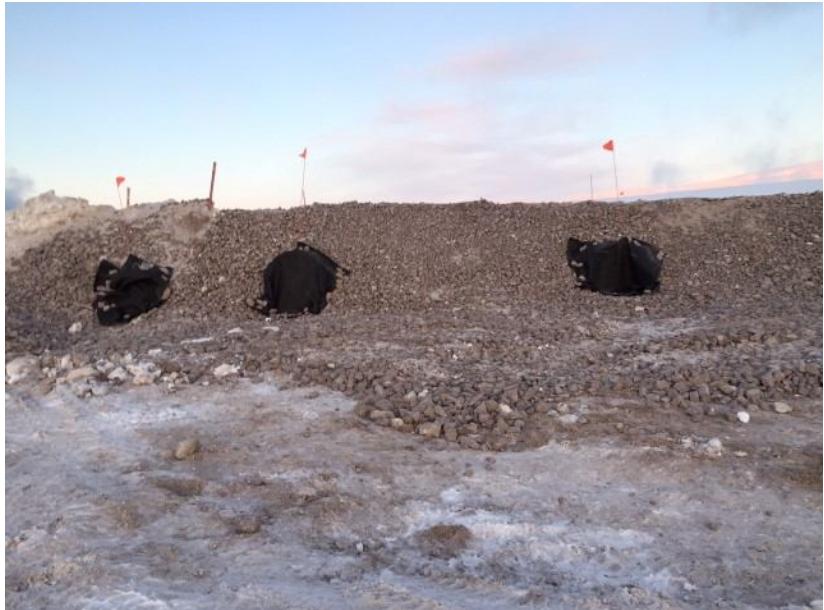
Figure 18. CV112 DS post-culvert extension
17-11-04

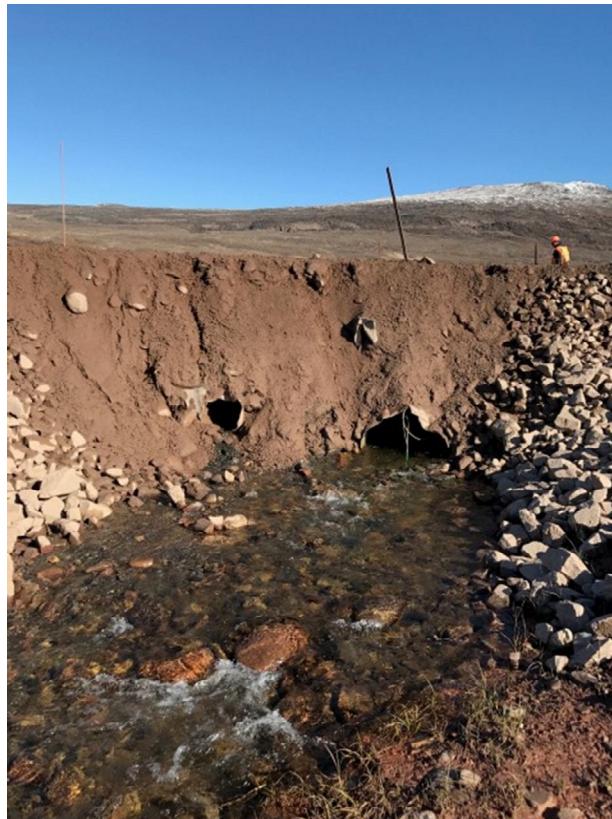
Figure 19. CV186 DS pre-culvert extension
17-09-02

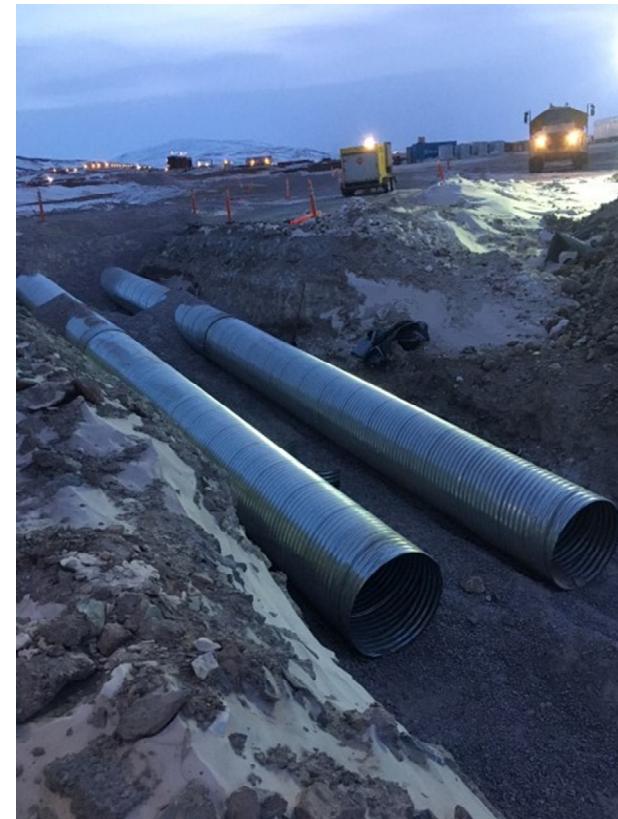
Figure 20. CV186 DS culvert extension
17-11-28

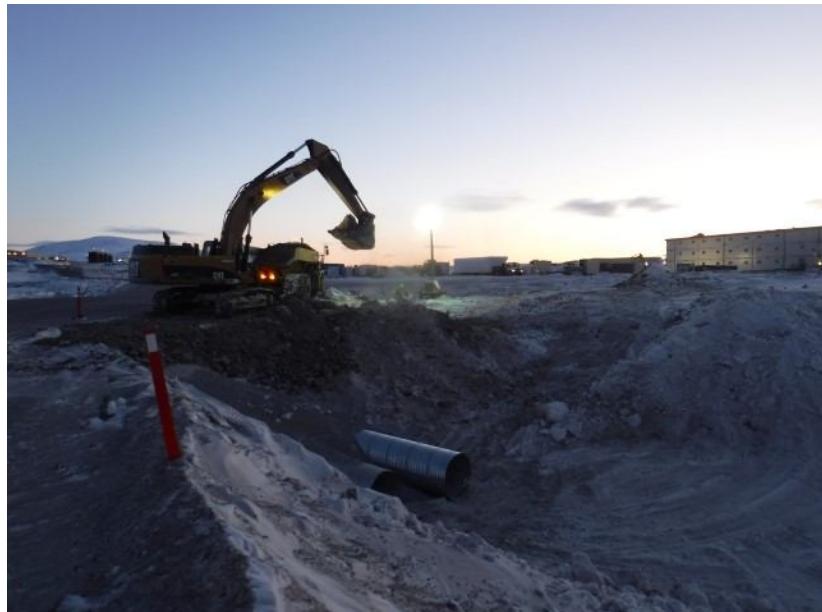
Figure 21. CV186 DS culvert installation
17-11-27

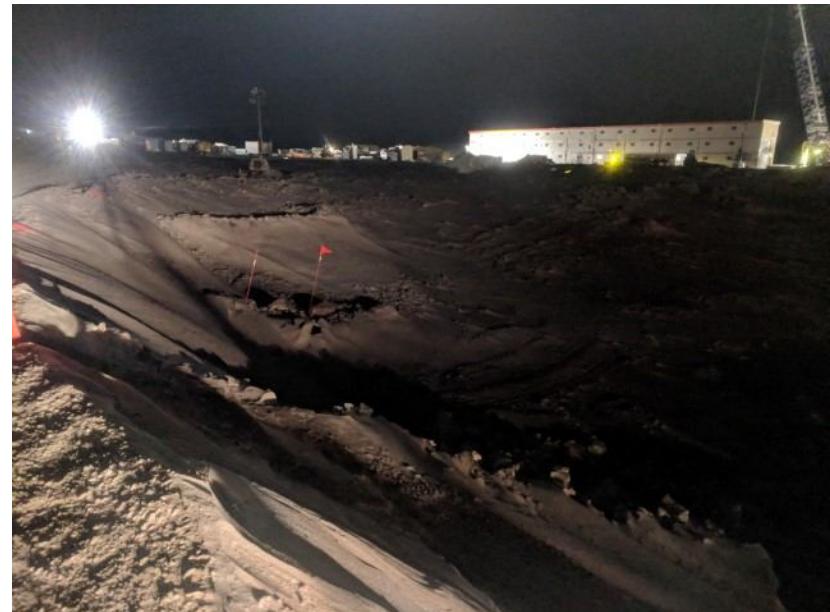
Figure 22. CV186 DS culvert extension
completed 17-12-01

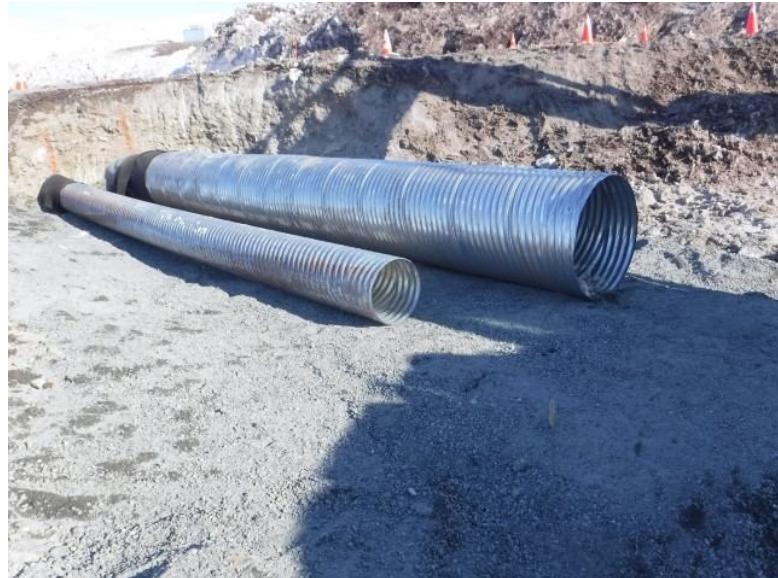
Figure 23. CV187 US culvert extension
17-04-23

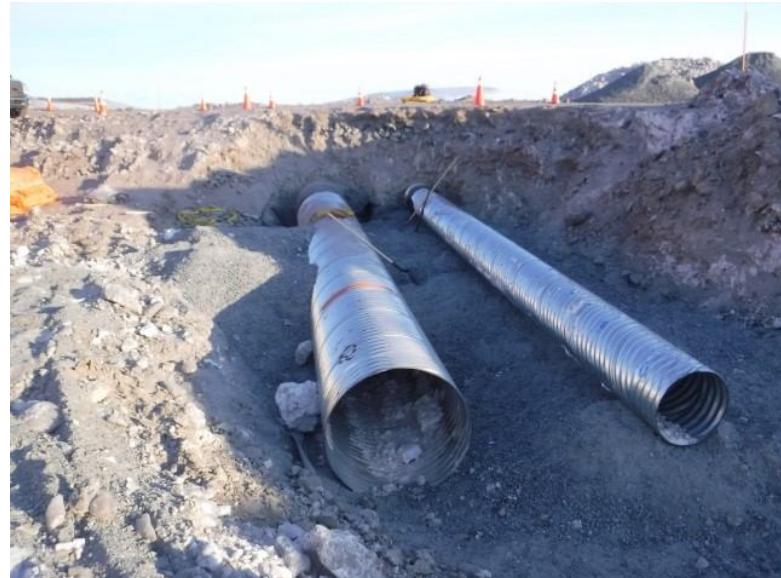
Figure 24. CV187 DS culvert extension
17-04-20

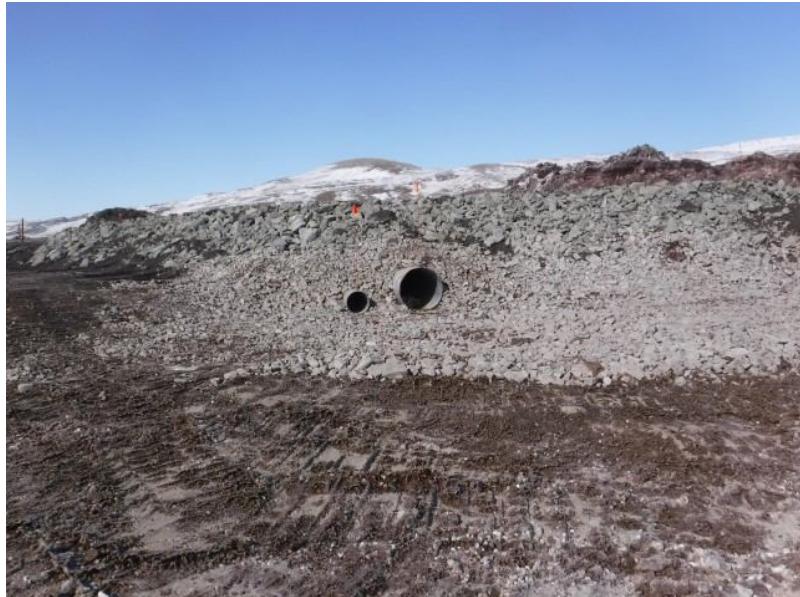
Figure 25. CV187 US culvert extension
completed 17-04-24

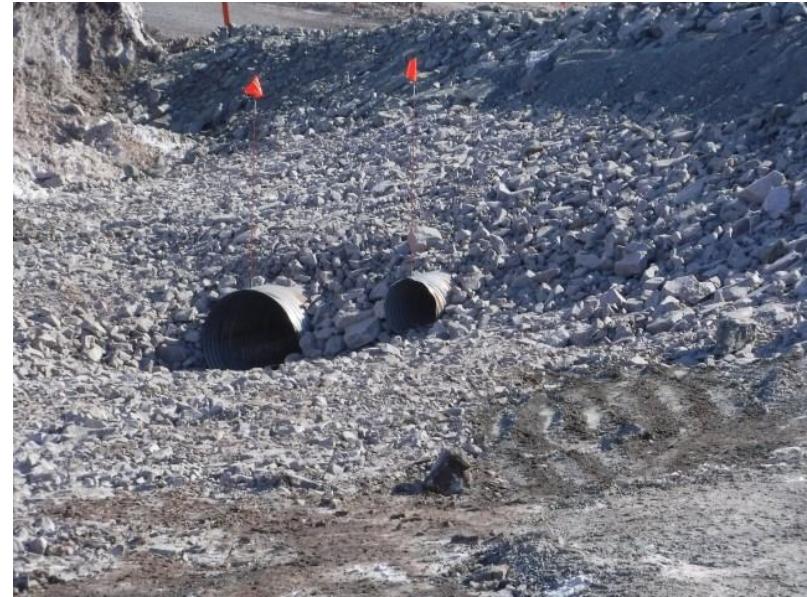
Figure 26. CV187 DS culvert extension
completed 17-04-24

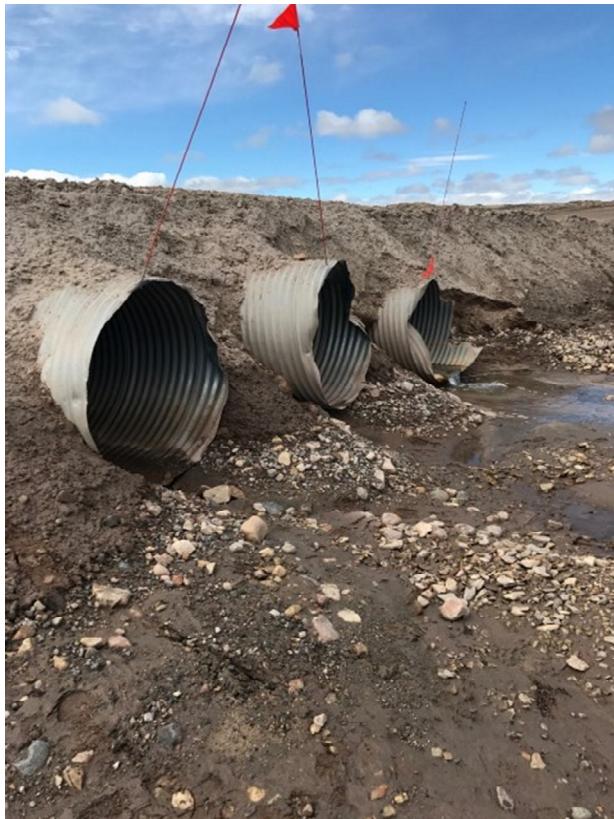
Figure 27. CV216 DS pre-culvert extension
17-07-24

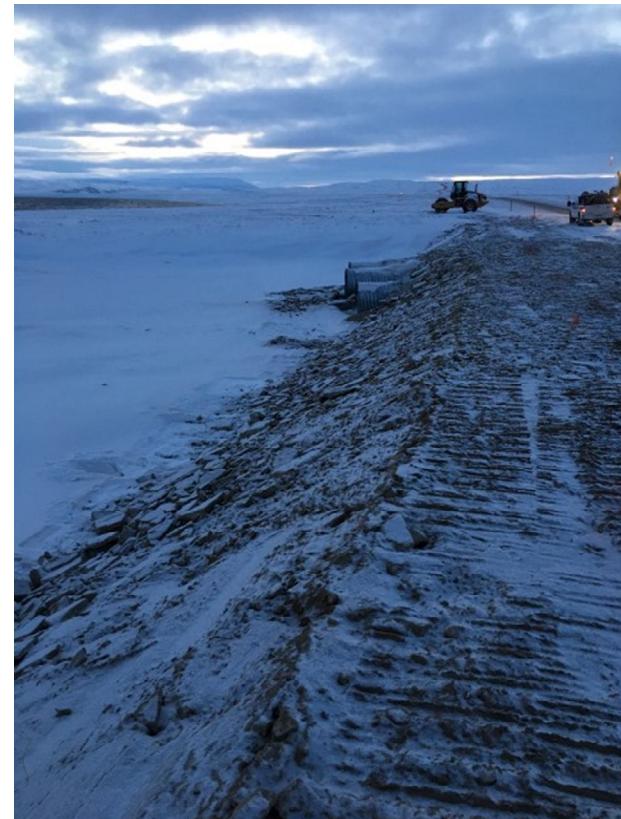
Figure 28. CV216 DS post-culvert extension
17-10-05
