FISHERIES ACT AUTHORIZATION 14-HCAA-00525

2017 Milne Ore Dock Fish Offset Monitoring Report

Report Number: 1663724-040-R-Rev0

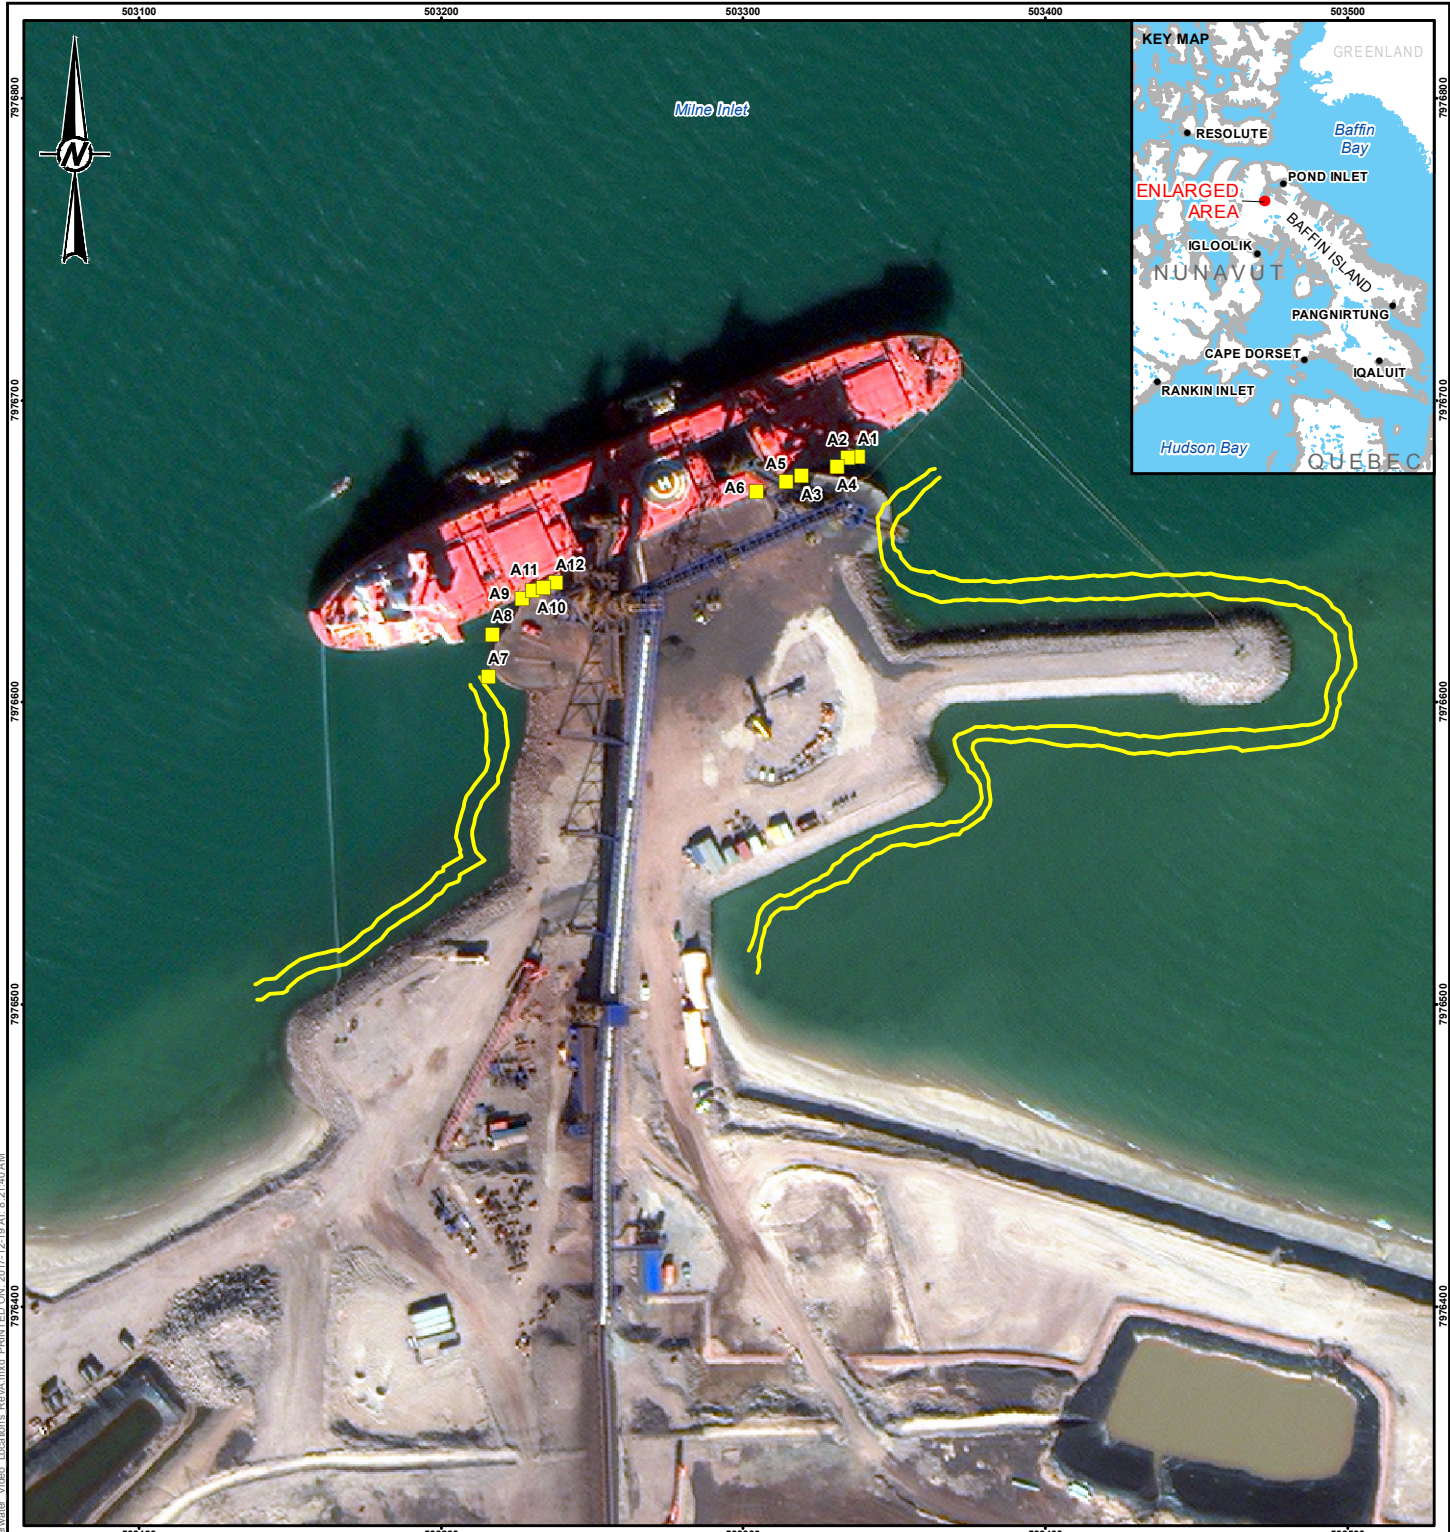
FIGURE
1

On 4 September 2017, towed video surveys were conducted along two ~470-m transects on the east side of the ore dock and two 170-m transects on the west side of the ore dock (Figure 1). Underwater video was also collected at 12 drop camera sampling stations along the north face of the dock where ship loading activities prevented access for towed video surveys (Figure 1). The underwater video system consisted of a Deep Blue Pro high resolution underwater video camera with integrated 300 lumen LED light pods and Global Positioning System

For towed video surveys, the video system was towed behind the field boat using an onboard winch system and video monitor for monitoring camera depth. For the drop camera surveys, the video system was lowered over the side of the ore dock until reaching the rock armour substrate, and video was collected for five to ten minutes at each of the twelve sampling stations (Figure 1).

UNDERWATER VIDEO LOCATIONS FOR FISH HABITAT OFFSET MONITORING, MILNE ORE DOCK, 2017

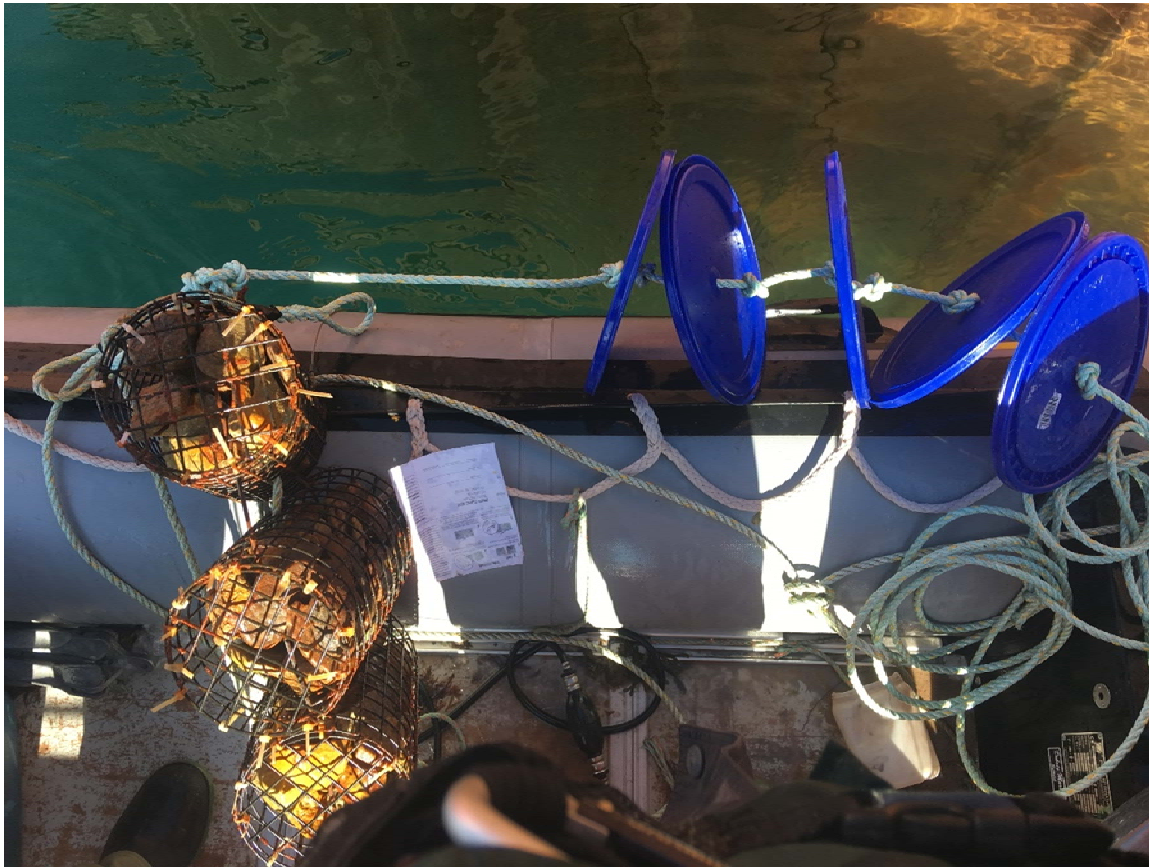
During the 2017 field season, Golder recovered three settlement baskets deployed in 2016 by SEM from the southwest corner of the ore dock near the caisson to allow for colonization by encrusting epifauna (SEM 2017b). The baskets were placed by SEM along the rock armouring at the base of the ore dock for a continuous 12-month period, tethered to the dock to allow for future retrieval and to limit displacement of the baskets from ice movement during the shoulder seasons. Each basket measured 16.5 cm in diameter and 28 cm in length, and was filled with cobble ranging from 8 to 12 cm in diameter.

Figure 2: Settlement Rock Basket Set-up and Addition of New Settlement Methods.

Settlement baskets retrieved by Golder in 2017 were redeployed and an additional string of settlement baskets was deployed on the east side of the ore dock. A set of plastic plates was attached to each string of baskets to provide more surface area for biological colonization, as well as a means of quantifying abundance on a known surface area. Settlement baskets deployed in 2017 will be re-assessed in 2018 when colonization is expected to be sufficient for sampling purposes.

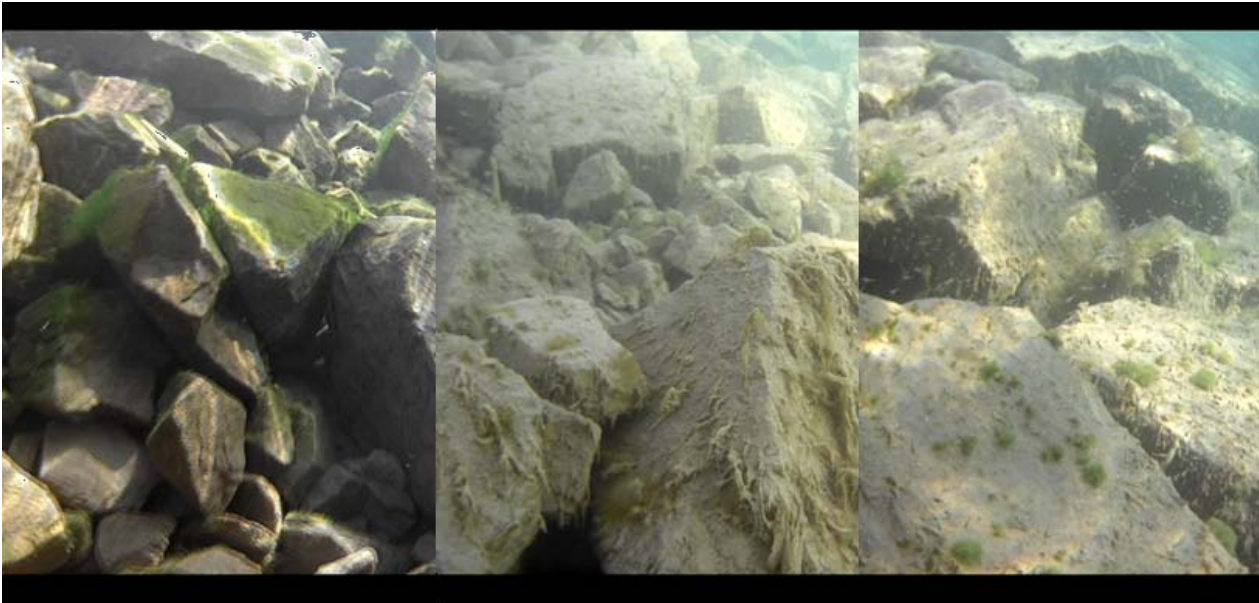
No evidence of movement or slumping of the armour stone was observed in the video surveys conducted in 2017. The placement of the armour stone was unaltered and functioning as constructed. Transects surveyed along the seafloor adjacent to the ore dock showed no evidence of loose or stray rocks in the sediment. There was a large amount of algal growth on the majority of the rocks along the east and west sides of the ore dock (Figure 3). Less prominent algal growth was observed on rocks directly adjacent to the caisson on both sides of the ore dock; however, a large number of sessile invertebrates (e.g., barnacles, hydroids, sponge) were observed on rocks near the caisson. Sediment deposition was generally minor with greater amounts of fine particulates observed along

the southern portion of the east side of the ore dock in an area that is more protected from wave and propeller scouring. Previous surveys (SEM 2017b) noted similar levels of algal growth and sediment deposition on the armour stone in 2016, and a low rate of biological colonization in the Project area as determined by monitoring of settlement baskets deployed in 2015. In general, patterns of biological growth and sediment deposition on the armour stone in 2017 suggest the rocks have been in a relatively stable position since their initial placement.

Figure 3: Armour stone around ore dock – still images from underwater video collected in 2017.

Video surveys confirmed that the structural integrity of the rock armouring is in place and does not currently require any upgrades, repairs, or enhancement. The video surveys did not show any evidence of movement or slumping of the rock armouring. Sediment deposition was generally minor with greater amounts of fine particulates observed along the southern portion of the east side of the ore dock in an area that is more protected from wave and propeller scouring. These conditions are similar to those observed during SEM's 2016 survey. The coarse rock substrate placed around the perimeter of the ore dock in Milne Inlet is functioning in accordance to the conditions set out in the FAA and as designed in the Offsetting plan.

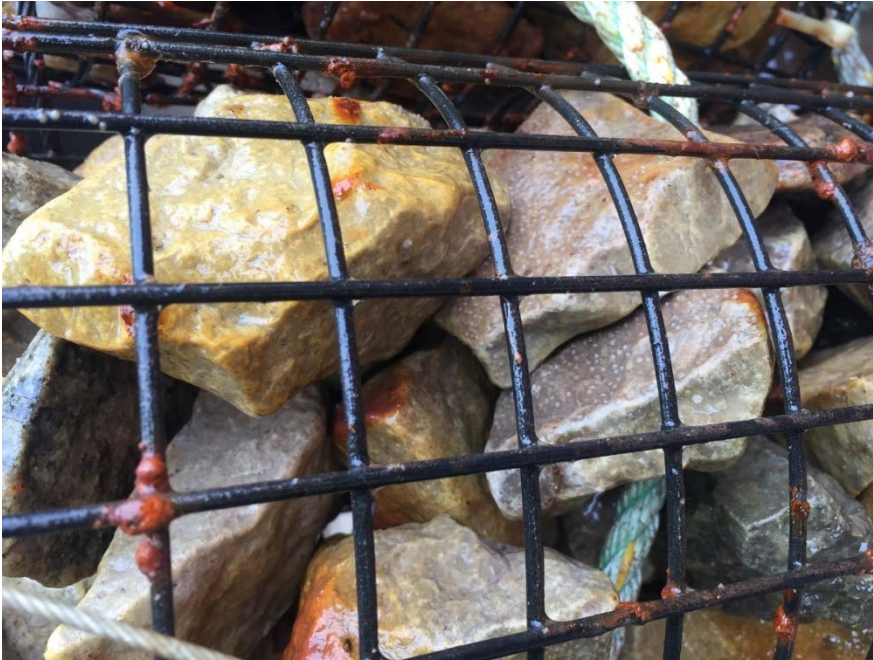
Settlement baskets deployed in 2016 by SEM were retrieved by Golder in September 2017 and examined for signs of colonization by encrusting epifauna. The cobble substrate in the settlement baskets exhibited limited evidence of colonization. No organisms were available for processing or taxonomic analysis. Although the majority of the rocks were bare, several rocks showed limited colonization by a white encrusting epifauna which could not be taxonomically identified (Figure 4). Previous surveys conducted by SEM indicated that the process of biological colonization was expected to be slow (occurring over several years) (SEM 2017a). As such, the baskets were redeployed for recovery in 2018. Similar observations were reported by SEM in 2015 for settlement baskets deployed in 2014, in which inadequate epifaunal growth was available on the settlement substrate to allow for taxonomic analysis. The baskets were retrieved again in 2016 at which point colonization was sufficient for sample collection.

Figure 4: Settlement basket retrieved from west side of ore dock in 2017.

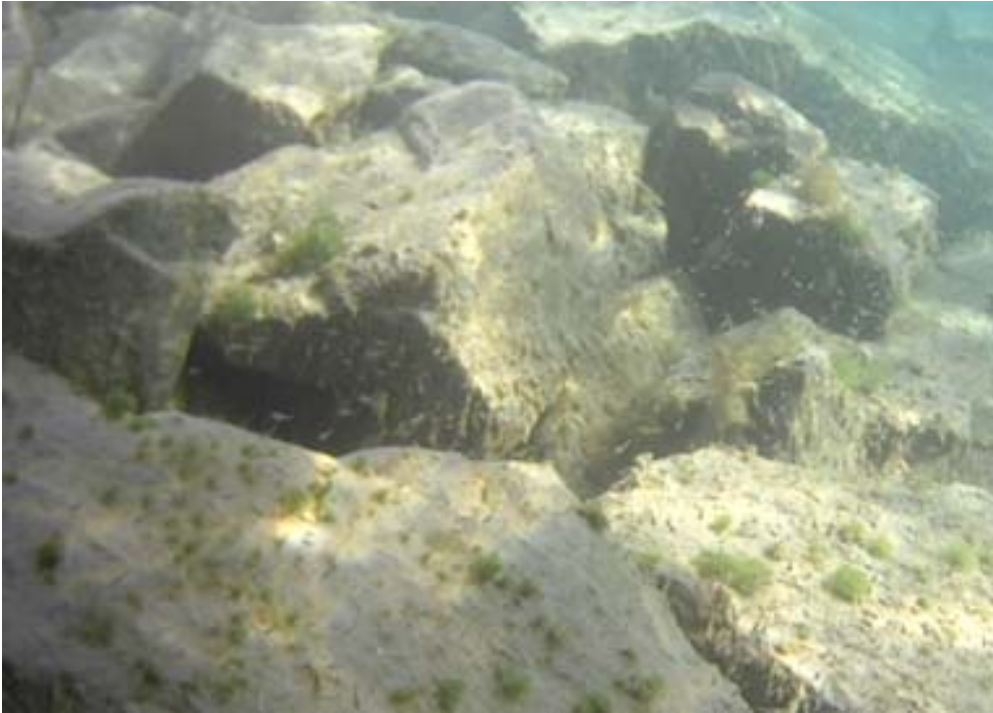
A large number of euphasid shrimp were observed during video transects around the ore dock in 2017 (Figure 5). A variety of other invertebrates including urchins, barnacles, krill, brittle stars, shrimp, and calcareous tube worms were also observed on the armour stone during the video surveys (Figure 6). The presence and general abundance of invertebrates on the armour stone suggests the offset habitat provides more suitable habitat for benthic invertebrates than the settlement baskets.

Figure 5: Euphasid shrimp observed during video surveys around ore dock in 2017.

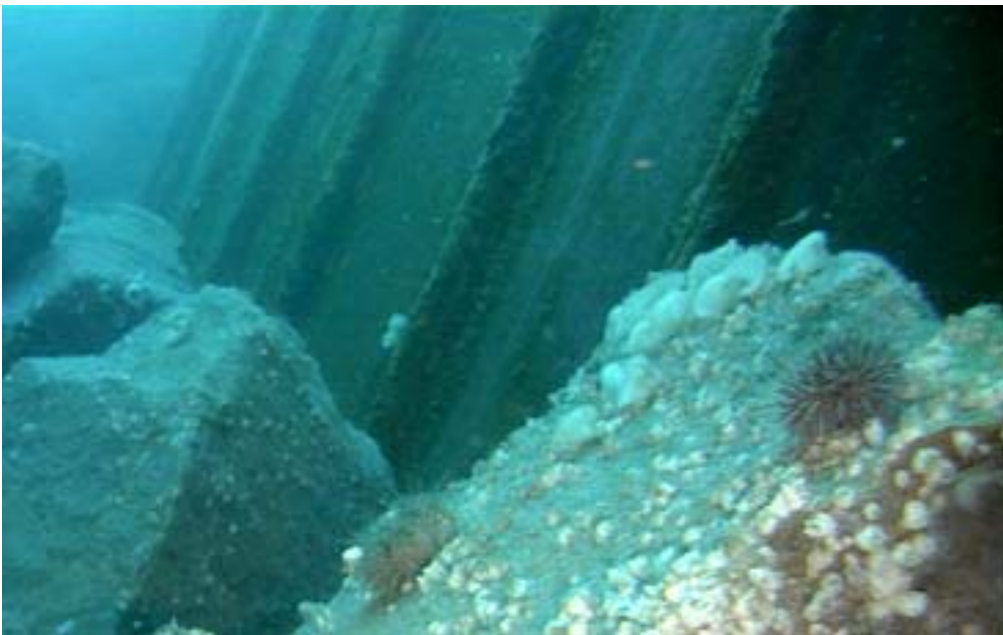
Figure 6: Barnacles and urchins observed on armour stone along east side of ore dock in 2017.

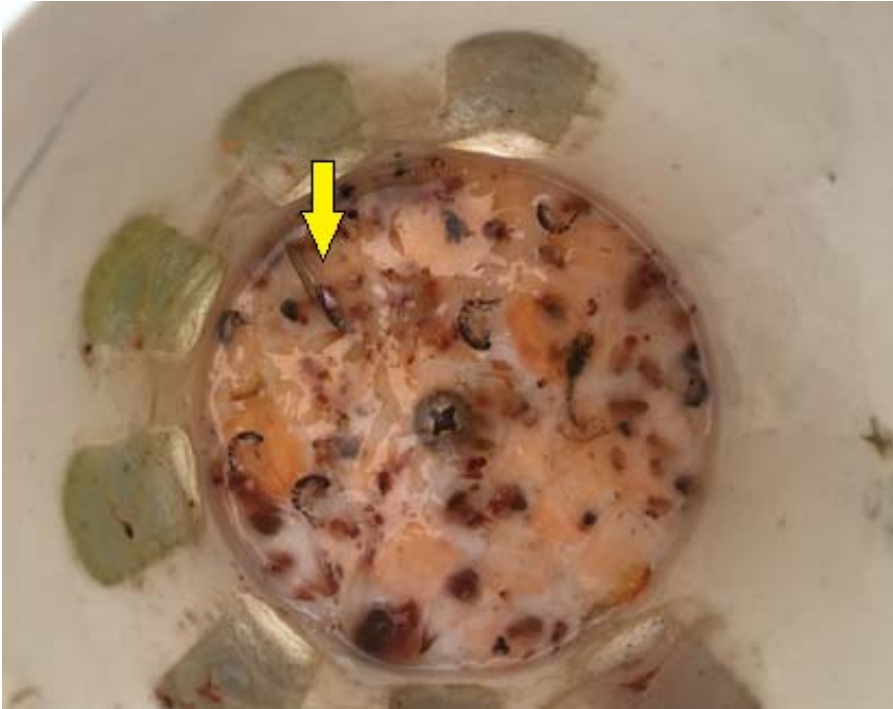
Fish larvae were not found in the settlement baskets retrieved in 2017. Fish larvae were also not observed in the drop camera or towed video transects around the ore dock; however, fish larvae were recorded during plankton sampling conducted as part of the Aquatic Invasive Species (AIS) monitoring program (Figure 7).

Figure 7: Fish larvae (yellow arrow) collected in plankton sample in Milne Inlet in 2017.

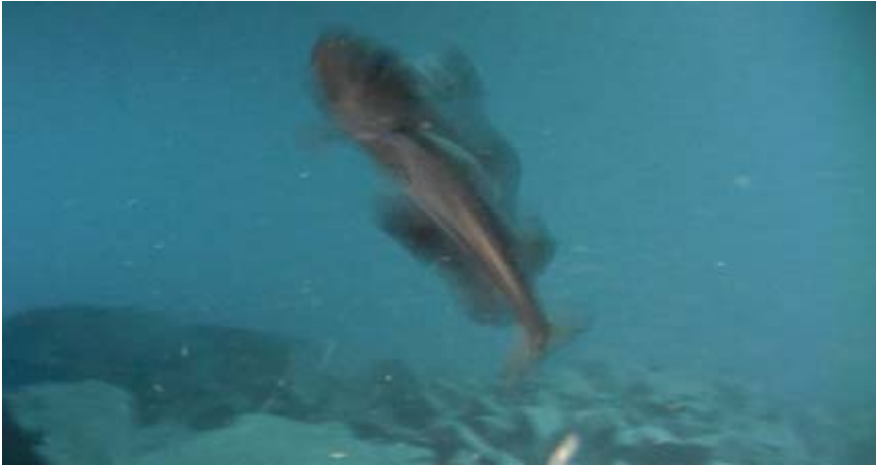
Underwater video collected along transects on the east and west sides of the ore dock, as well as at the 12 drop camera sampling stations, was analyzed to document the association of fish with the armour stone substrate. The video resulted in a total of three adult cod observed swimming above or hiding within the rock substrate (Figure 8). The cod appear to be using the rock armouring habitat for both cover and foraging. One cod, which was observed at station A5 off the eastern side of the ore dock, was identified as an adult Greenland cod (*Gadus ogac*) (Figure 9). The other two cod were observed off the western side of the ore dock and could not be identified to species level.

Figure 8: Adult cod swimming above Milne Inlet, 2017.

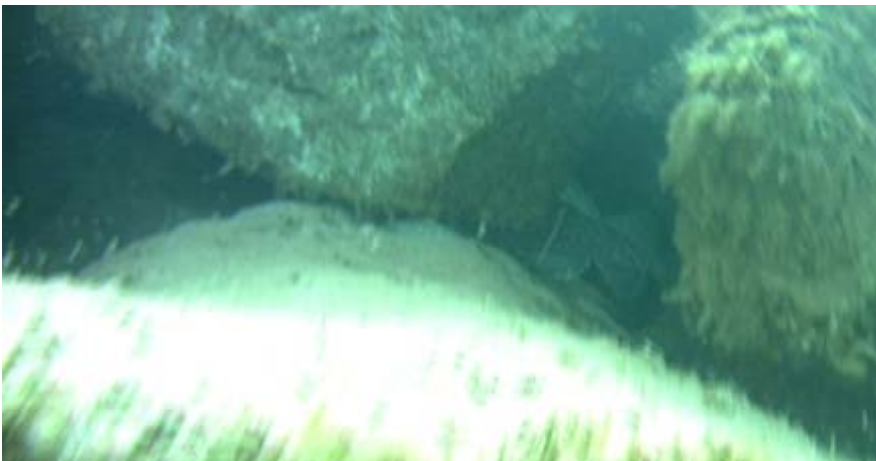
Figure 9: Adult Greenland cod using armour stone for cover Milne Inlet, 2017.

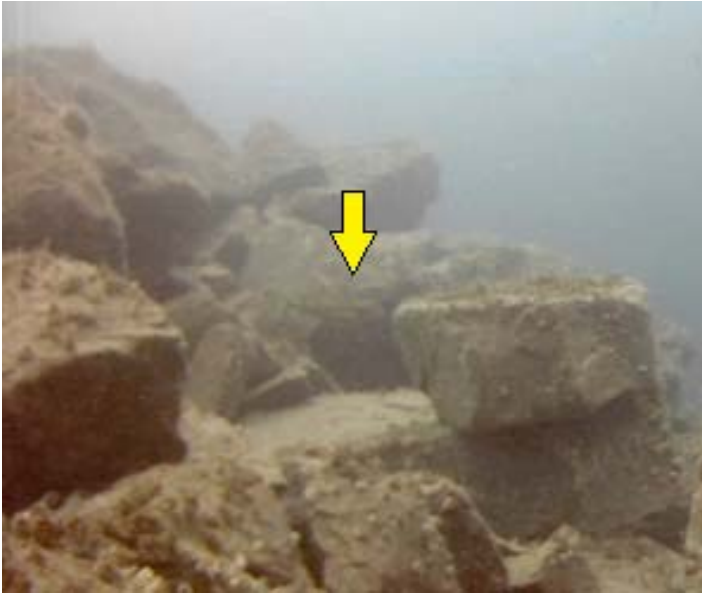
Three unidentified adult sculpins were also observed occupying the armour stone substrate (Figure 10 and Figure 11). Two of the sculpins were observed along the west side of the ore dock and one was observed along the east side. No other fish were observed during the drop camera surveys. The sculpin were noted to be using the rock materials to provide shelter and cover.

Figure 10: Sculpin (yellow arrow) in armour stone during drop camera survey, Milne Inlet, 2017.

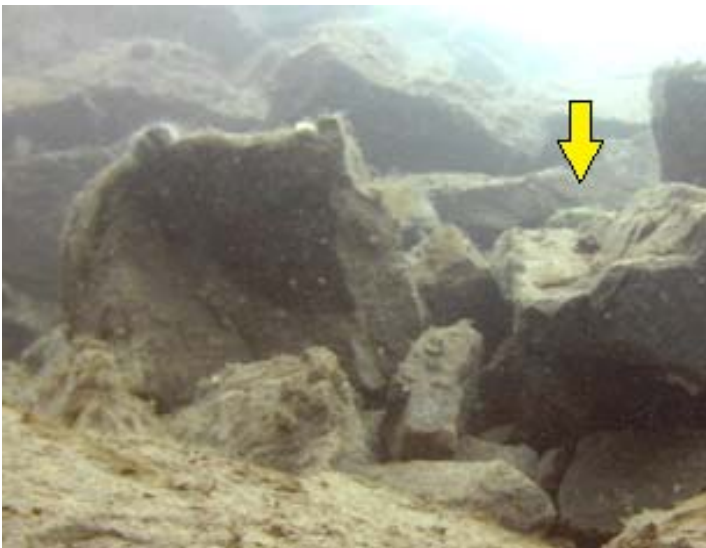
Figure 11: Sculpin (yellow arrow) on armour stone during drop camera survey, Milne Inlet, 2017.

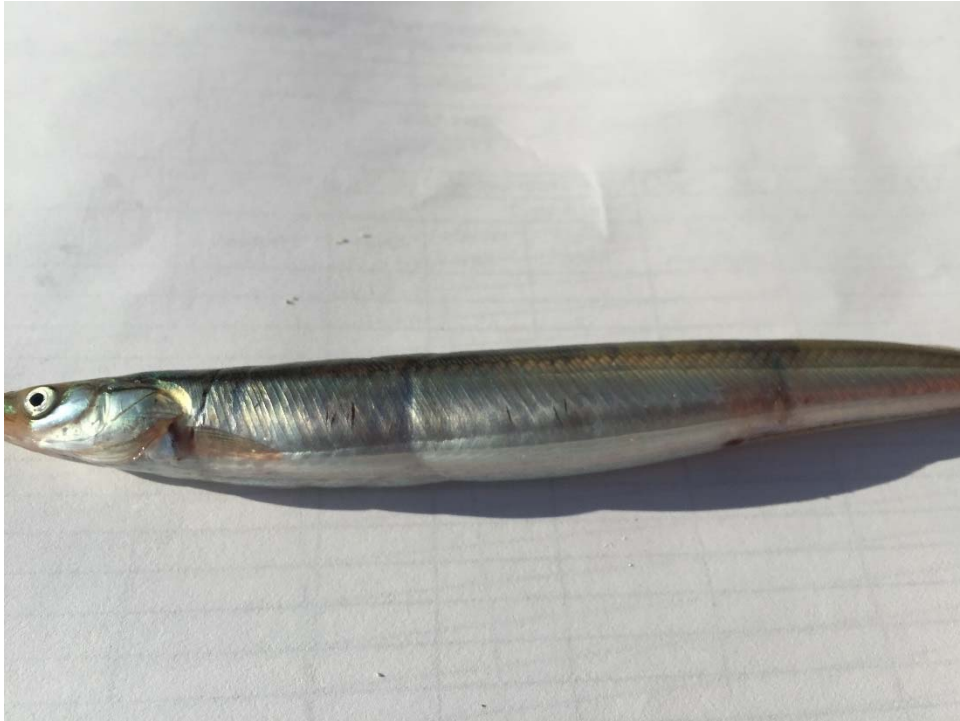
MEEMP, sculpin (multiple species) were recorded near the base of the ore dock. Northern sand lance (*Ammodytes dubius*) were also caught in a Fukui trap deployed during the MEEMP program on the east of the ore dock (Figure 13). The large number of sessile invertebrates (e.g., barnacles, hydroids, sponge) observed on the rock armour substrate is thought to serve as a food source for fish (e.g., cod and sculpin) observed in the habitat offset area.

Figure 13: Northern sand lance caught in Fukui traps east of the ore dock in 2017
