BAFFINLAND IRON MINES CORPORATION
MARY RIVER PROJECT

Freshet 2021 Monitoring Report

Rev 0

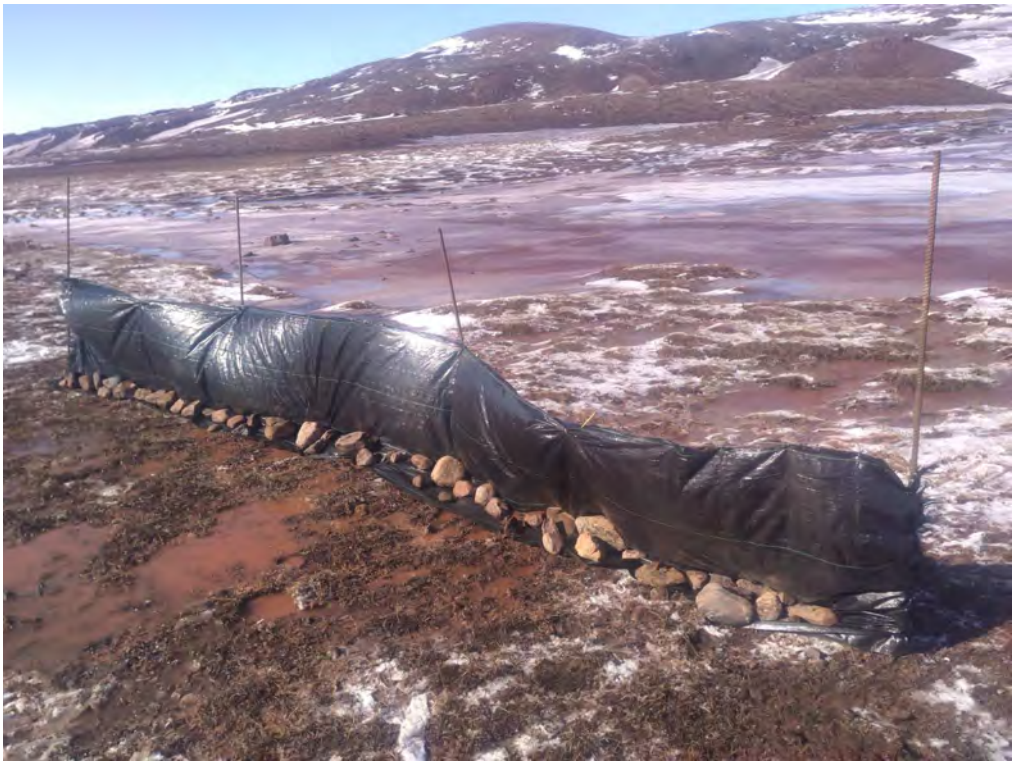
Photo 3. Erosion and Sediment Control at CV-186 Upstream of SDLT-OUT (May 12, 2021)

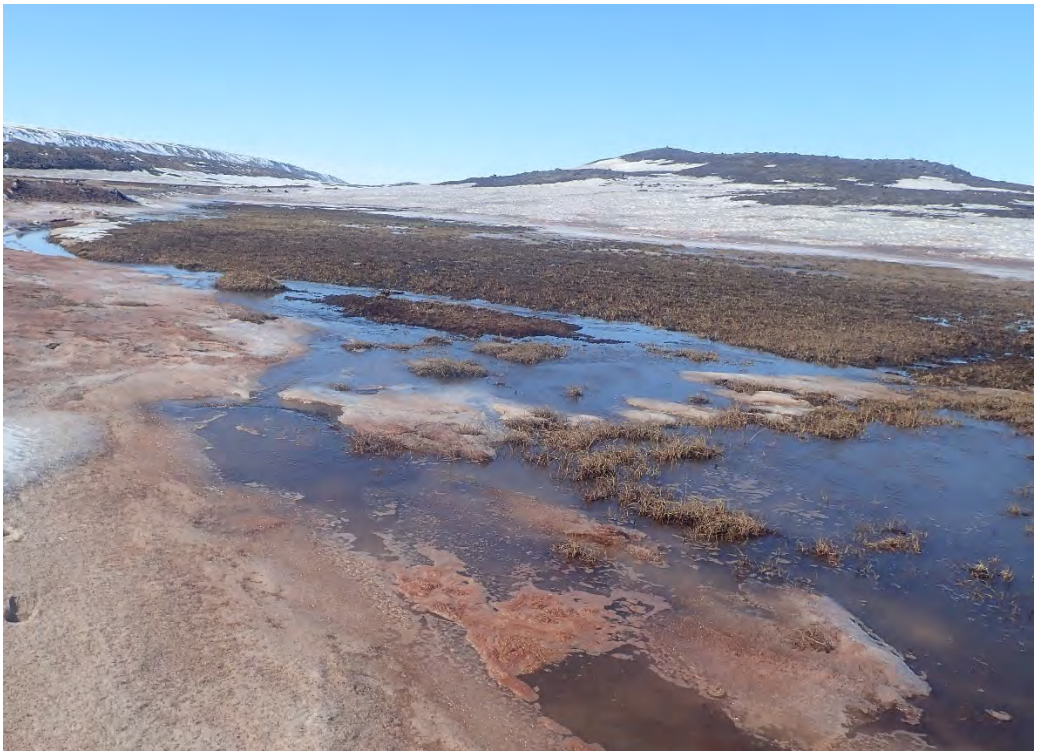
Photo 1. CV-001 Culvert Crossing Upstream on May 26, 2021

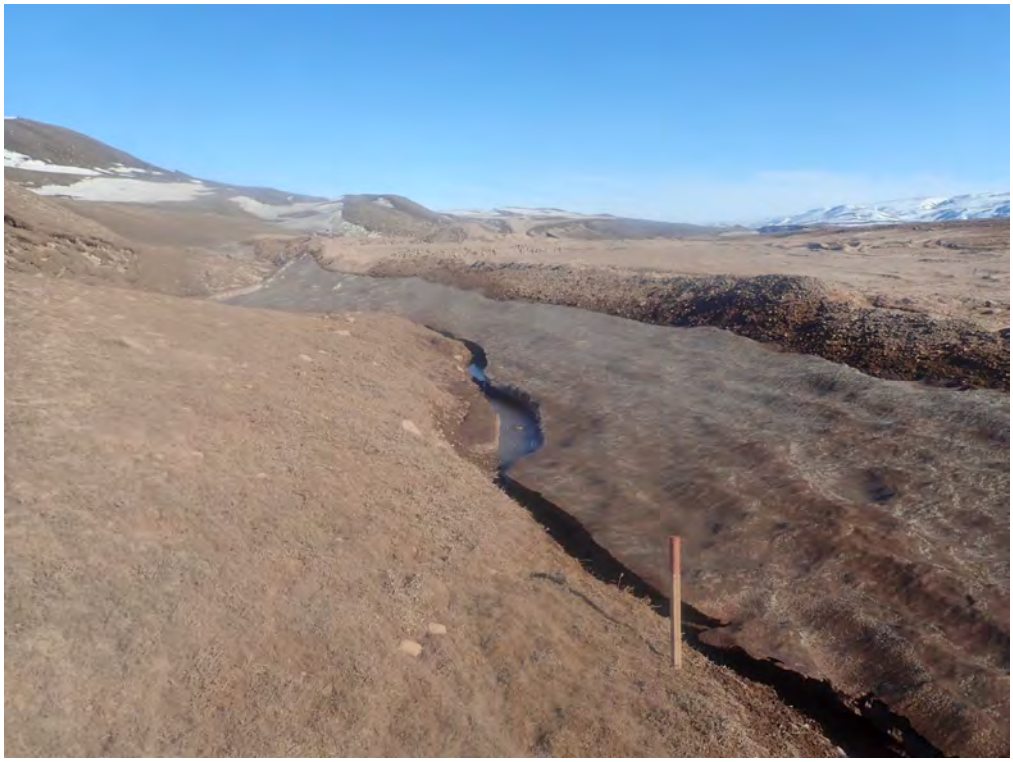
Photo 1. CV-154-A Culvert Crossing Upstream on June 1, 2021

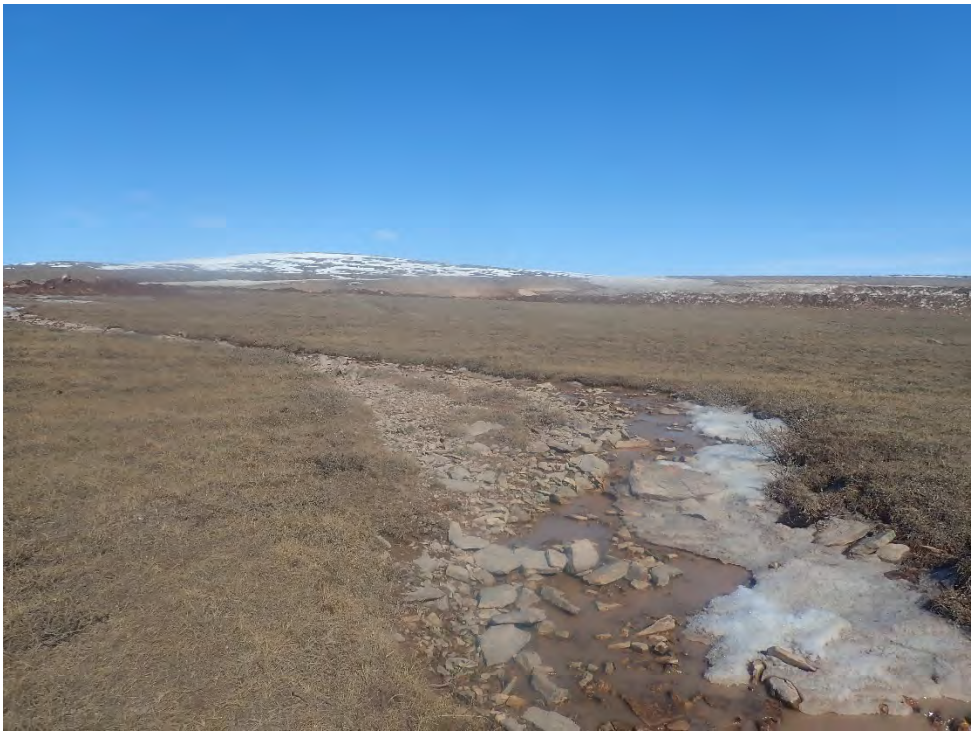
Photo 2. CV-112 Culvert Crossing Downstream on June 1, 2021

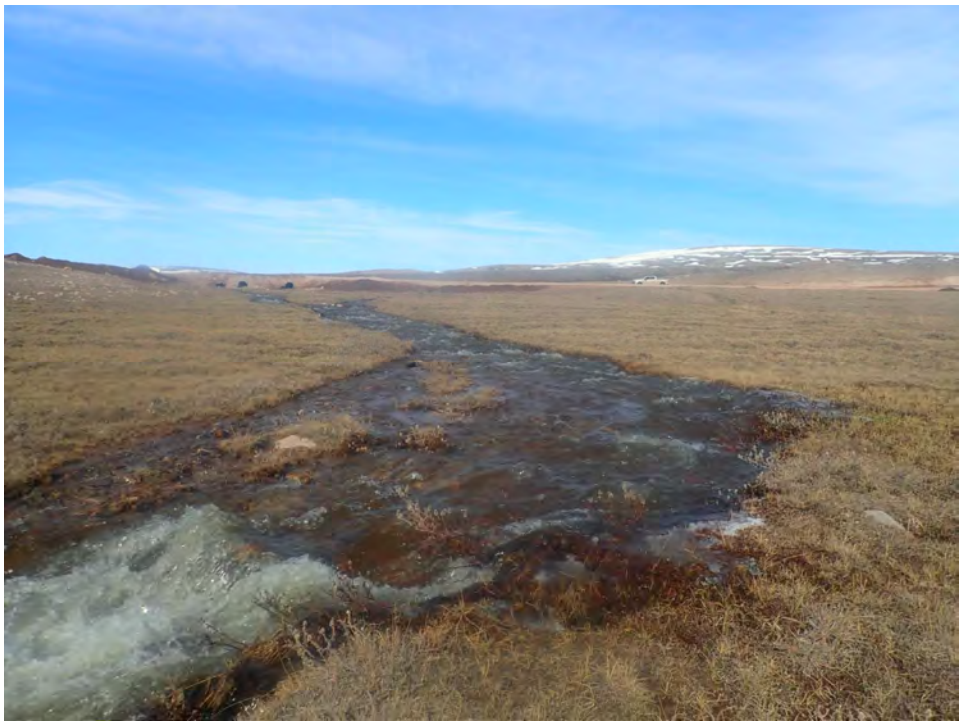
Photo 3. CV-112 Culvert Crossing Downstream on June 9, 2021

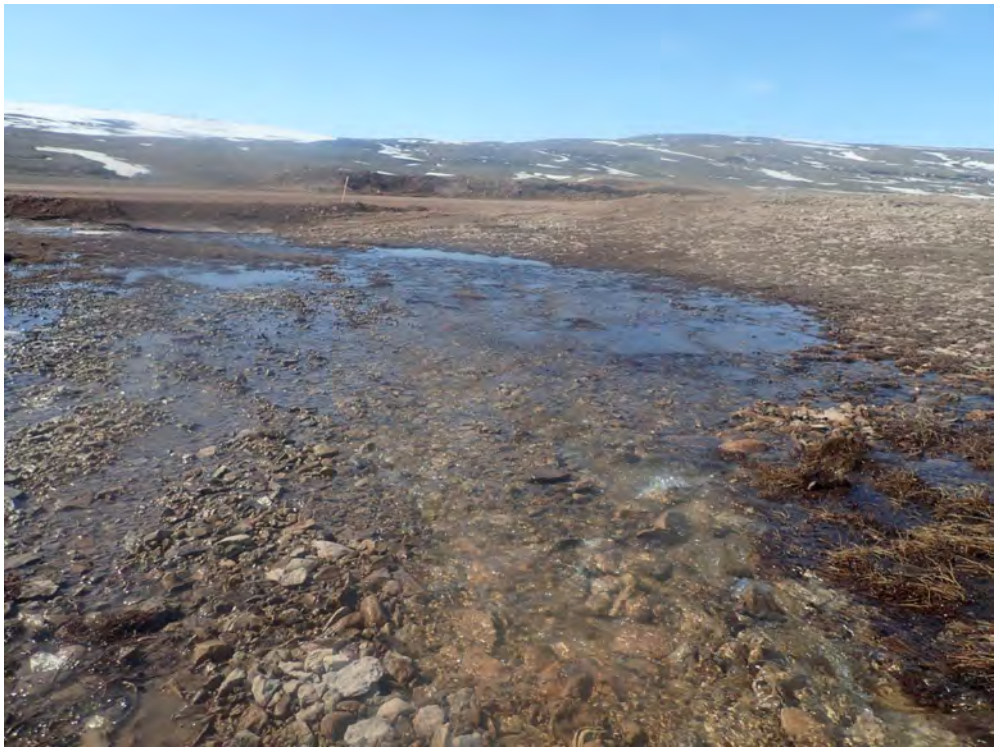
Photo 1. CV-093 Culvert Crossing Upstream on June 9, 2021

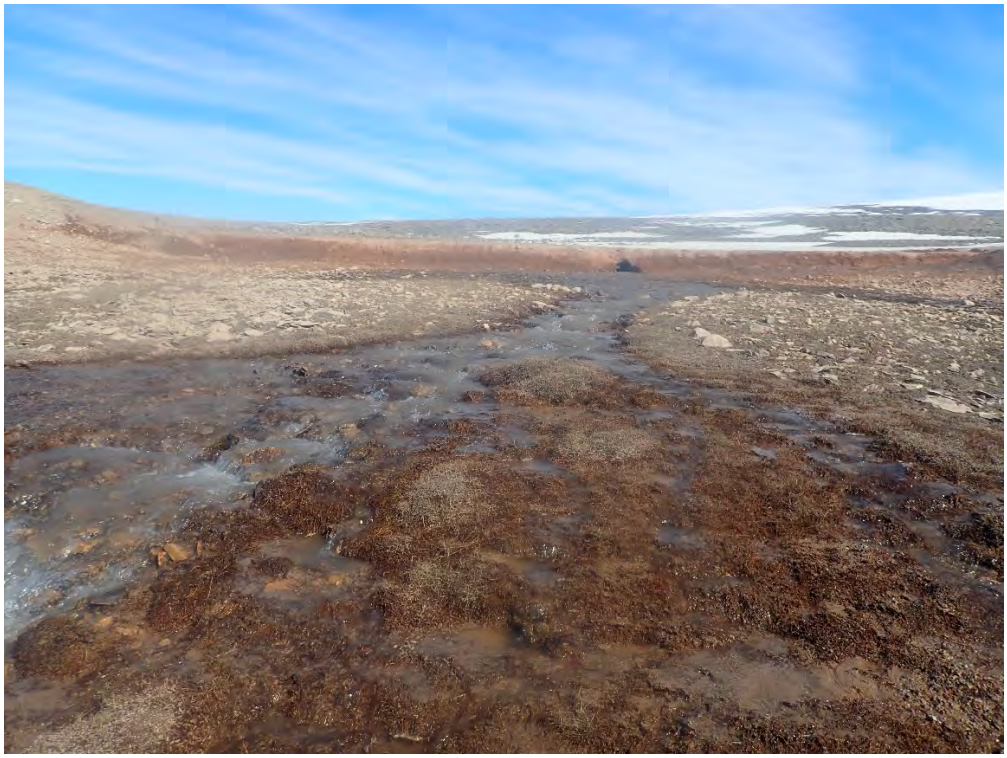
Photo 2. CV-093 Downstream Culvert Crossing on June 9, 2021

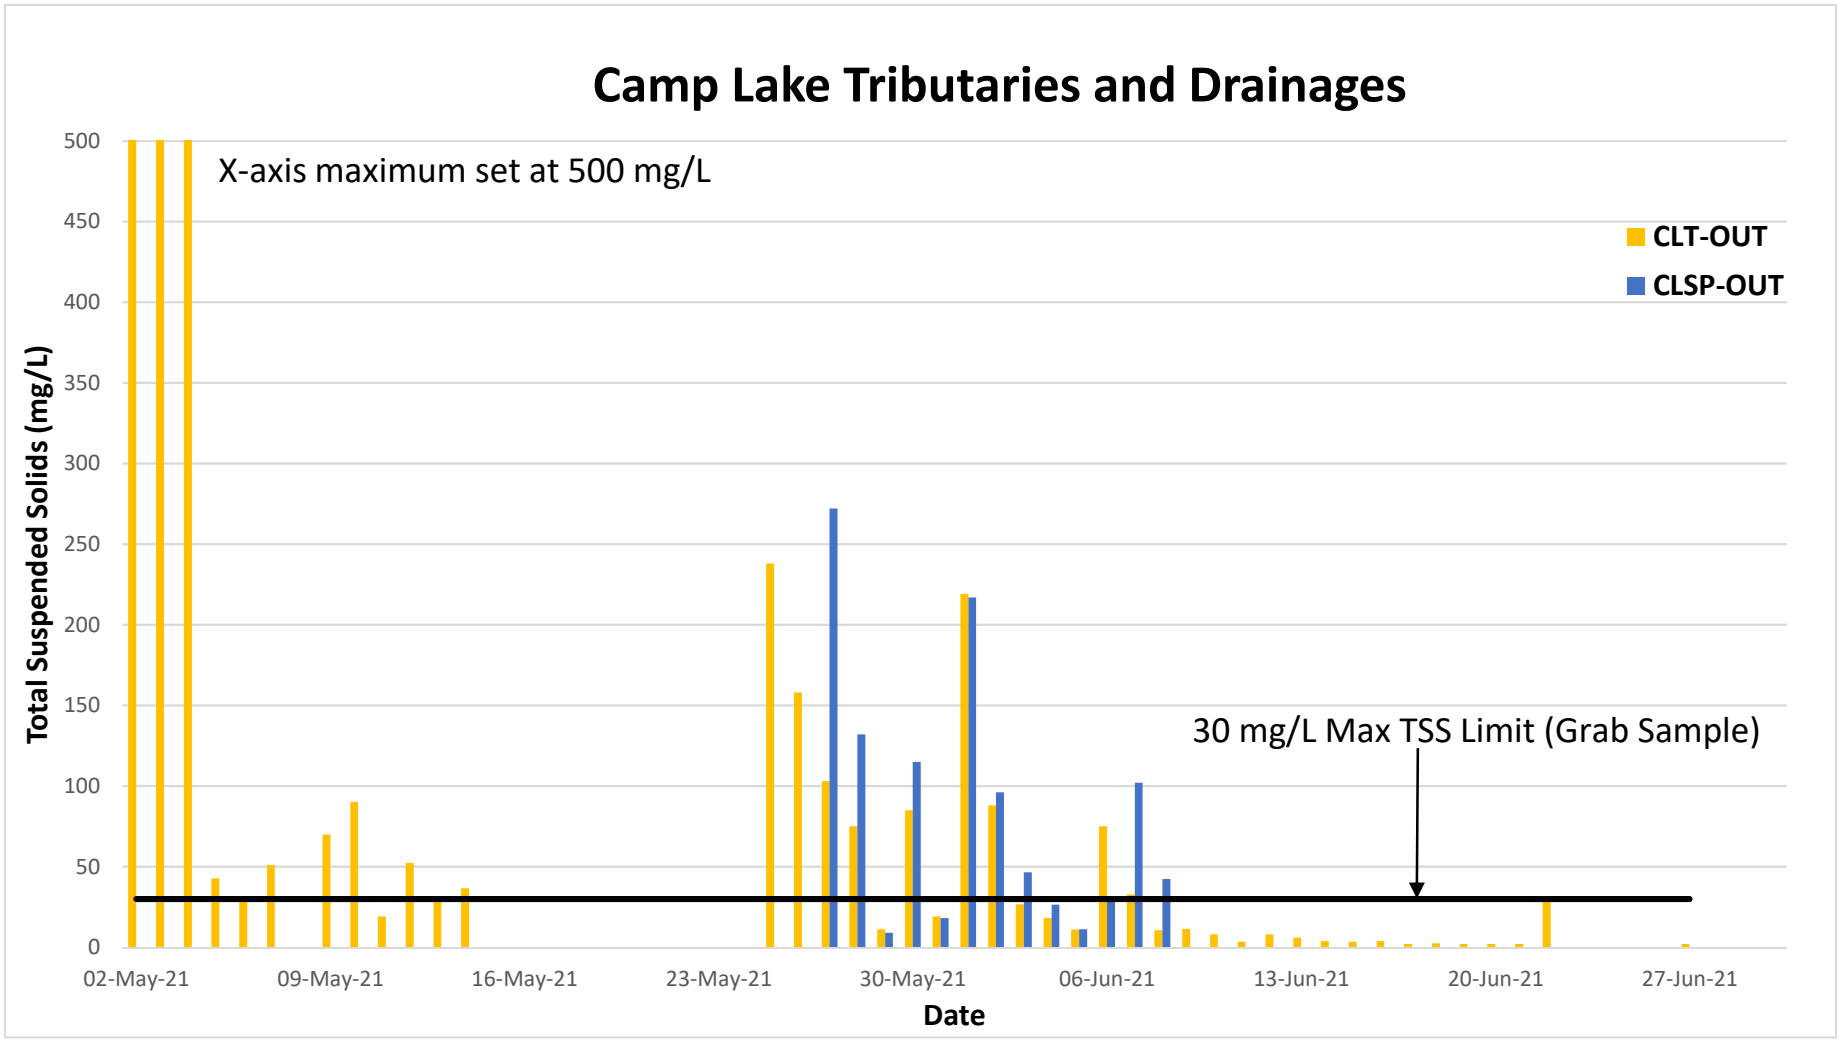
In comparing the water quality results for CLT-OUT to the water quality criteria outlined in Table 1, TSS exceeded the 30 mg/L TSS grab sample limit on eighteen (18) days (May 2- 5, 7, 9-10, 12, 14, 25-28, 30, and June 1-2, 6-7) out of forty-two (42) sampling days. No water samples were taken at CLT-OUT before May 2 or during May 15 through 24 due to frozen conditions. Moreover, no water samples were collected

at CLT-OUT on May 8 due to environmental staff adherence to COVID-19 isolation requirements. In addition, average TSS concentrations at CLT-OUT during May and June 2021 were 235.5 mg/L and 24.8 mg/L, respectively, exceeding the monthly average TSS concentration limit of 15 mg/L outlined in Table 1. Although elevated TSS levels were observed, water samples taken at CLT-OUT on May 4 and 6, 2021, confirmed runoff at the monitoring location was not acutely toxic. Following June 22, the water quality monitoring frequency at CLT-OUT was changed from daily to weekly due to seven (7) consecutive water quality samples being compliant with all water quality criteria outlined in Table 1. A final water sample was taken at CLT-OUT on June 27, which was compliant for all relevant parameters. No other exceedances of applicable water quality criteria (Table 1) were observed at the CLT-OUT during the 2021 Mine Site Freshet Monitoring Program.

Camp Lake Tributaries and Drainages
X-axis maximum set at 500 mg/L
CLT-OUT
CLSP-OUT
Total Suspended Solids (mg/L)
500
450
400
350
300
250
200
150
100
50
0
30 mg/L Max TSS Limit (Grab Sample)
02-May-21
09-May-21
16-May-21
23-May-21
30-May-21
06-Jun-21
13-Jun-21
20-Jun-21
27-Jun-21
Date

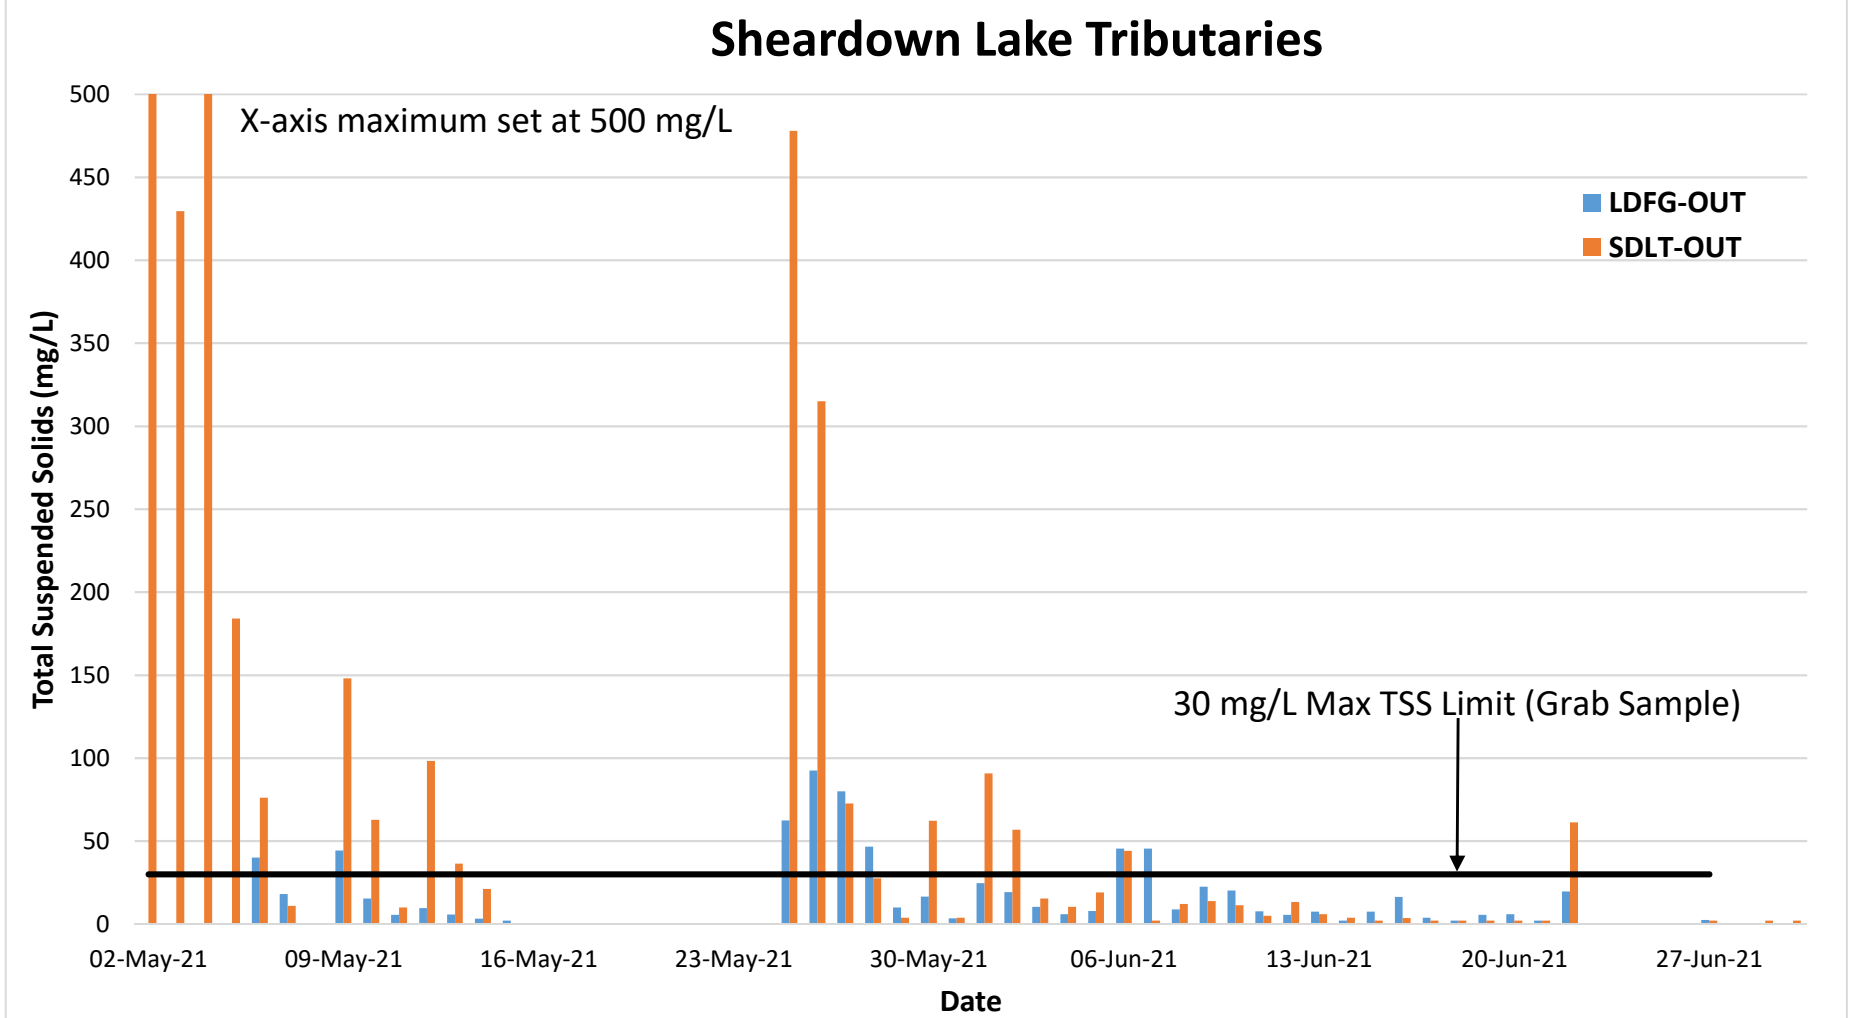
In comparing the water quality results for SDLT-OUT to the water quality criteria outlined in Table 1, TSS exceeded the 30 mg/L TSS grab sample limit on sixteen (16) days (May 2-5, 9-10, 12-13, 25-27, 30 and June 1-2, 6, 22) out of forty-four (44) sampling days. No water samples were taken at LDFG-OUT before May 2 or during May 15 through 24 due to frozen conditions. Moreover, no water samples were collected at SLDT-OUT on May 8 due to environmental staff adherence to COVID-19 isolation requirements. In addition, average TSS concentrations at SDLT-OUT during May and June 2021 were 186.6 mg/L and 16.1 mg/L, respectively, exceeding the monthly average TSS concentration limit of 15 mg/L outlined in Table 1. Although elevated TSS levels were observed, water samples taken at SDLT-OUT on May 4 and 6, 2021, confirmed runoff at the monitoring location was not acutely toxic. Following June 22, the water quality monitoring frequency at SDLT-OUT was changed from daily to weekly due to seven (7) consecutive water quality samples (June 15 – 21) being compliant with all water quality criteria outlined in Table 1. Water quality monitoring was re-initiated at SDLT-OUT on June 27, when it was observed that the June 22 water sample exceeded the 30 mg/L TSS grab sample limit. Upon receiving the external lab result from the June 22 sampling event, subsequent water quality monitoring was completed on June 29 and 30 at SDLT-OUT, which were compliant for all relevant parameters. No other exceedances of applicable water quality criteria (Table 1) were observed at the SDLT-OUT during the 2021 Mine Site Freshet Monitoring Program.

In comparing the water quality results for LDFG-OUT to the water quality criteria outlined in Table 1, TSS exceeded the 30 mg/L TSS grab sample limit on eight (8) days (May 6, 9, 25-28 and June 6-7) out of thirty-nine (39) sampling days. No water samples were taken at LDFG-OUT before May 6 or during May 16 through 24 due to frozen conditions. Moreover, no water samples were collected at LDFG-OUT on May 8 due to environmental staff adherence to COVID-19 isolation requirements. In addition, average TSS concentrations at LDFG-OUT during May and June 2021 were 27.7 mg/L and 12.5 mg/L, respectively, exceeding the monthly average TSS concentration limit of 15 mg/L outlined in Table 1 during May 2021. Although elevated TSS levels were observed, a water sample taken at LDFG-OUT on May 10, 2021, confirmed runoff at the monitoring location was not acutely toxic. Following June 22, the water quality monitoring frequency at LDFG-OUT was changed from daily to weekly due to seven (7) consecutive water quality samples being compliant with all water quality criteria outlined in Table 1. A final water sample was taken at LDFG-OUT on June 27, which was compliant for all relevant parameters. No other exceedances of applicable water quality criteria (Table 1) were observed at the LFDG-OUT during the 2021 Mine Site Freshet Monitoring Program.

Sheardown Lake Tributaries
X-axis maximum set at 500 mg/L
LDFG-OUT
SDLT-OUT
Total Suspended Solids (mg/L)
500
450
400
350
300
250
200
150
100
50
0
30 mg/L Max TSS Limit (Grab Sample)
02-May-21
09-May-21
16-May-21
23-May-21
30-May-21
06-Jun-21
13-Jun-21
20-Jun-21
27-Jun-21
Date
