RE: Submission of 2019 Geotechnical Inspection Report No. 1 (July 2019)

Annual Geotechnical Inspections – 2019 Report 1. Mary River Iron Mine Complex – Nunavut

Annual Geotechnical Inspections – 2019 Report 2. Mary River Iron Mine – Nunavut

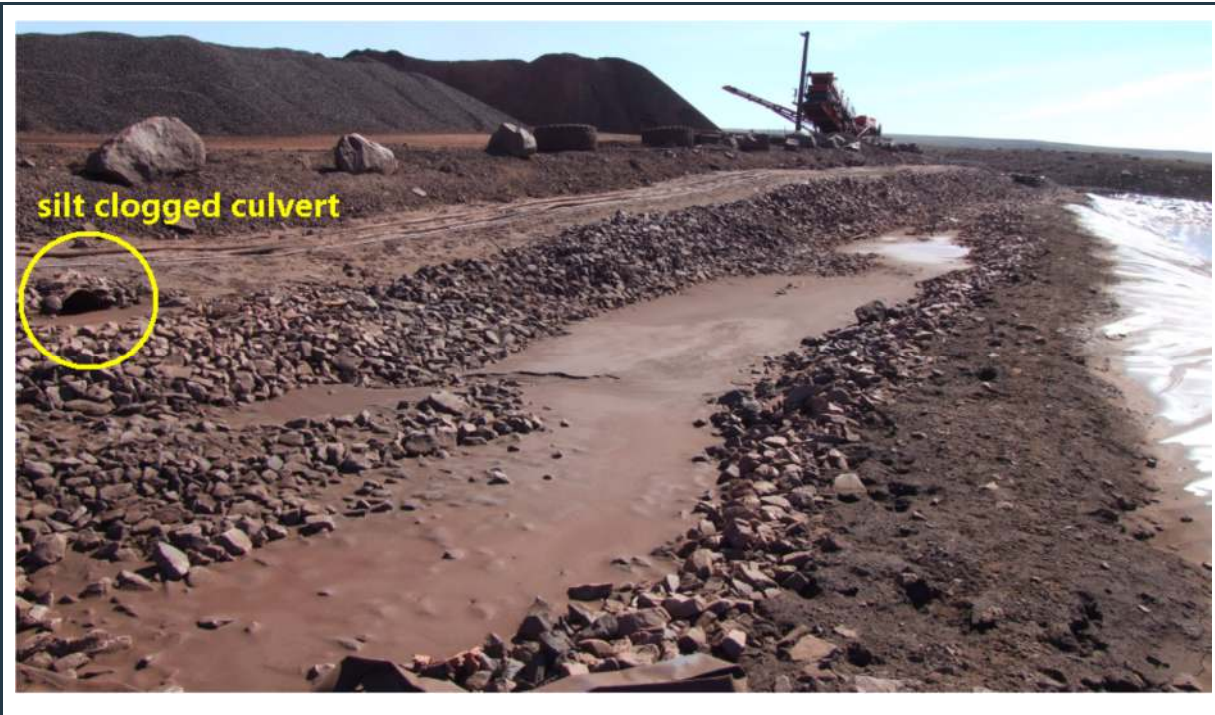
Figure 22: Surface water collection ditch with clogged culvert

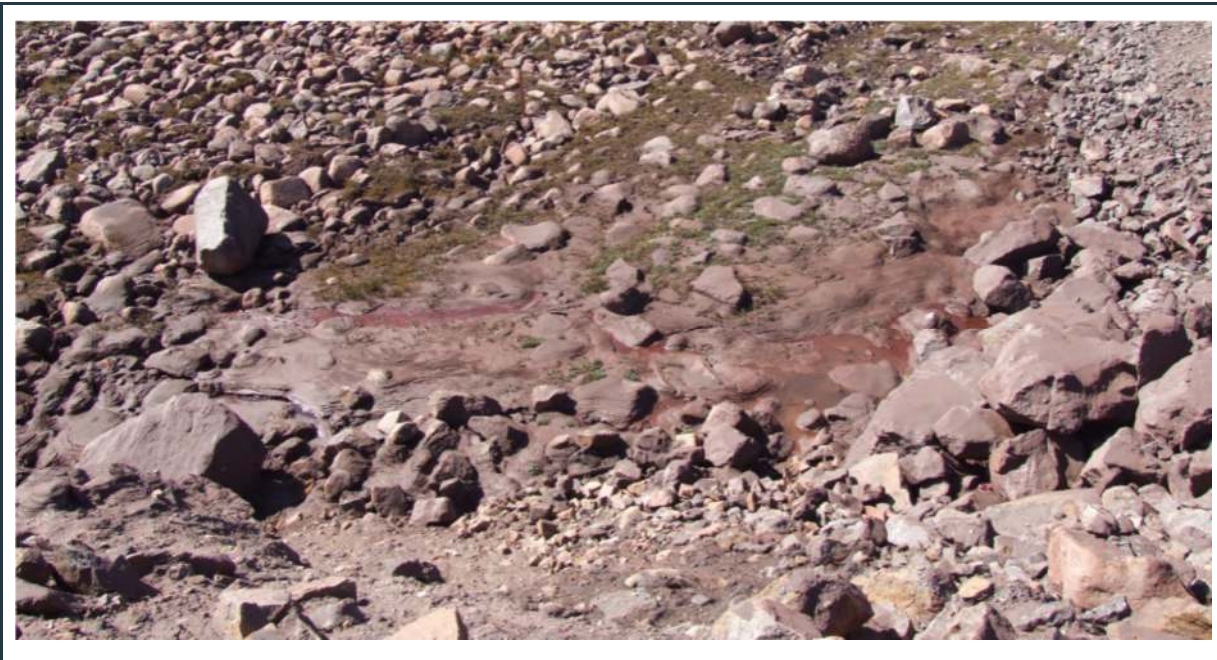
Minor potential pad seepage water was observed at the toe of the berm at one location adjacent to the pond where the pad meets the tundra, as shown in Figure 24. This clear water seepage; however, is not to be mistaken as seepage from the subject pond and ditches.

Figure 24: Water seepage at the toe of the tote road embankment near the crusher pad

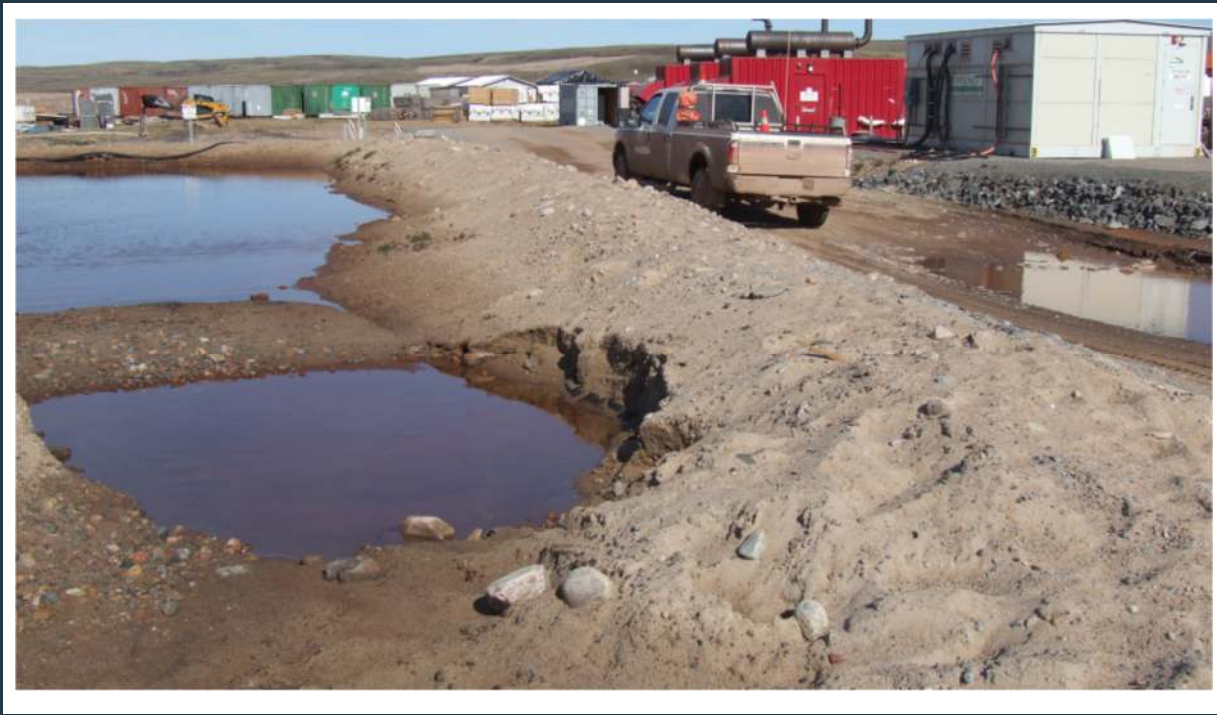
Figure 30: View of minor slope problem at the south-east corner of the berm at the Genset pond

In addition to the repair work on the slope, the southern, somewhat lower section of the berm should also be reconstructed to its original geometry. Again, truck traffic on the berm must be avoided.

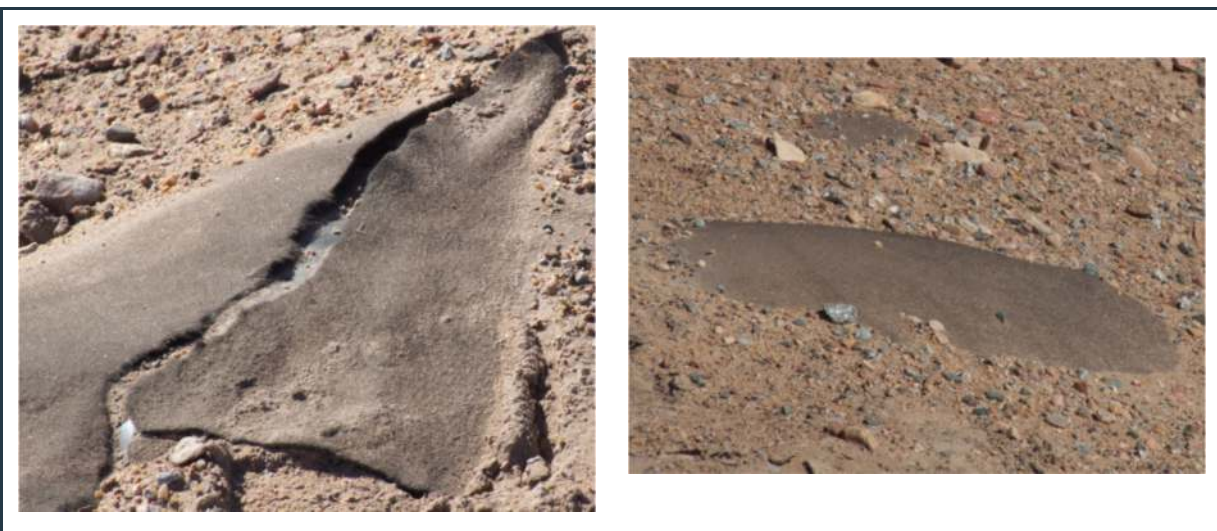
Figure 33: Exposed and ripped geotextile fabric on the berm of the jetfuel farm

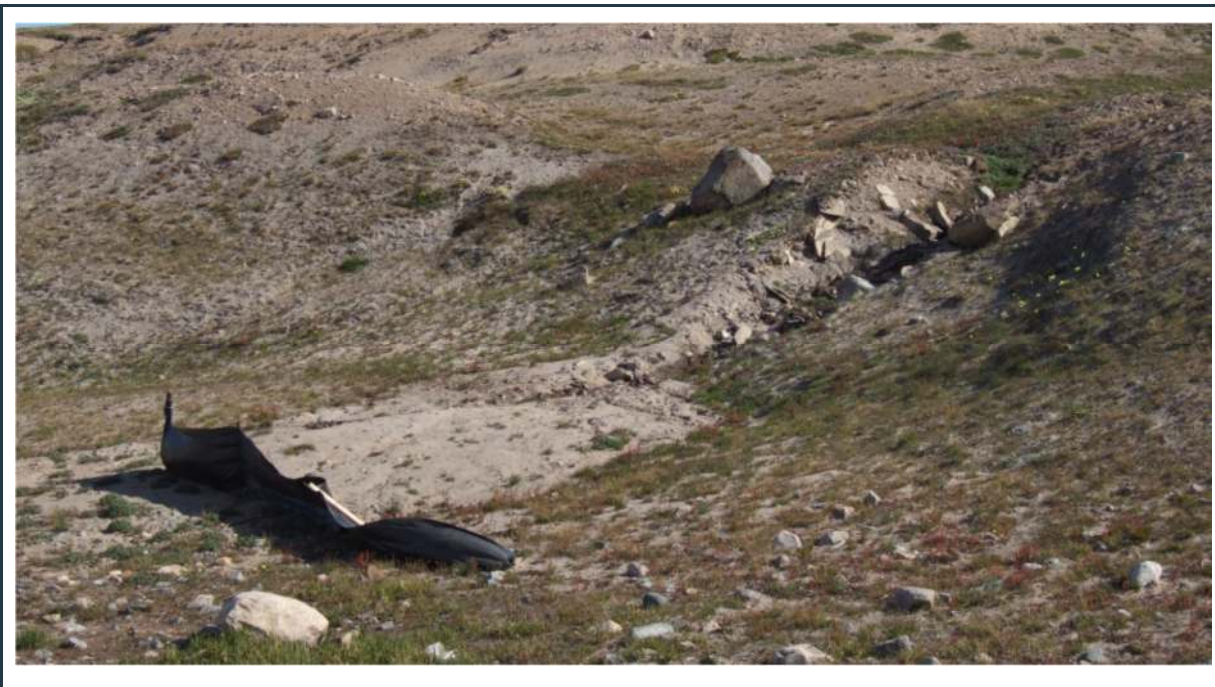
Figure 39: Slope erosion in the vicinity of the CLSP check dams

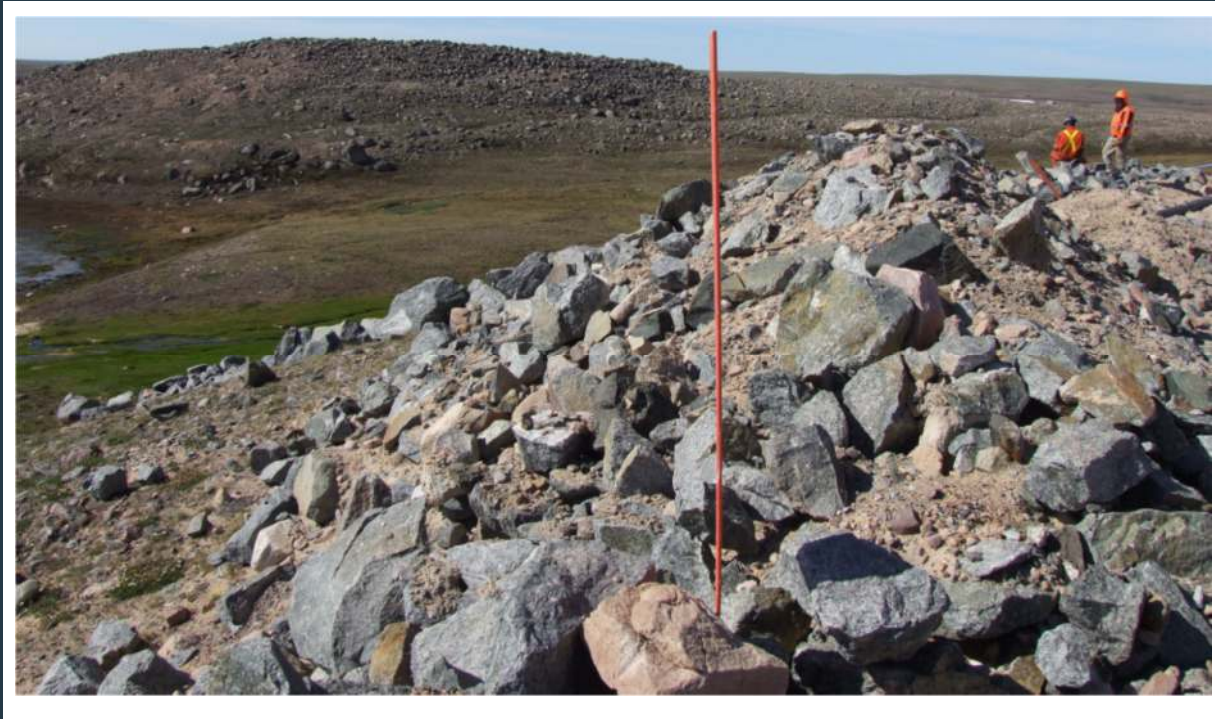
Figure 40: Water discharge area. Stable slope, comprising a mix of crushed rock and soils.

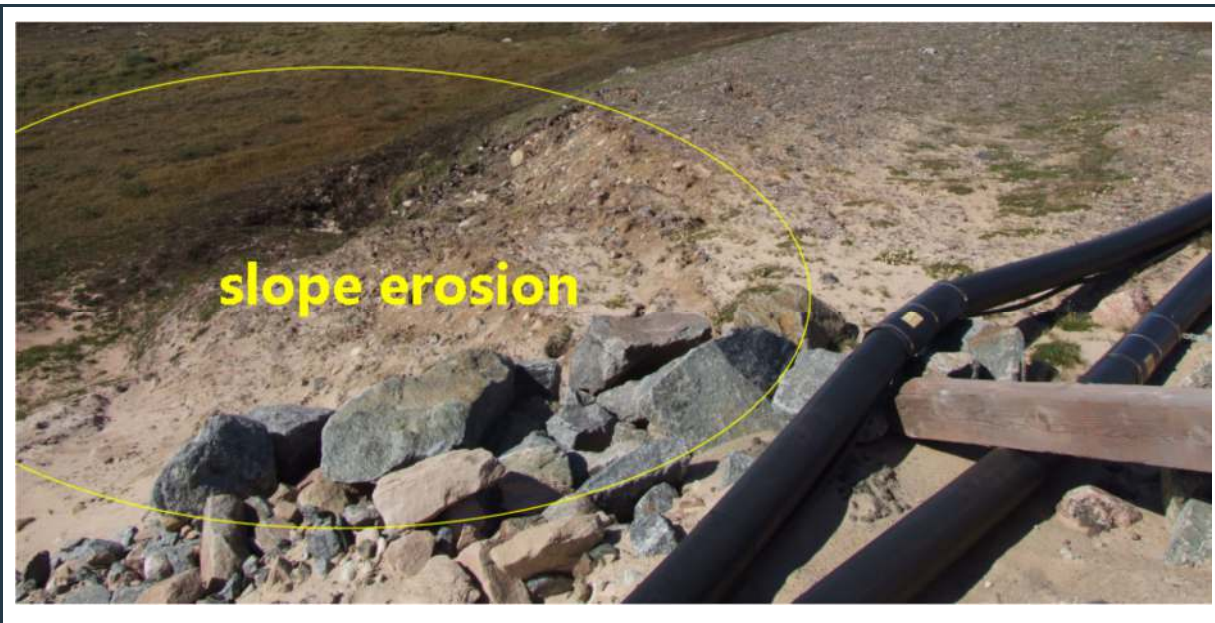
Figure 41: Minor slope erosion adjacent to the water discharge area.

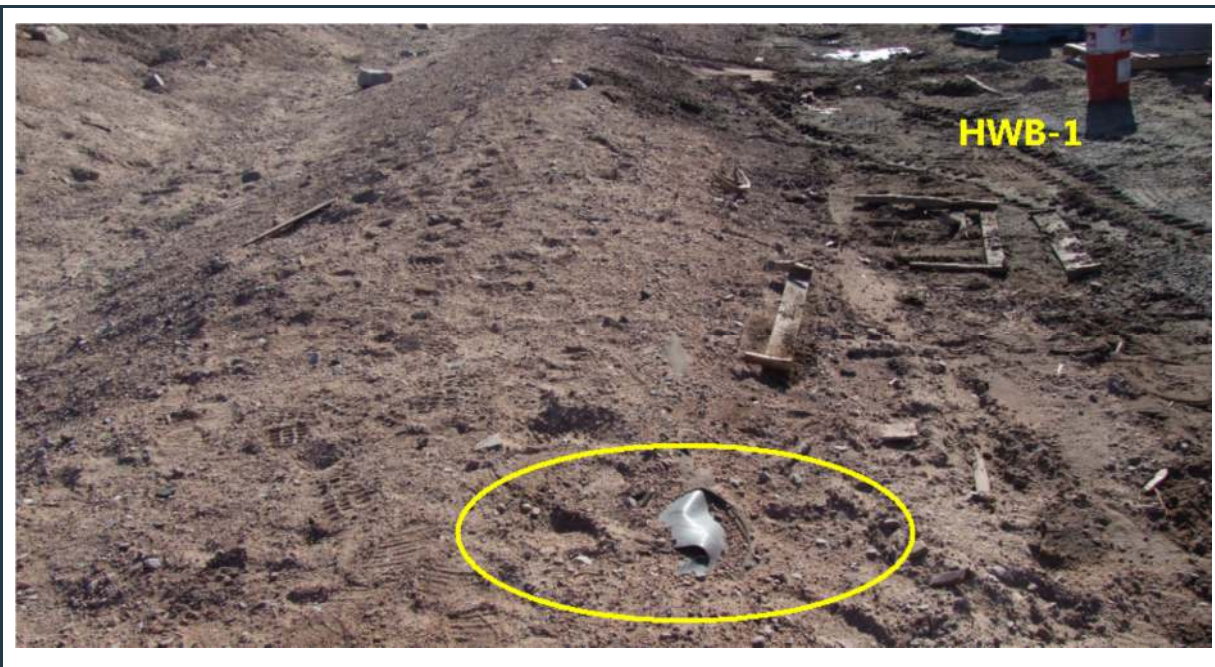
Figure 43: Ripped geotextile and exposed liner at the HWB-1 cell

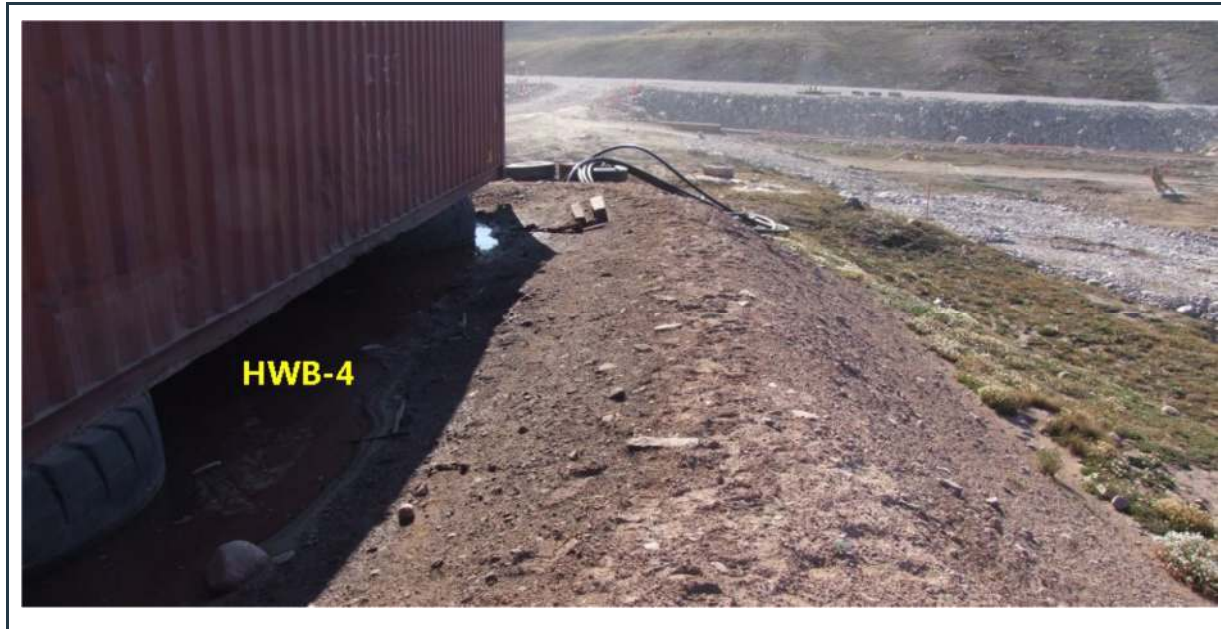
Figure 46: Stable berm at the HWB-4 pond

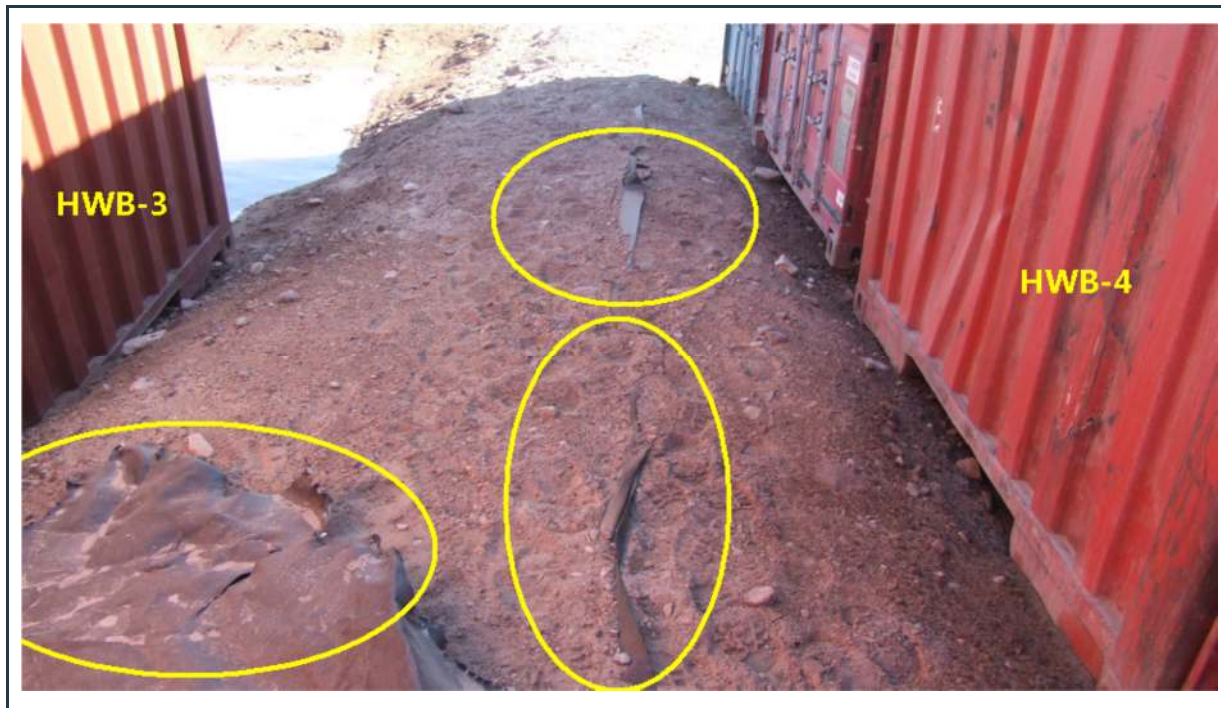
Figure 47: Exposed liner between the HWB 3 and HWB-4 ponds

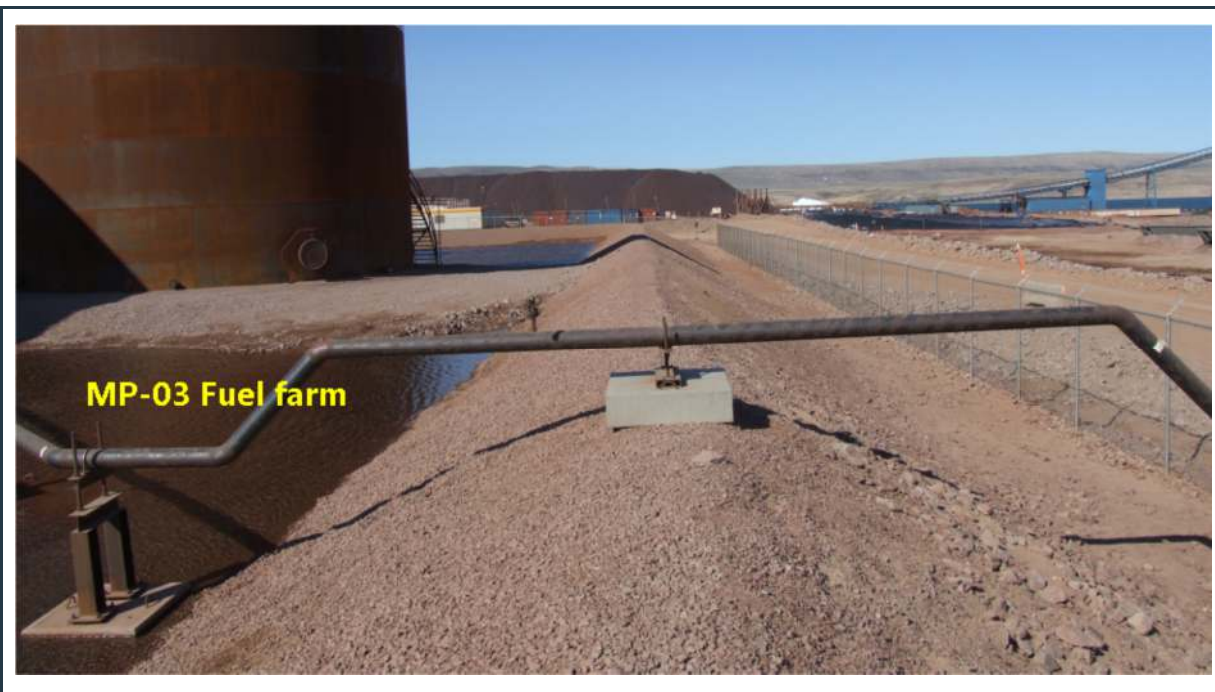
Figure 51: View of stable, well maintained berms around the MP-03 fuel tank farm

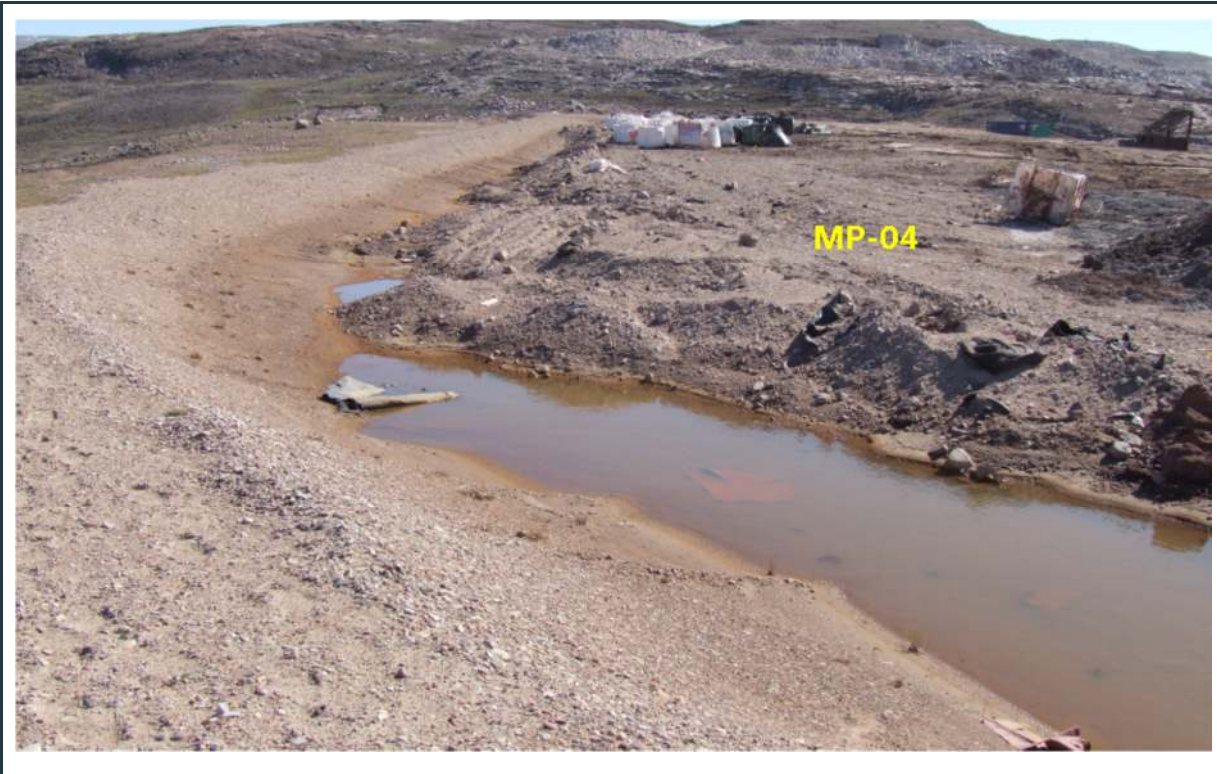
Figure 52: View of the waste and the stable berm at the MP-04 landfarm

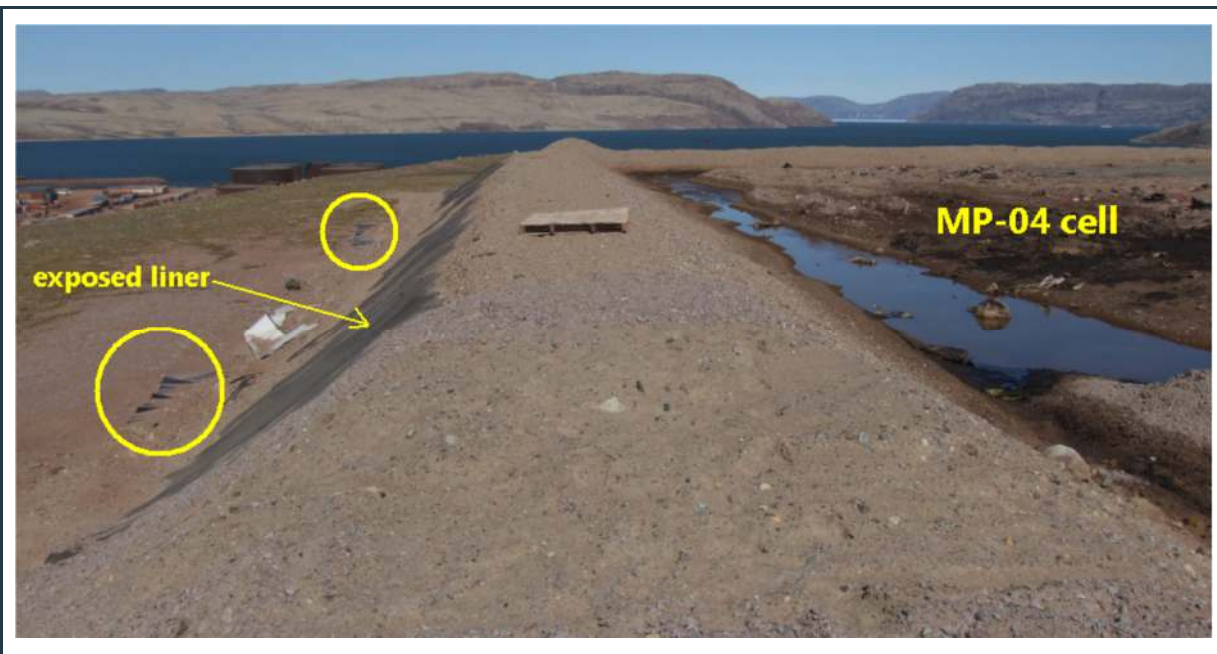
Figure 53: Stable berm at the MP-04 landfarm with exposed liner on the downstream face of the berm

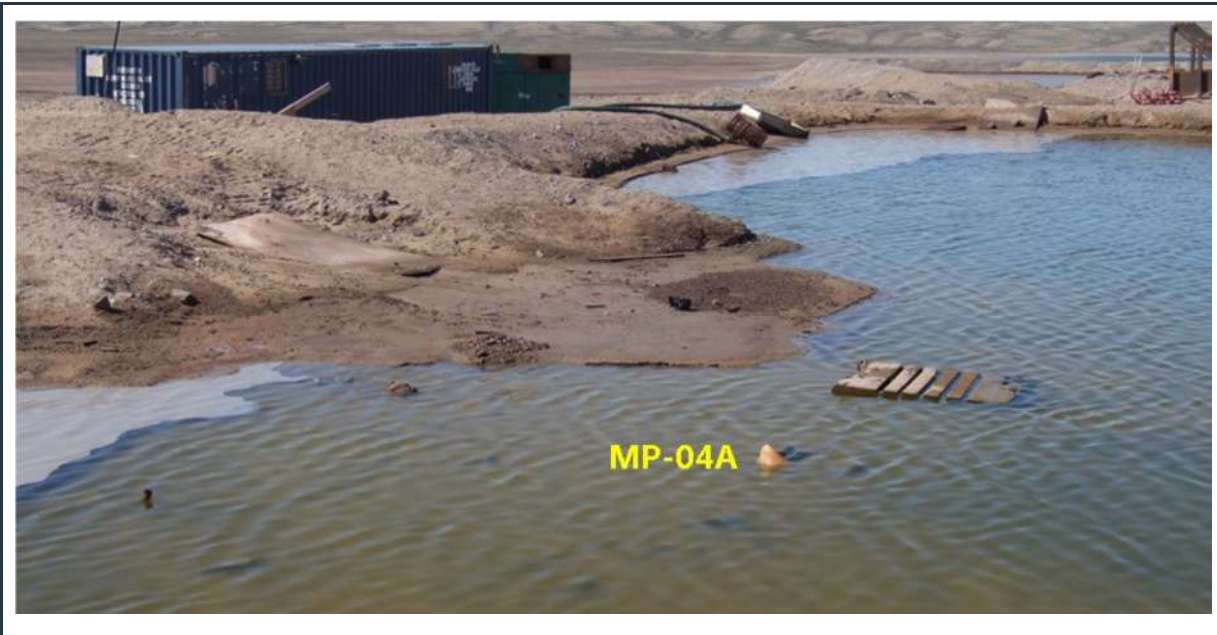
Figure 54: Condition of the ramp at the MP-04A contaminated snow dump

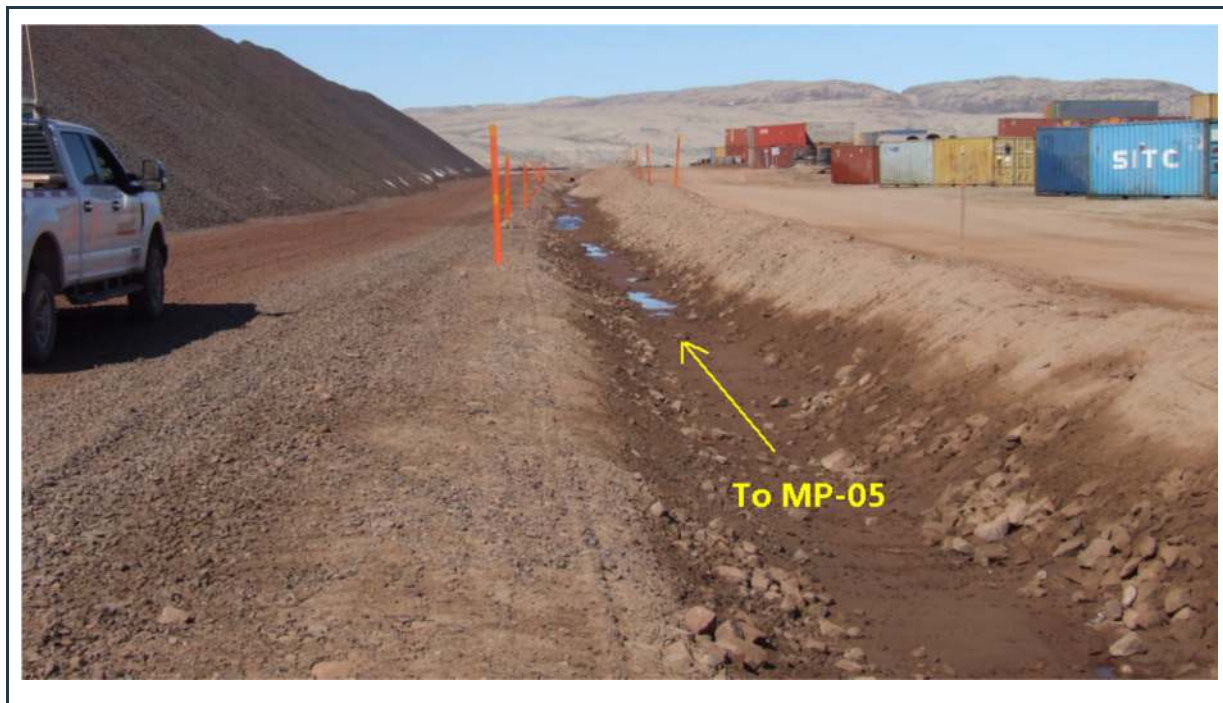
No instability, erosion or settlement was noted at the berms and no toe seepage from the ponds is visible anywhere around the ponds' perimeter. The surface water from around the stockpile is collected in the two well maintained drainage ditches, shown in Figures 57 and 60, reporting to the two ponds via the intakes.

Figure 57: Surface water collection ditch adjacent to stored, crushed ore (leading to the MP-05 pond)

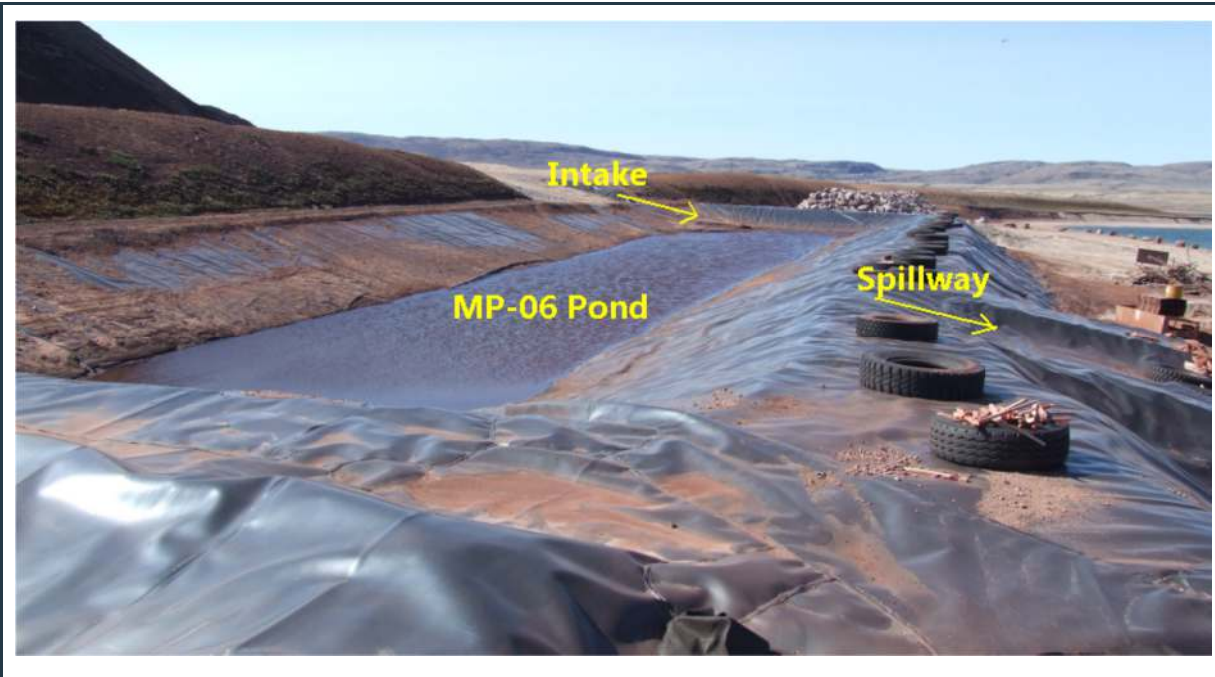
The MP-05 pond is located adjacent to the north-east corner of the stockpile, while MP-06 has been constructed at the north-west corner. Both ponds are in excellent condition with stable, well maintained berms and intact geomembrane liners, as shown in Figures 55, 56, 58 and 59.

Figure 58: View of the MP-06 pond at the front of the north-west corner of the ore stockpile

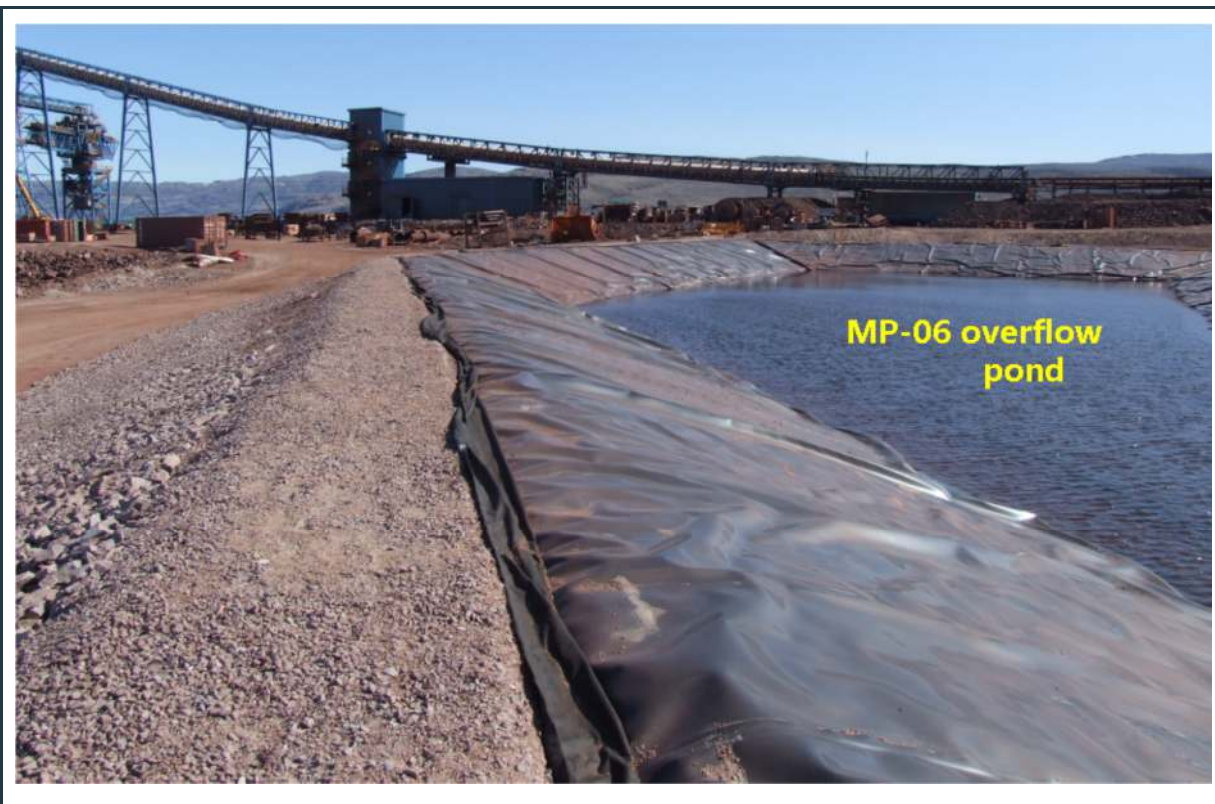
Pond MP-06 is divided into two ponds by a liner-covered internal berm and the northern cell within the pond is called the overflow cell, as shown in Figure 59. Both water collection ponds have emergency spillways. The water level in both ponds was well below the spillways' inverts at the time of the inspection.

Figure 59: View of the MP-06 overflow pond with stable berm in excellent condition

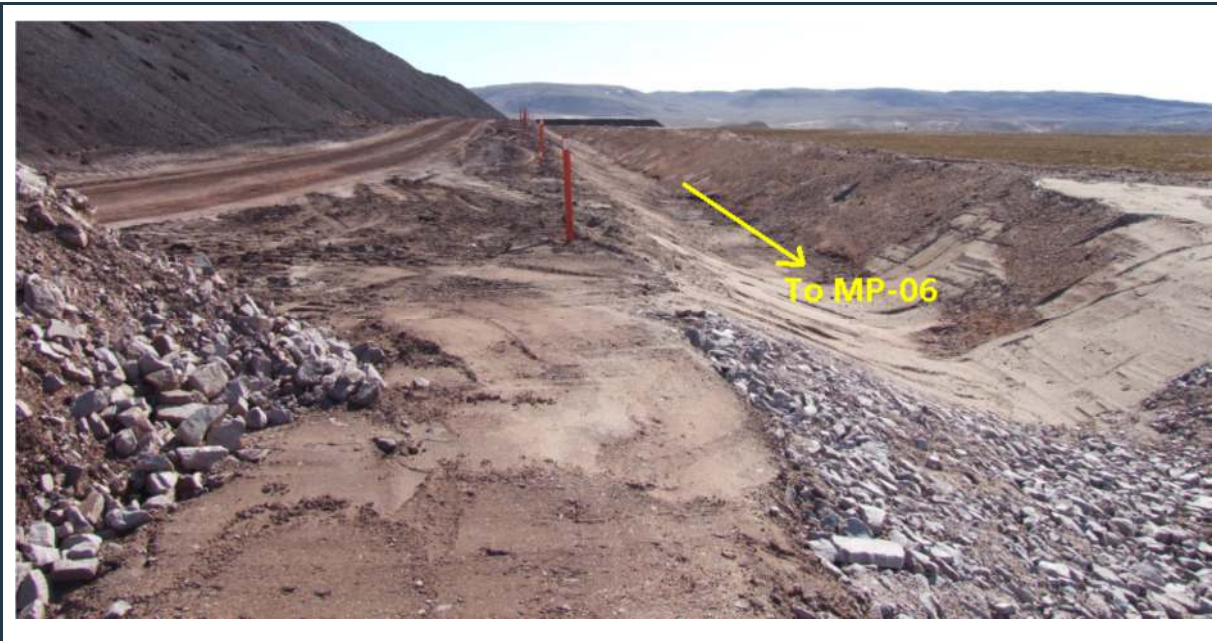
Figure 60: Surface water collection ditch, adjacent to stored, crushed ore leading to the MP-06 pond

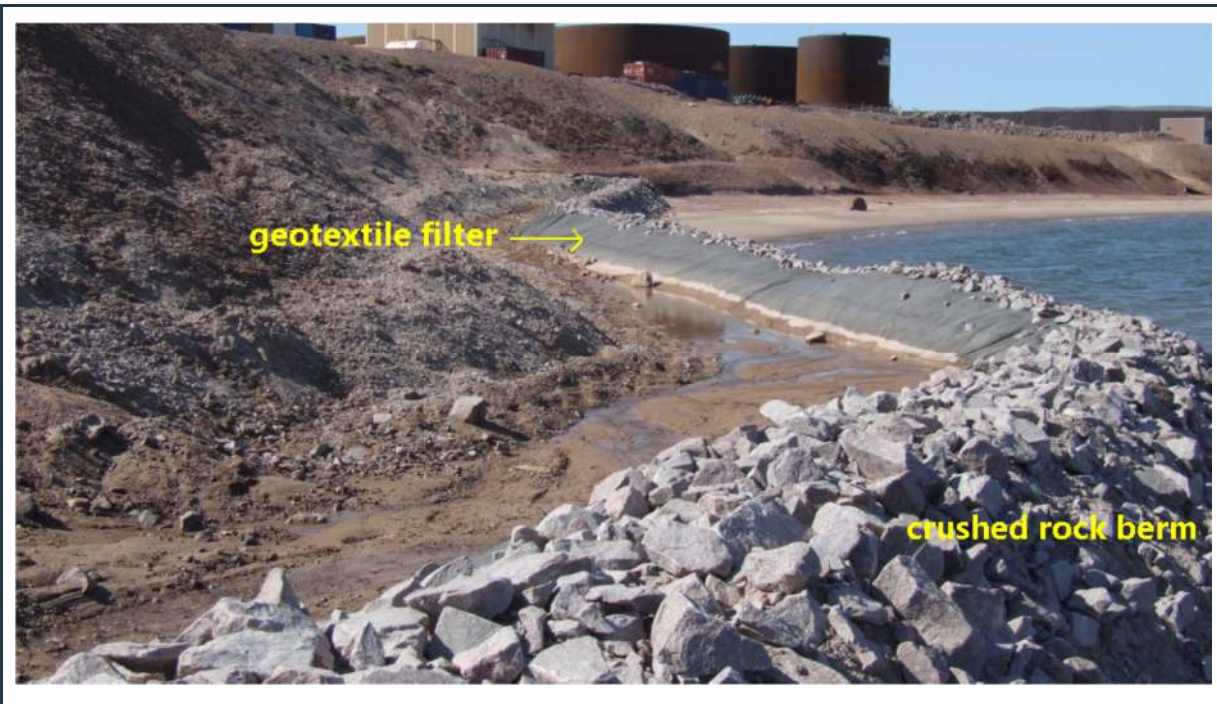
The freight dock check dam is a newly constructed structure comprising a crushed rock fill berm with geotextile cover on its upstream slope, as shown in Figure 61. This structure collects fine-grained soil particles (silt and clay) that may erode down from the port site and from the adjacent slope located along the bay's shore, approximately at the front of the HWB-1 pond. The berm/dam appears to be stable for intended purpose. It is suggested, however, that its condition be monitored during ice formation in the bay and check its resistance against the impact of ice forces.

Figure 61: View of the freight dock check dam/berm with geotextile filter on the upstream face of the crushed rock berm, to retain silt

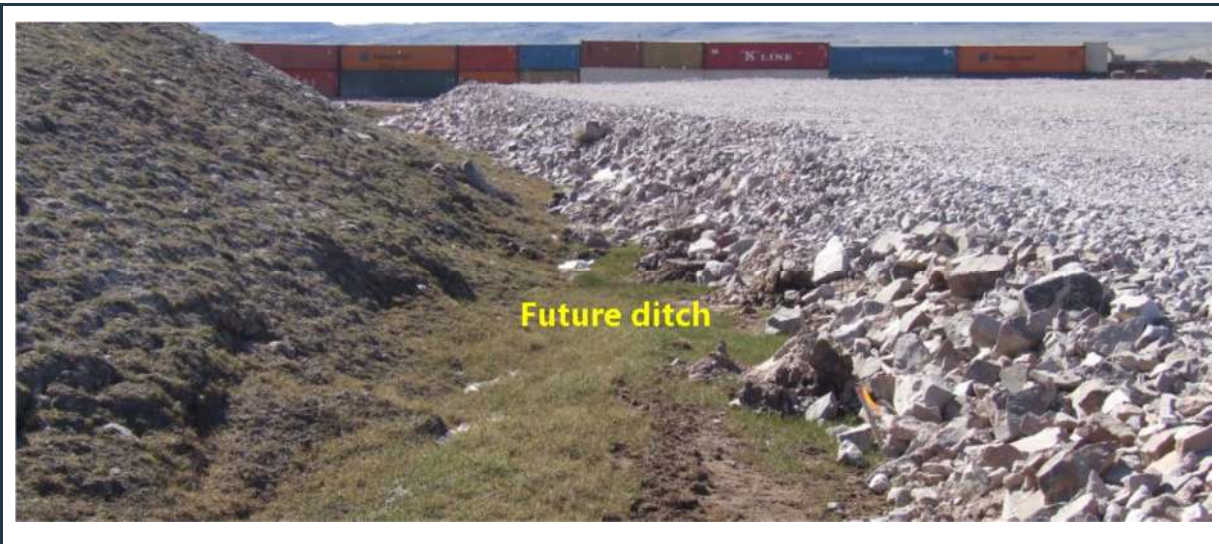
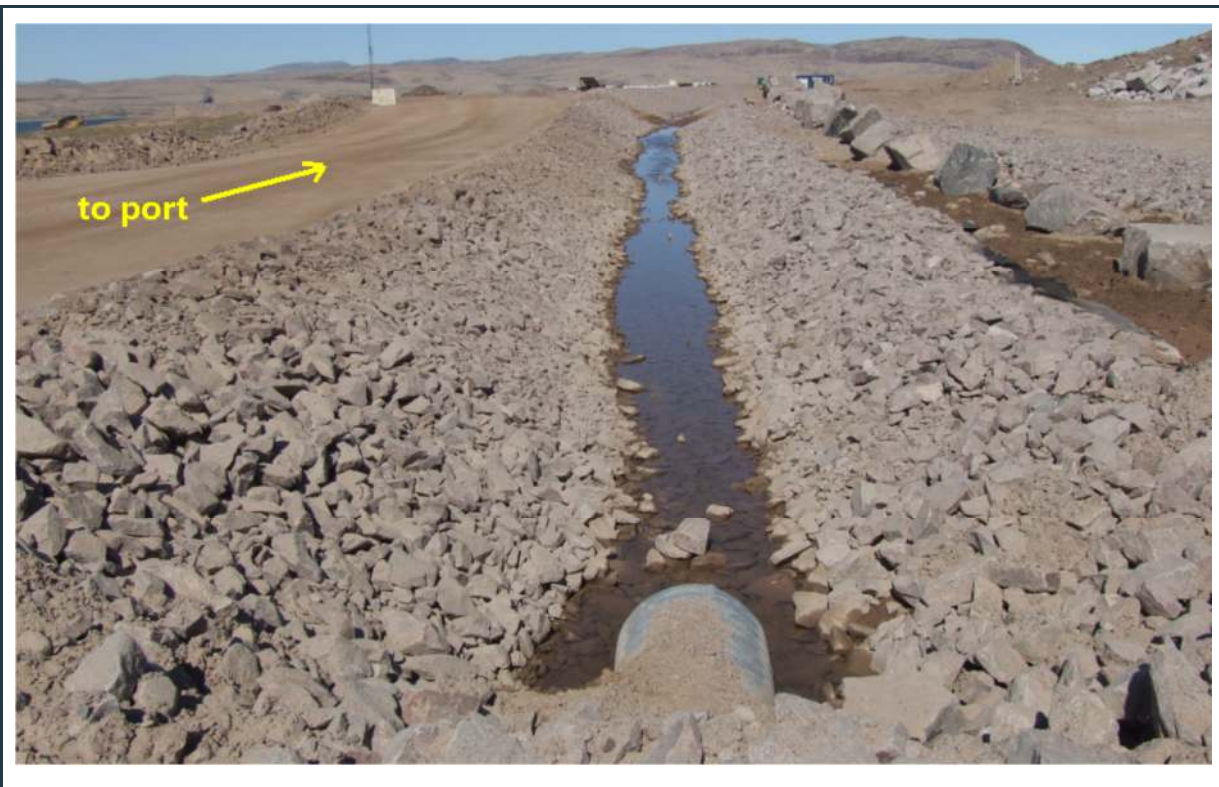
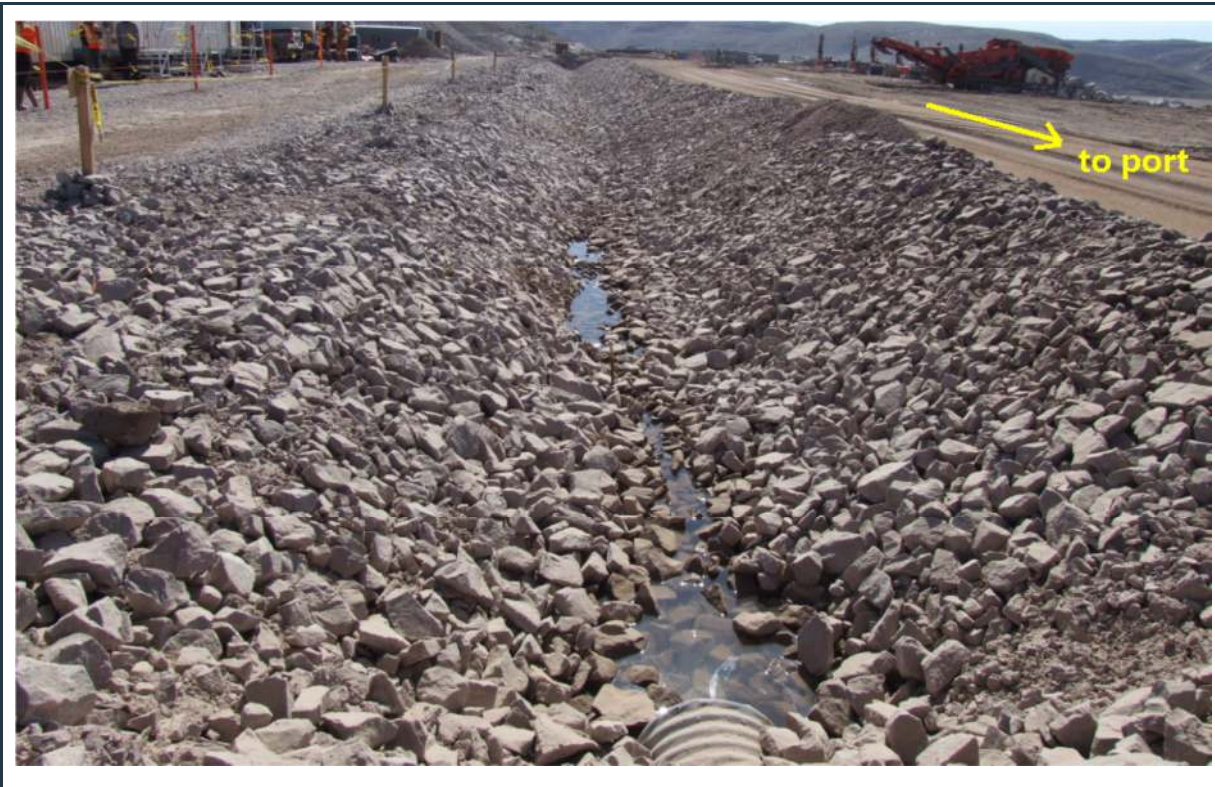
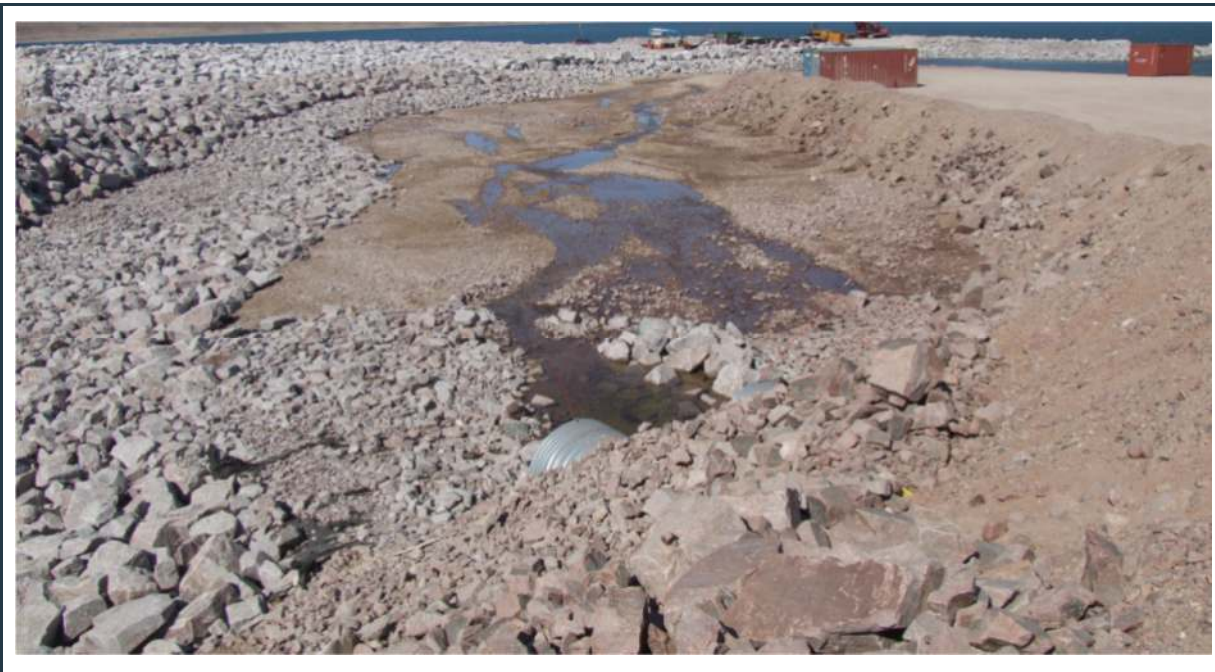
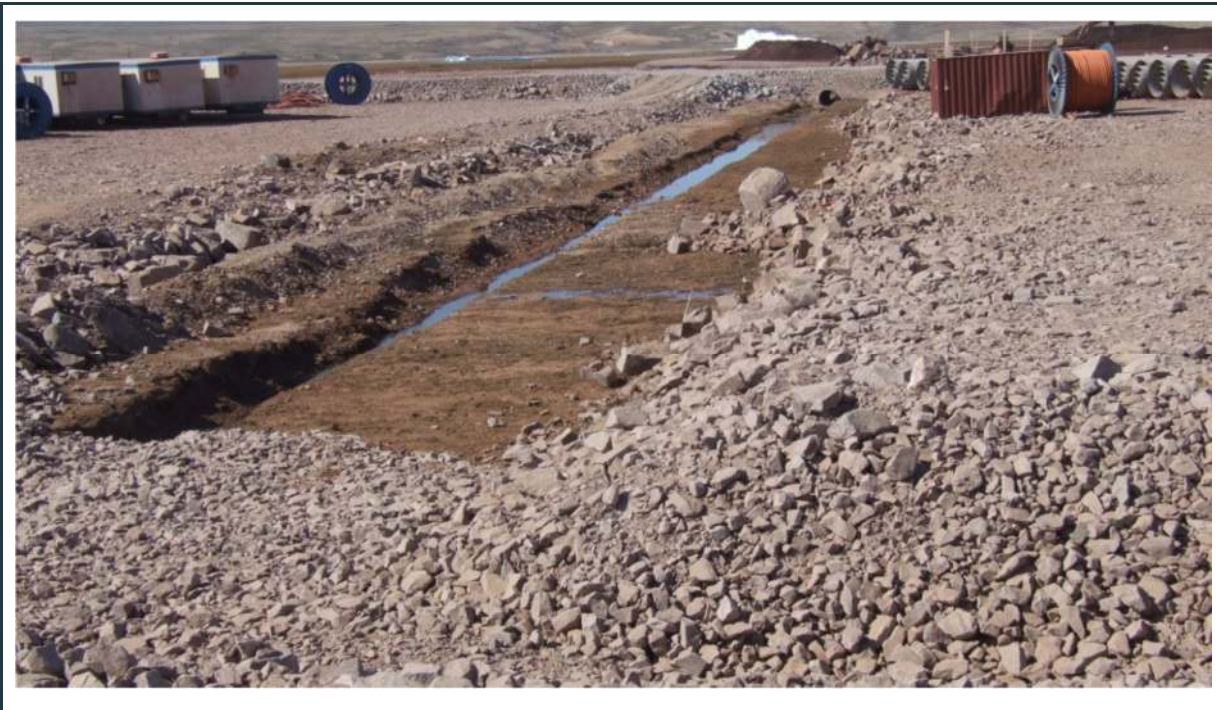
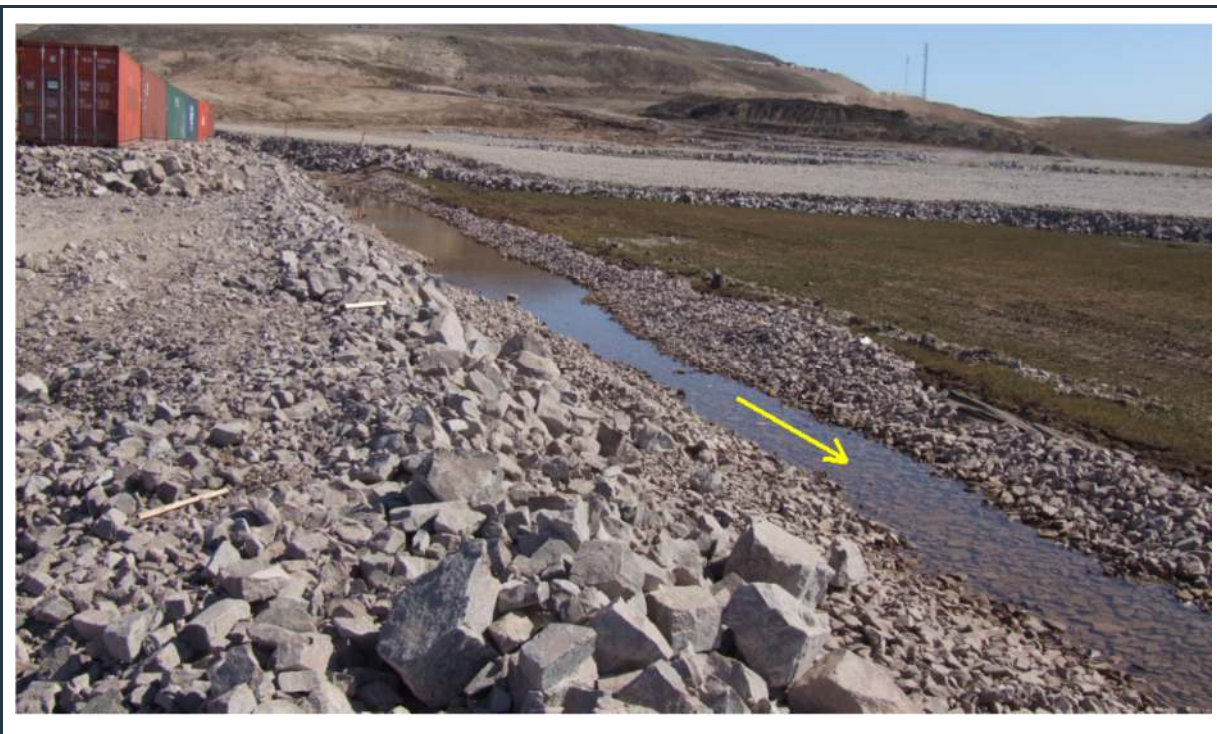
There are several water collection drainage ditches (listed above), most of them still under construction or improvement, as shown in Figures 62 to 67. These open ditches are excavated somewhat into the native soils and then their sides and inverts receive erosion protection layers composed of fine crushed rock. It was noted during the inspection that geotextile have been used wherever the native subgrade composed of fine-grained material to prevent migration of fines into the rockfill. The condition of these ditches should be monitored, particularly prior to the spring freshet, and any potential slope deterioration should be rectified prior to the anticipated increased flow during the thaw period of the year.

Figure 62: Future “P-SWD-3 LP2” surface water collection ditch – under construction

Figure 63: P-SWD-5 Q1 North surface water collection ditch

Figure 64: P-SWD-6 Q1 South surface water collection ditch

Figure 65: P-SWD-7 surface water collection ditch adjacent to the new freight dock (under construction)

Figure 66: W13-W14 surface water collection ditch (under construction)

Figure 67: 380 M surface water collection ditch (under construction)

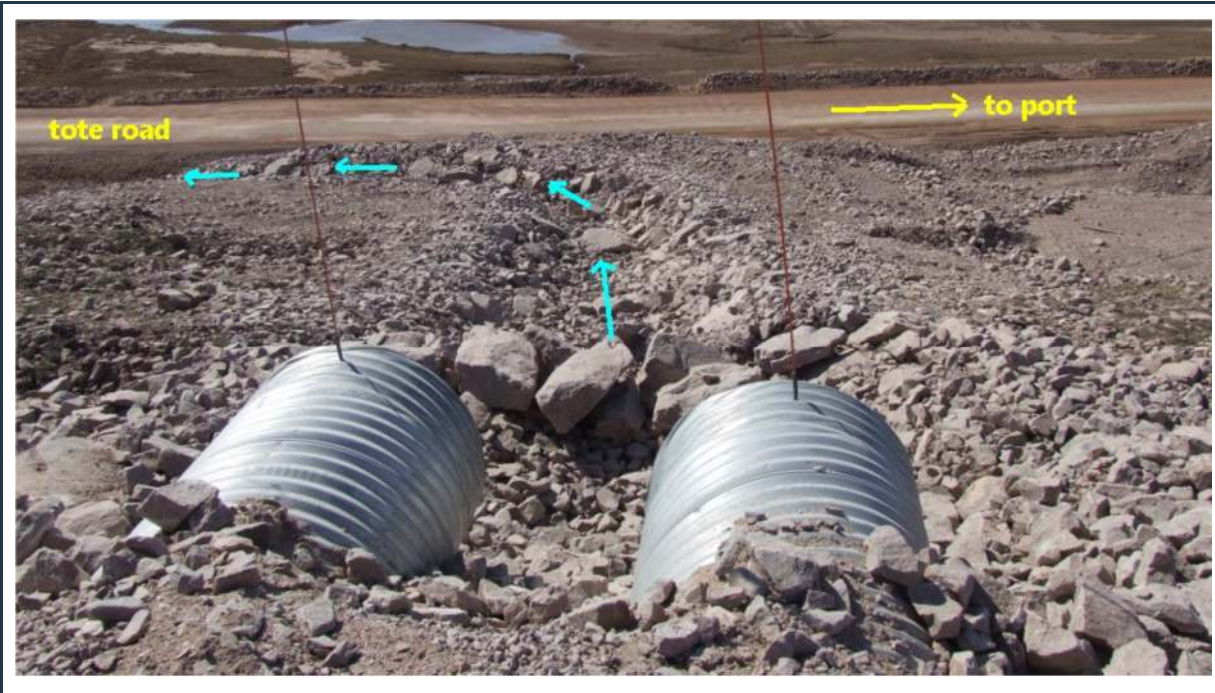
Figure 68: Culverts and drainage ditch, conveying surface water from higher elevation toward the road
