RE: Submission of 2019 Geotechnical Inspection Report No. 1 (July 2019)

Annual Geotechnical Inspections – 2019 Report 1. Mary River Iron Mine Complex – Nunavut

Annual Geotechnical Inspections – 2019 Report 2. Mary River Iron Mine – Nunavut

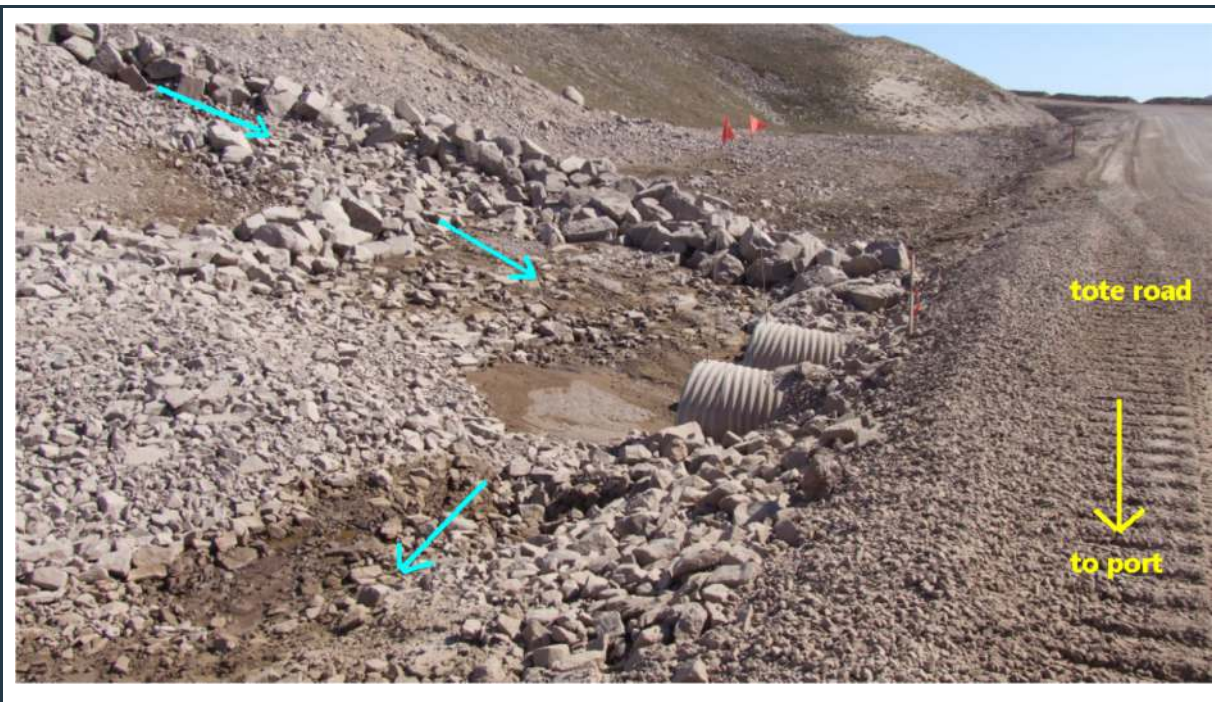
Figure 69: Surface water bypassing the two culverts installed under the tote road

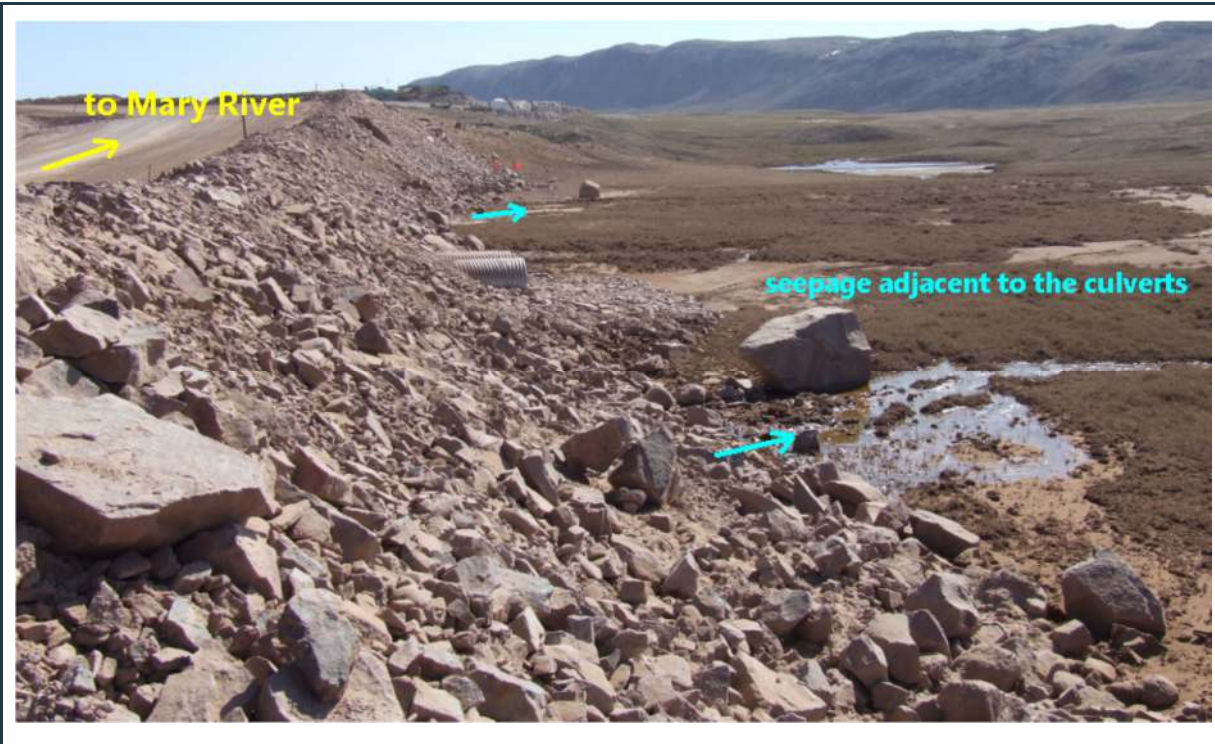
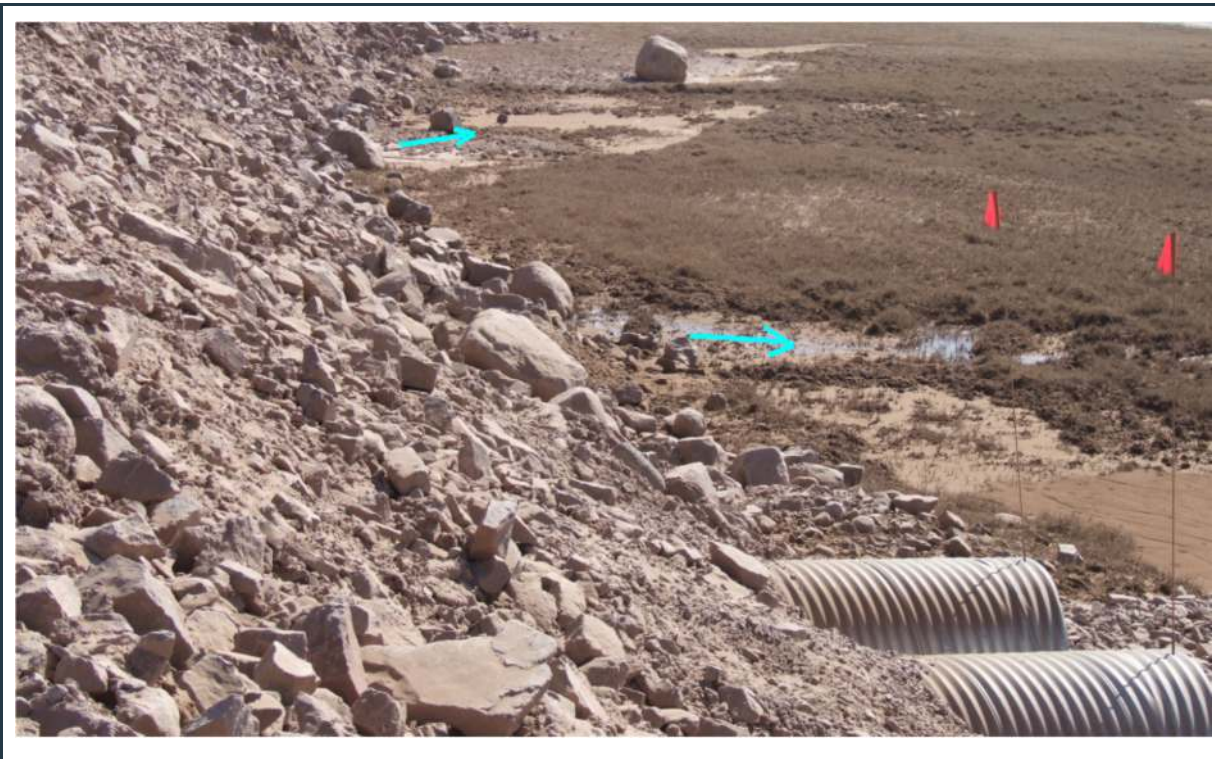
Surface water from higher elevations around the rock quarry is collected in drainage ditches and conveyed down the slope through corrugated galvanized steel culverts, installed under an internal haul road and then under the tote road. The water in the ditches is conveyed to small natural ponds, located along the west side of the tote road, as shown in Figures 68 to 71. Figure 68 shows the outlet of two culverts, located under the internal haul road at higher elevation, well above the tote road. The blue arrows in the image show the alignment of the drainage ditch and the theoretical flow path for the collected water. Figure 68 shows the two culverts located under the tote road that should convey the collected surface water to the other side of the tote road. However, since all fill in the area (road embankment and slope cover) comprise crushed rock fill, a portion of the water bypasses the two culverts beneath the tote road embankment (through-flow) and finds its way to nearby ponds (see Figures 70 and 71).

Figure 70: Water seepage through the road embankment adjacent to the tote road culverts

Figure 71: Water seepage through the road embankment adjacent to the tote road culverts

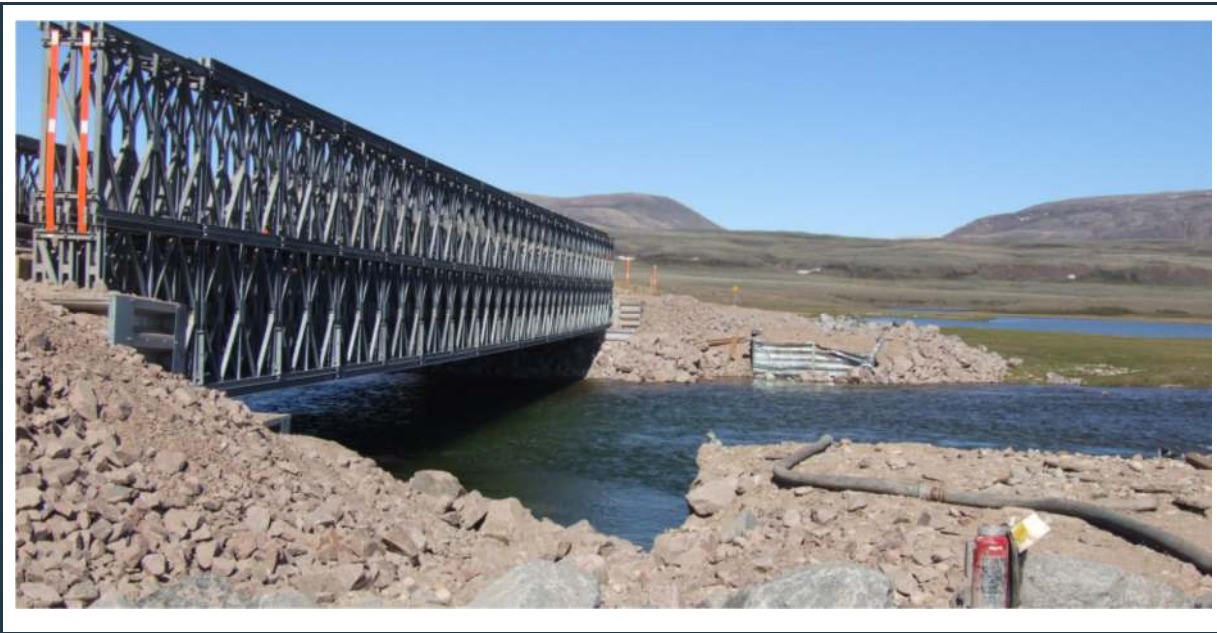
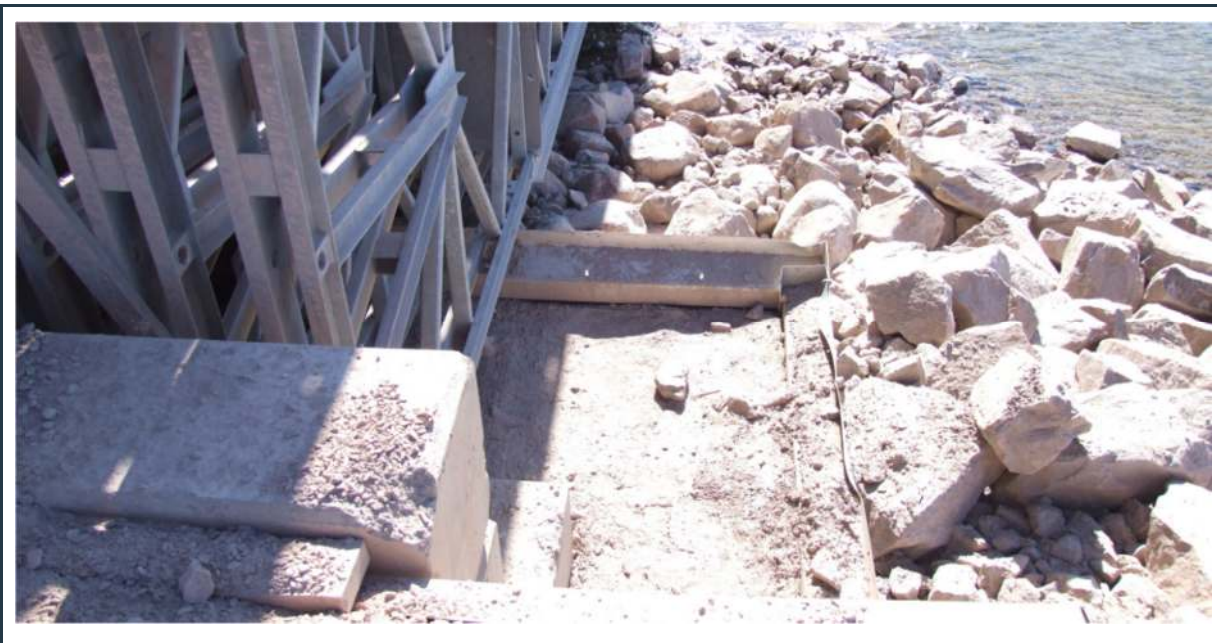
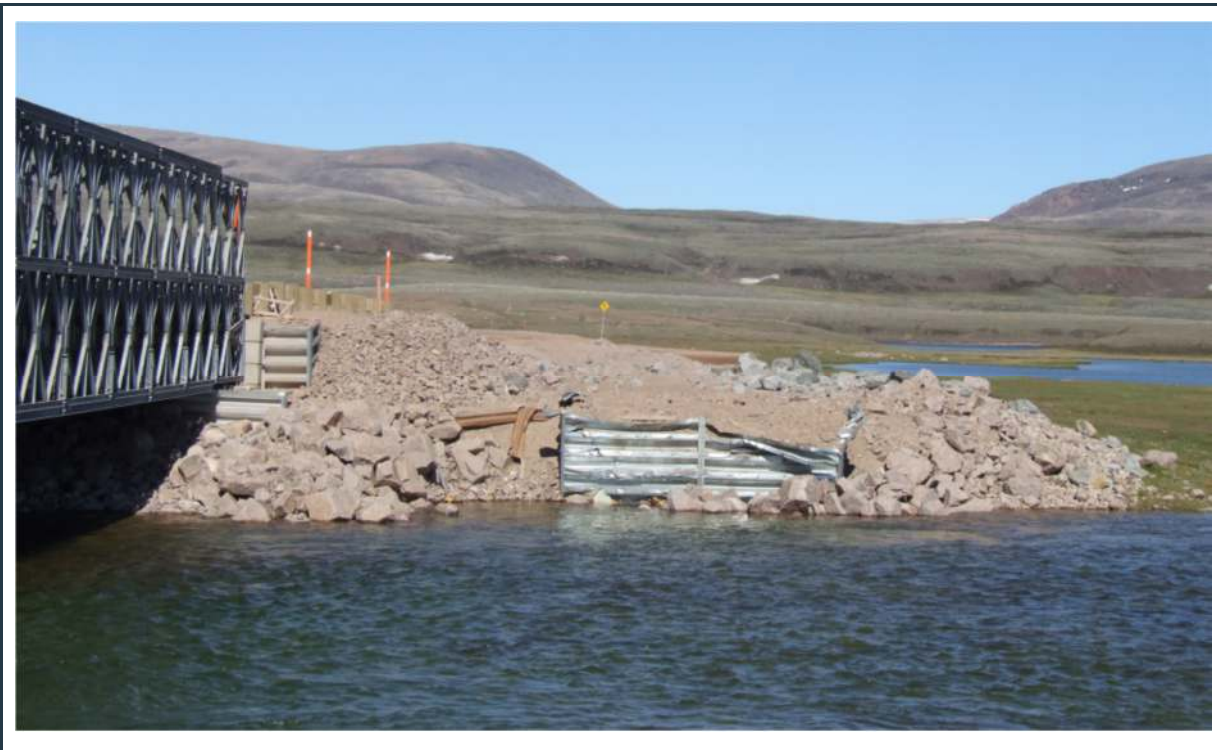
a) Bridge 17 (located approximately 17 km from Milne Inlet port)

As shown in Figures 72 to 75, the abutments of this bridge are stable and no scour in the river-bed was noted during the site visit. The abutments show no differential settlement or any structural discrepancy, like cracking on the foundation concrete. There are two historic abutments, located immediately adjacent to the "new" ones. The metal front and wing walls of both "old" abutments have suffered damages in the past, particularly the south abutment, as shown in Figure 75. That image also shows that a pump is operated on the top of the abutment, supplying water to the water trucks from the river (used for dust control on the road).

Figure 72: View of bridge 17 (17 km from the port), looking north-east

Figure 73: Foundation and rip-rap conditions at one of the abutments at bridge 17

Figure 75: The “old” north-east abutment at bridge 17

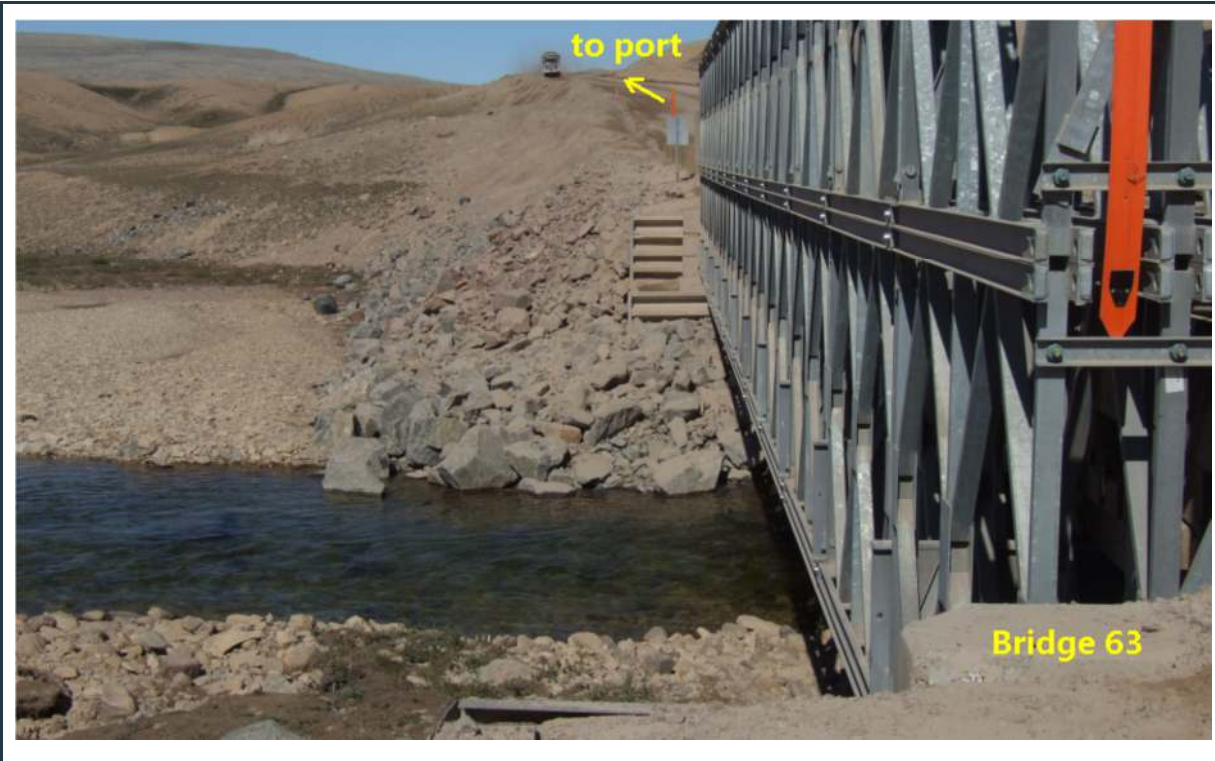
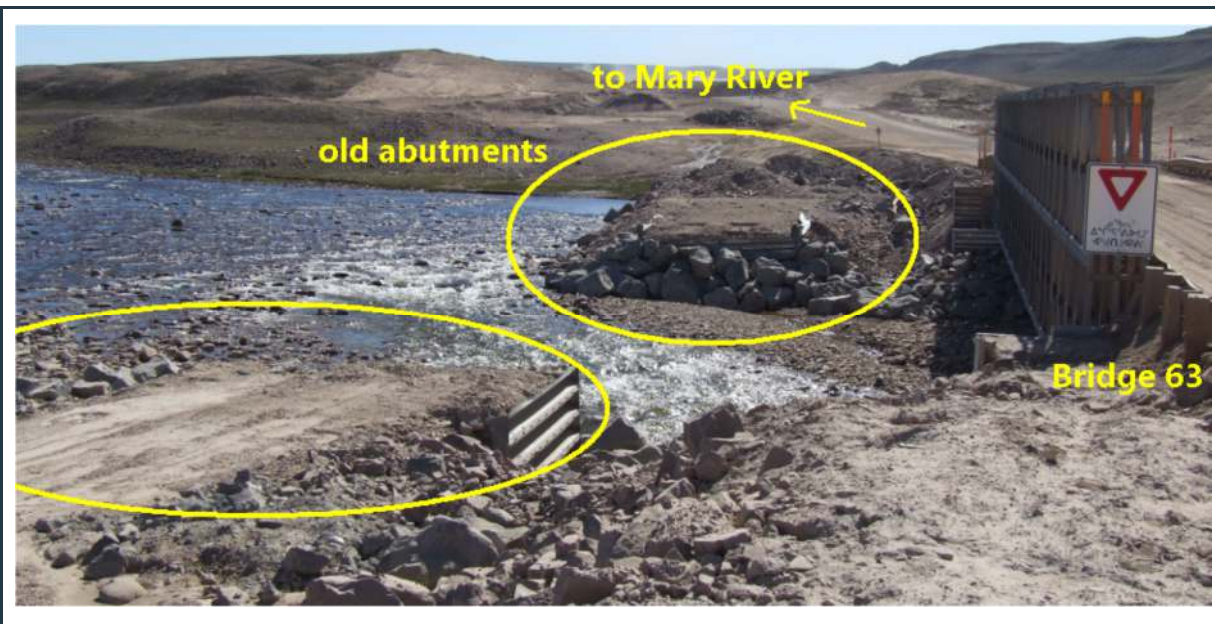
b) Bridge 63 (located approximately 63 km from Milne Inlet port)

As shown in Figures 76 to 78, the abutments of this bridge are stable and no scour in the river-bed was noted during the site visit. The abutments show no differential settlement or any structural discrepancy like cracking on the foundation concrete. The wing-wall at the north-west abutment appears to be short and minor erosion of the road fill was noticed (Figure 78). At that location a metal section should be added to the wing-wall or alternatively some rock-fill be placed there to prevent soil erosion from the road into the river.

Figure 76: View of bridge 63, looking north

Figure 77: View of the "old" abutments at bridge 63

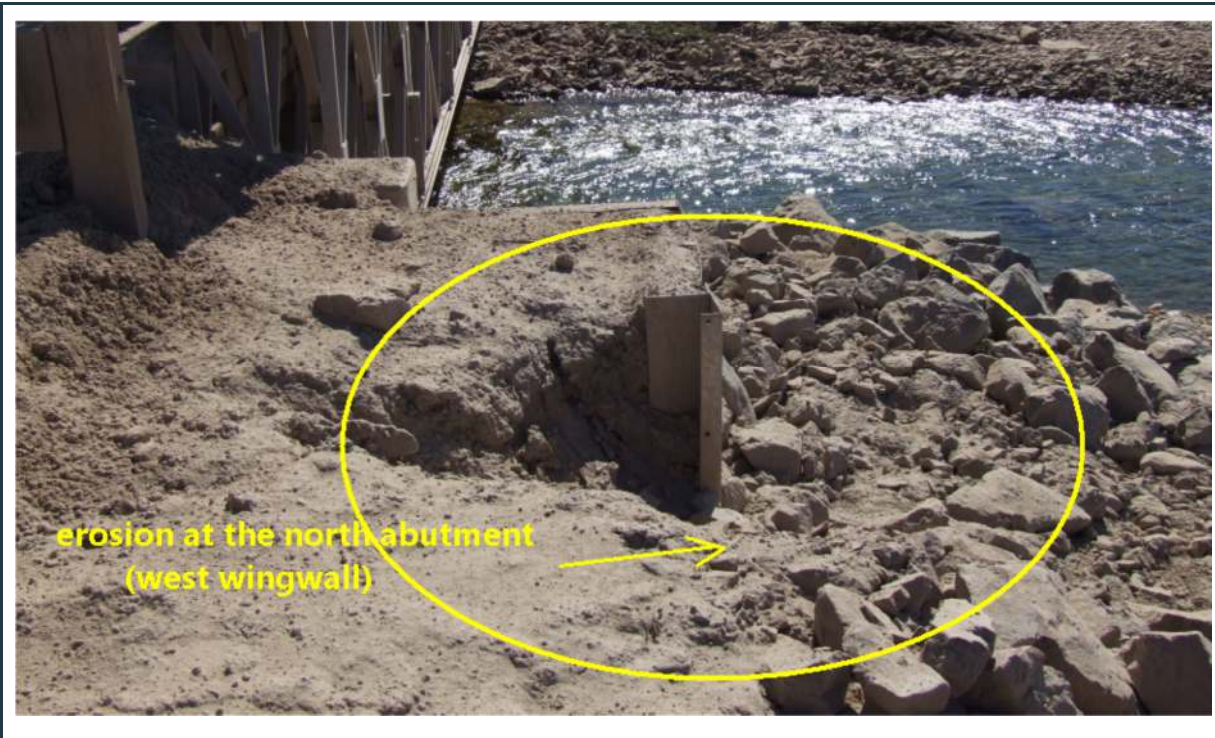
Figure 78: Minor erosion at the north-west wingwall at bridge 63

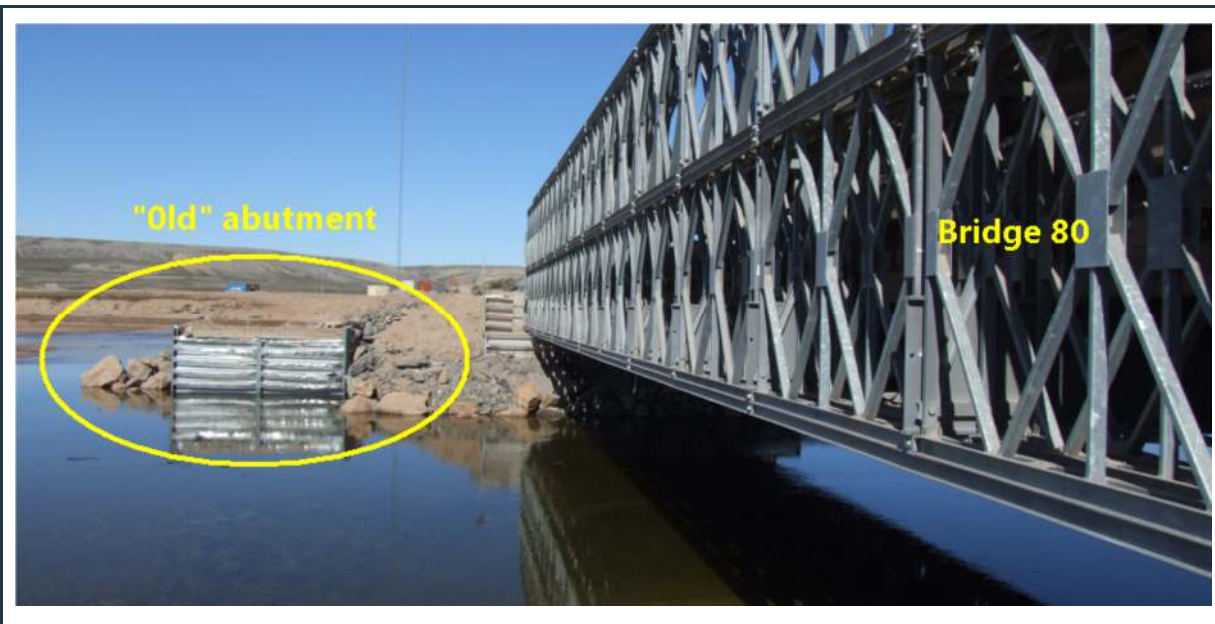
c) Bridge 80 (located approximately 80 km from Milne Inlet port)

As shown in Figure 79, the abutments of this bridge are stable and no scour in the river-bed was noted during the site visit. The abutments show no differential settlement or any structural discrepancy like cracking on the foundation concrete.

Figure 79: View of bridge 80 with one of the old abutments, looking north

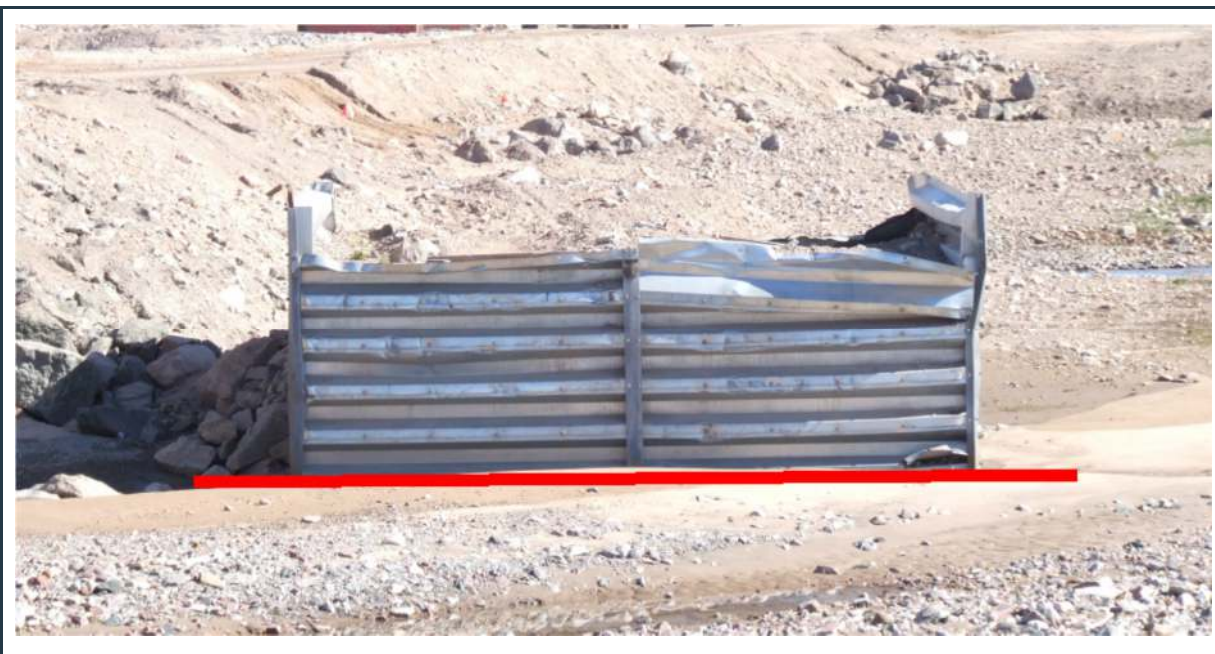
d) Bridge 97 (located approximately 97 km from Milne Inlet port)

As shown in Figure 80 and 81, the abutments of this bridge are stable and no scour in the river-bed was noted during the site visit. The abutments show no differential settlement or any structural discrepancy like cracking on the foundation concrete.

Figure 80: View of bridge 97, looking south

Figure 81: One of the "old" abutments at bridge 97. The section above the red-line may be removed, but the removal is not necessary.

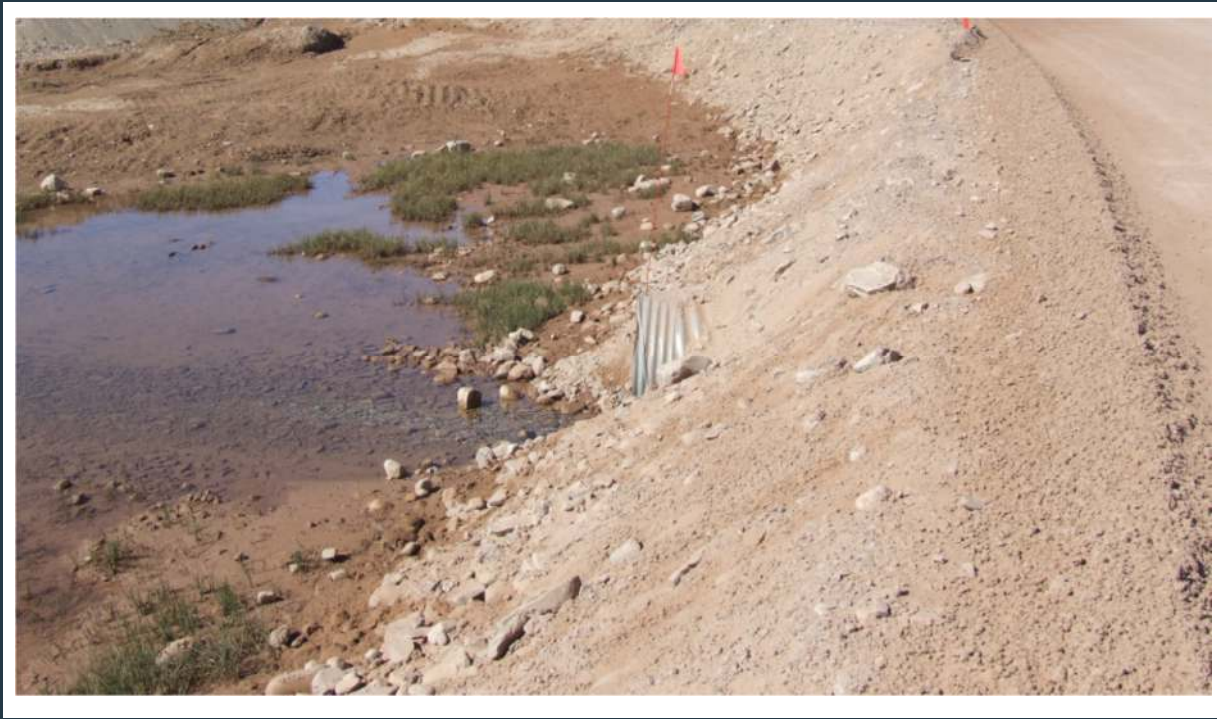
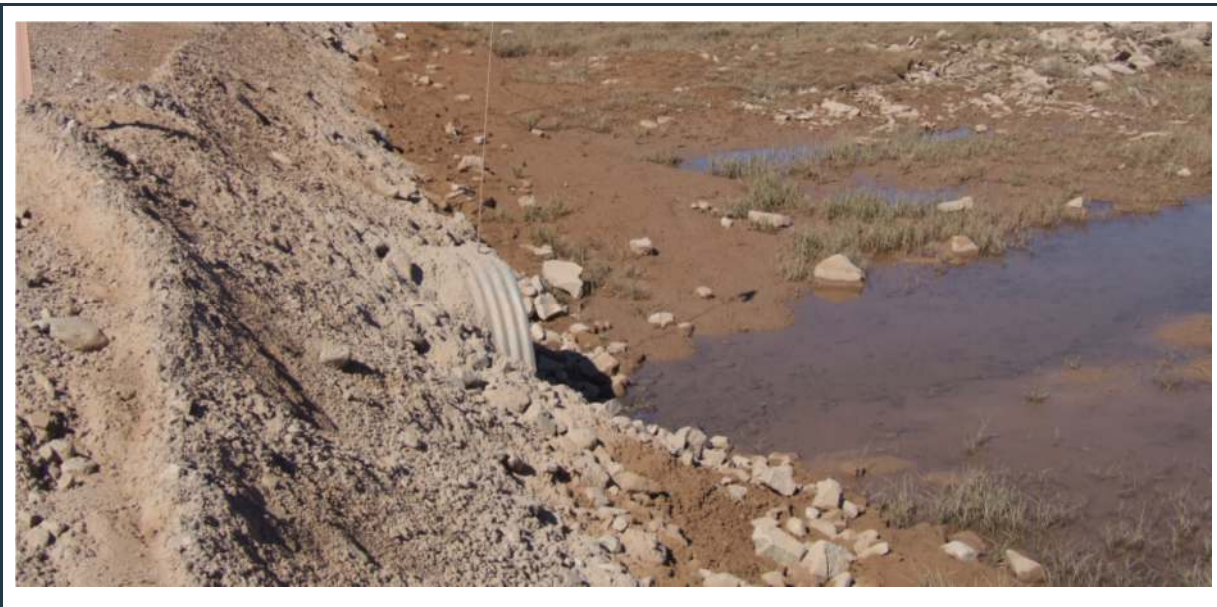
a) CV-076

Figure 82: View of culvert 076 (outlet)

Figure 83: View of culvert 076 (inlet)

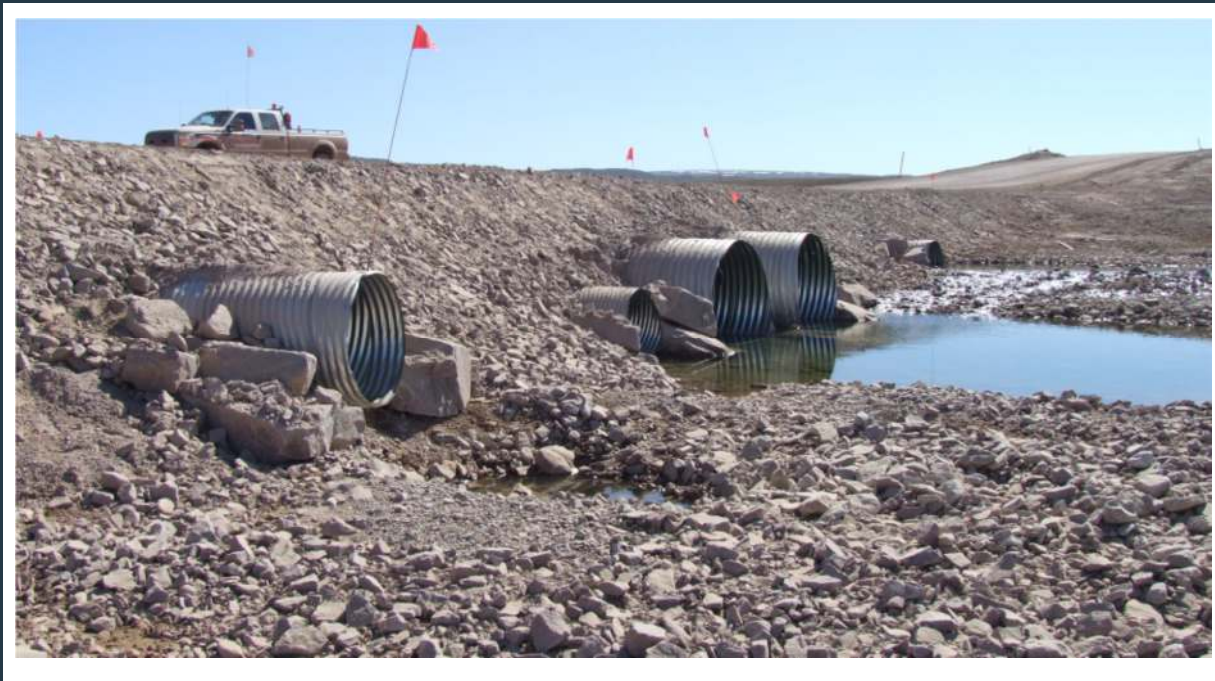
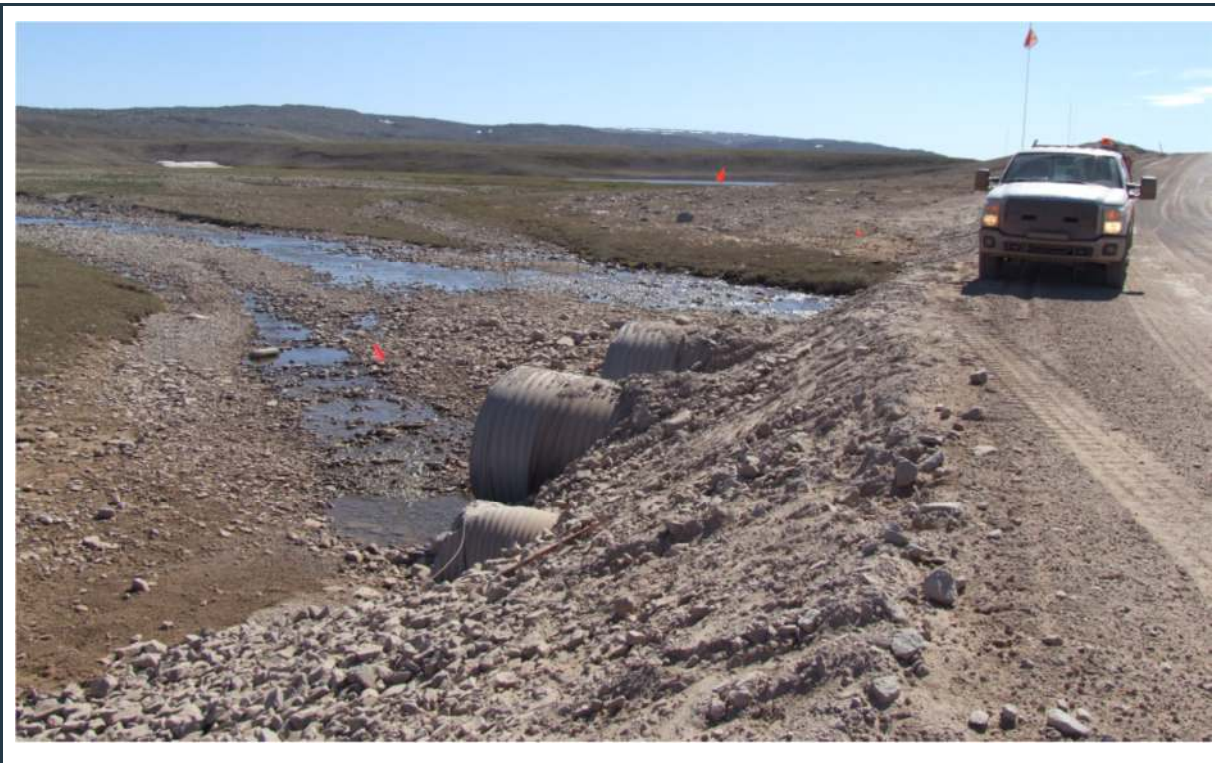
b) CV-078

Figure 84: View of culvert(s) 078 (outlet)

Figure 85: View of culvert(s) 078 (inlet)

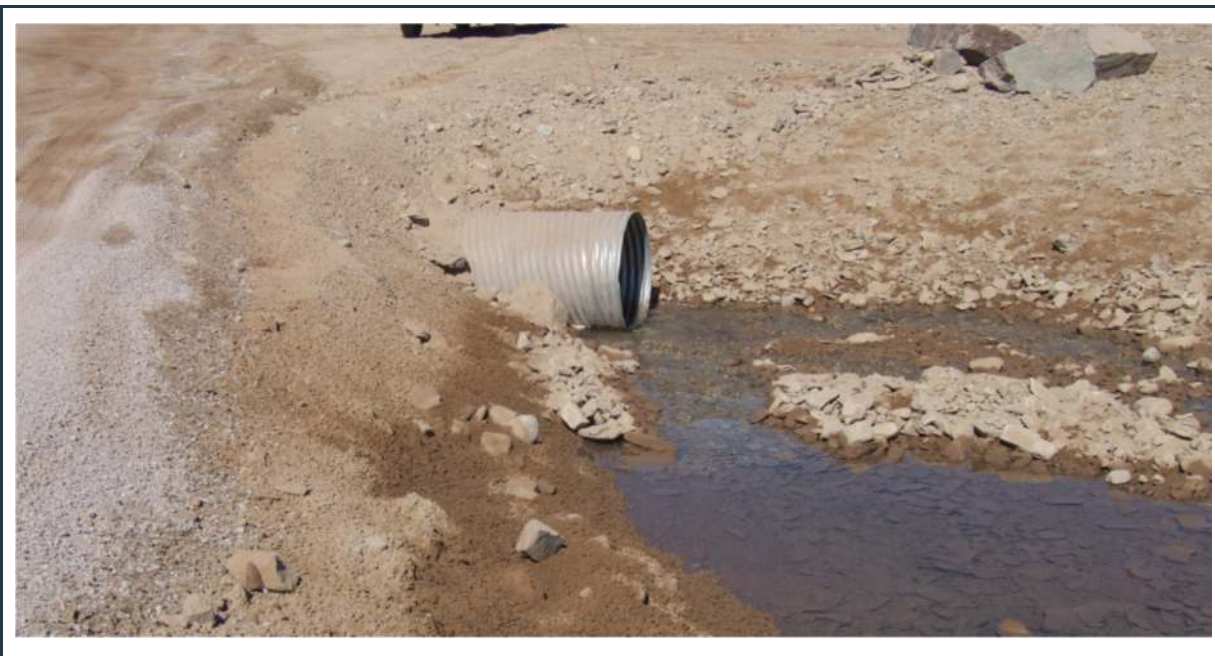
Figure 87: View of culvert 083 (inlet)

CV-083 (Figures 86 and 87): The outlet of this culvert appears to be short. It should be extended by about 1.5 m and the adjacent road embankment shall be upgraded to a more stable slope with the placement of crushed stone. Crushed rock fill should also be placed adjacent to the culvert at its inlet, to prevent erosion of the road embankment by the flowing water in the creek. Improvement of the creek's alignment at the front of the inlet is also recommended (minimize water flow parallel with the embankment at its toe, to prevent toe erosion and subsequent potential slope instability).

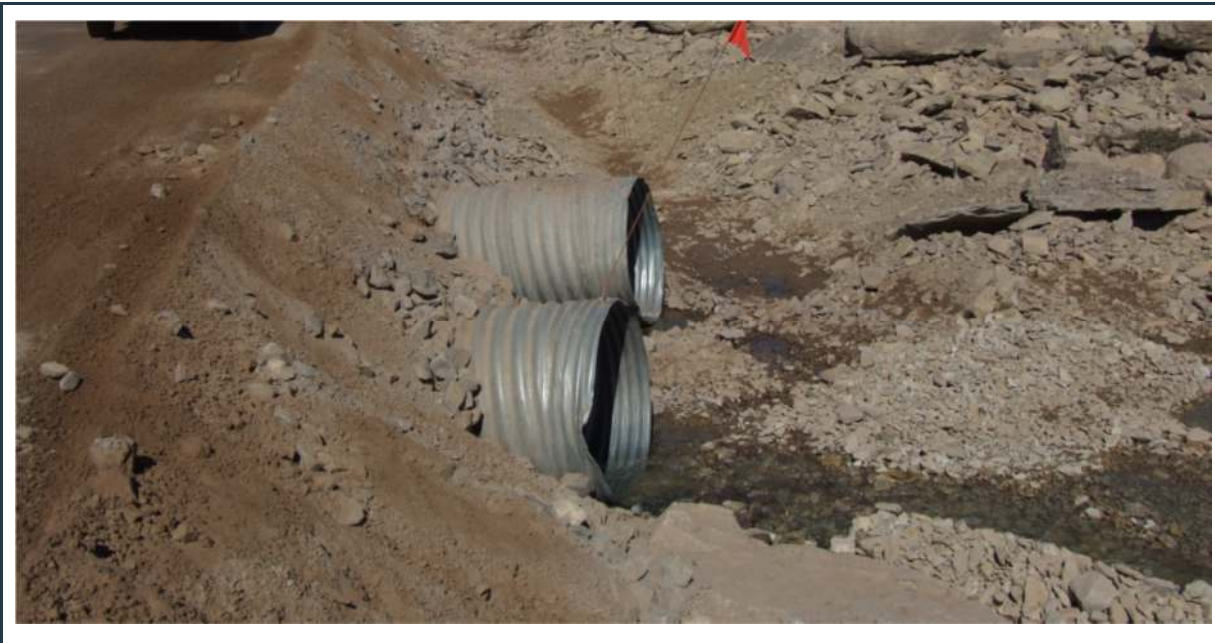
Figure 89: View of culvert(s) 094 (inlet) in excellent conditions

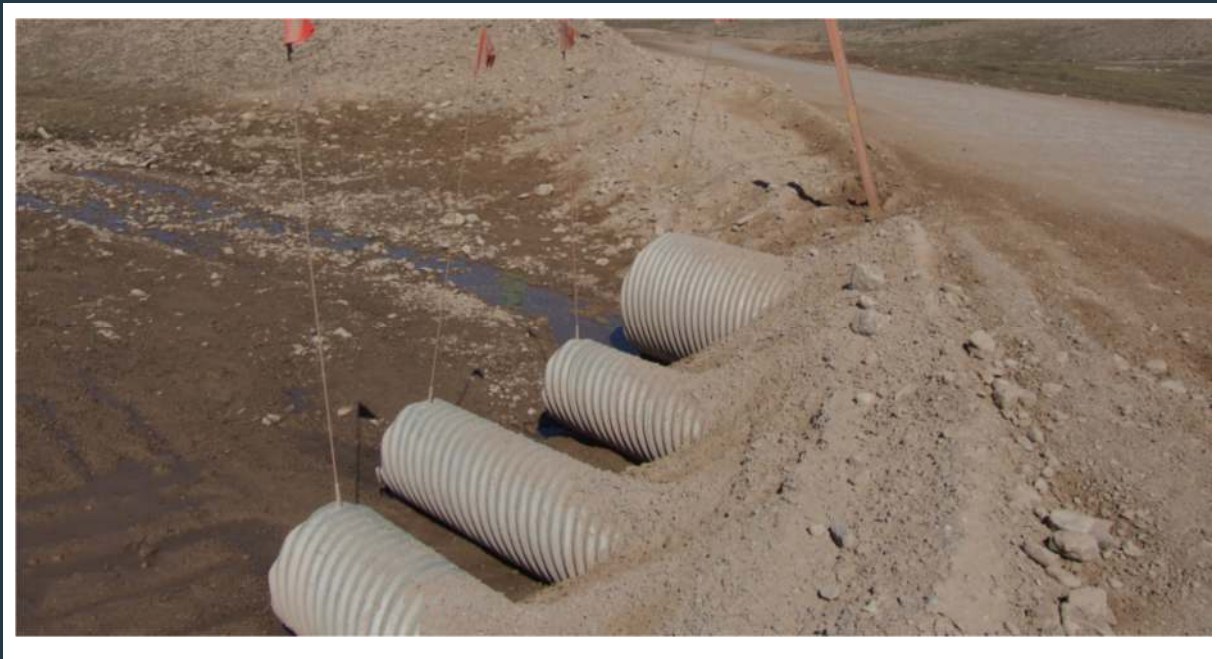
e) CV-102

Figure 90: View of culvert(s) 102 (outlet) in excellent conditions

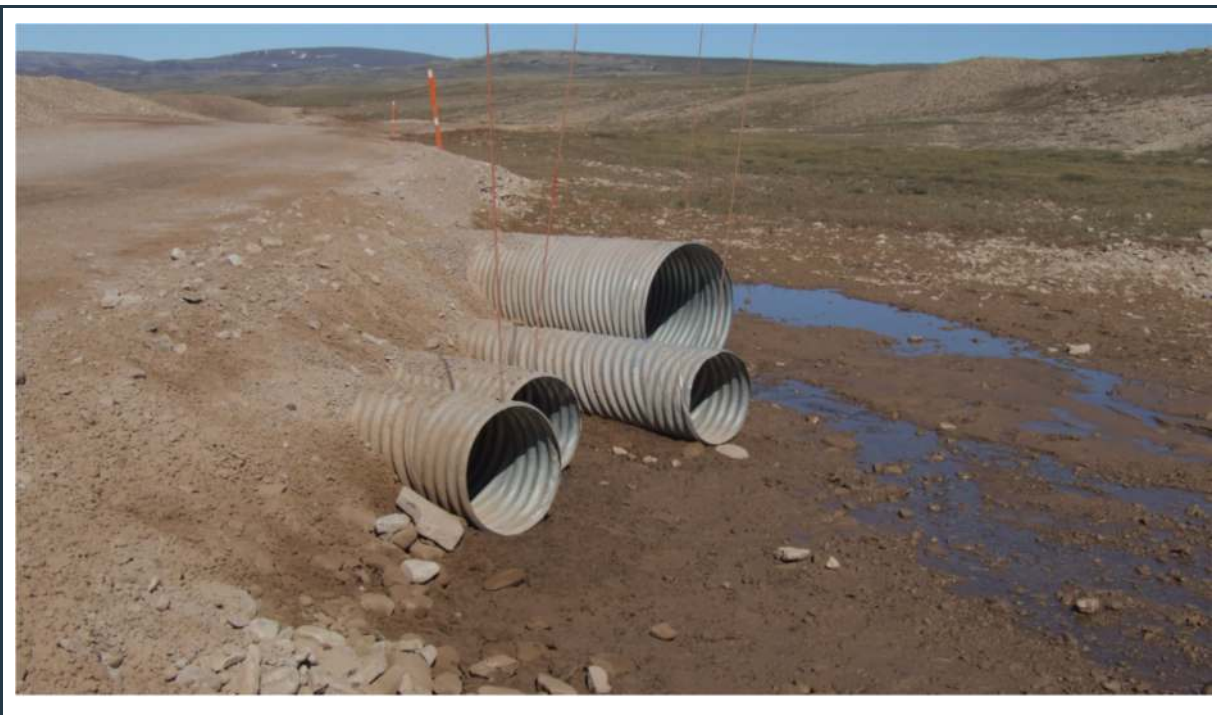
Figure 91: View of culvert(s) 102 (inlet) in excellent conditions

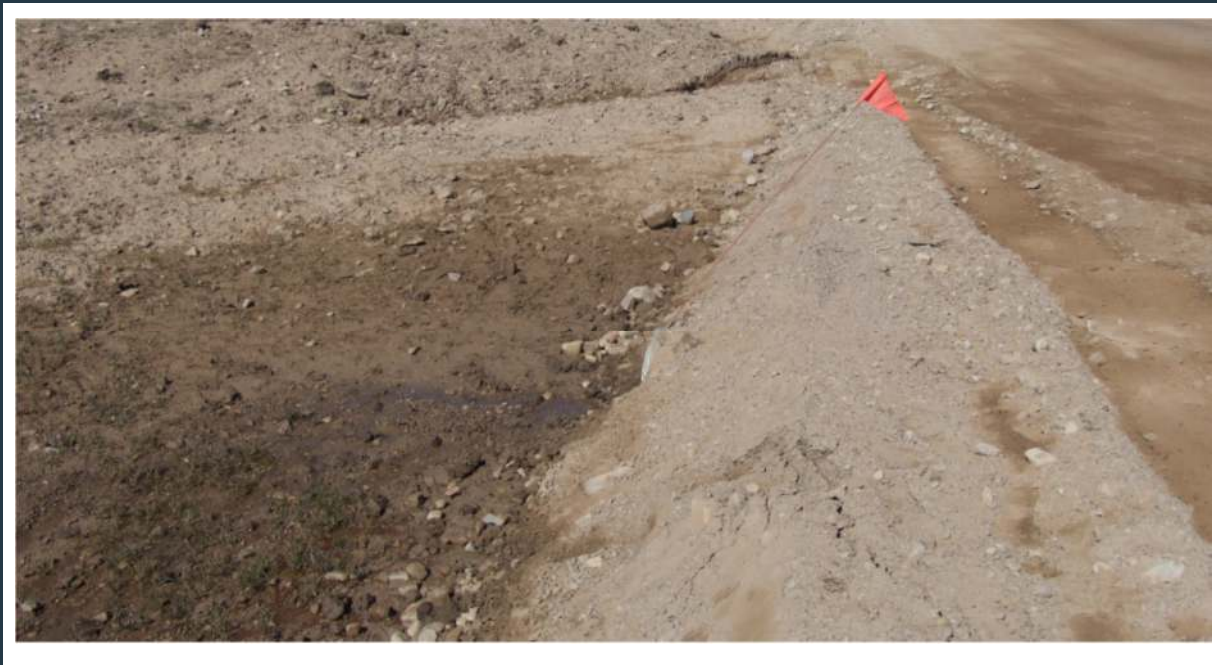
Figure 92: View of culvert 107 (outlet)

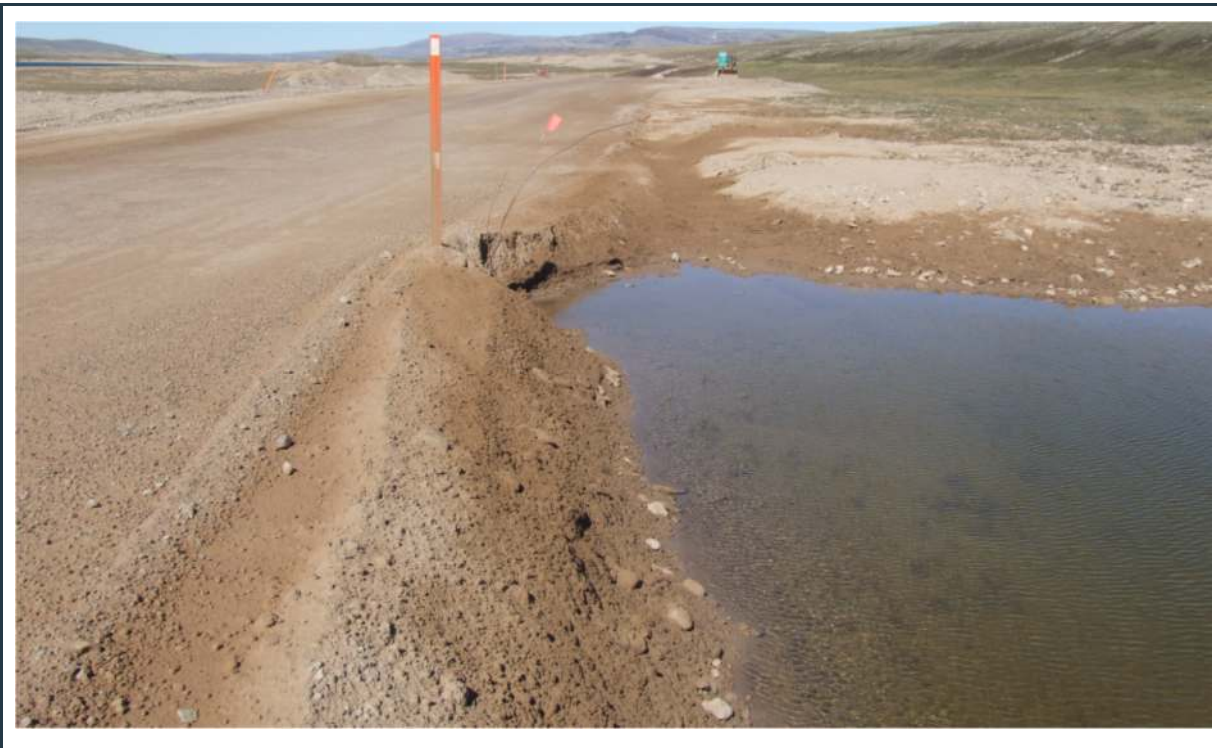
Figure 93: View of culvert 107 (inlet). Extension of the culvert is required.

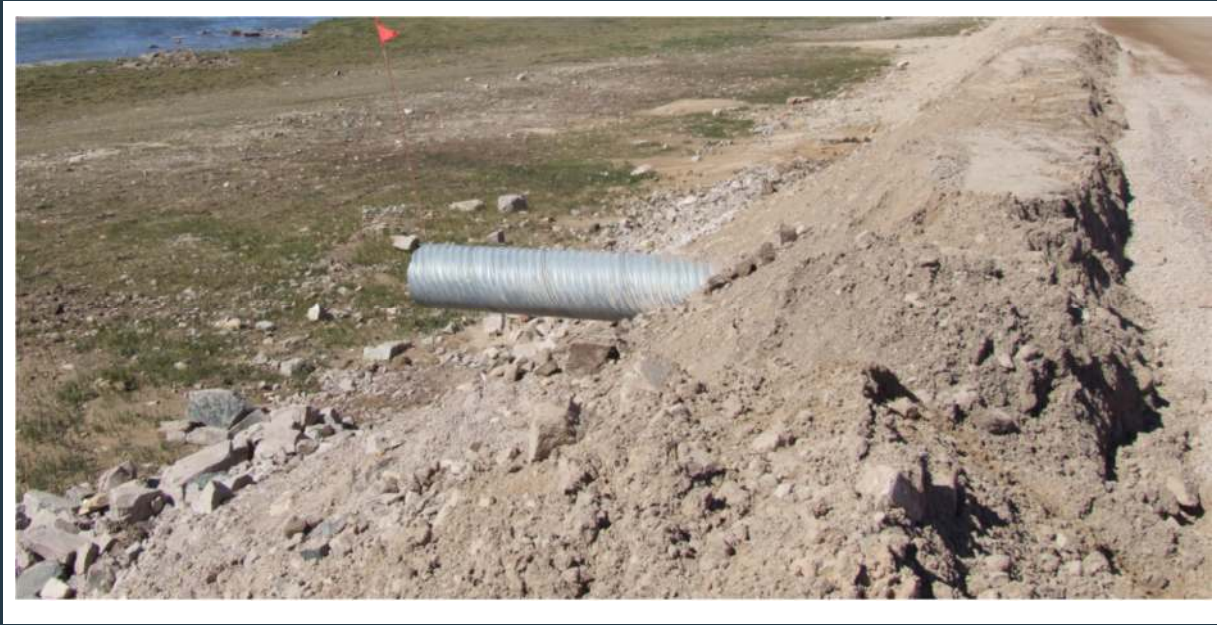
g) CV-110A

Figure 94: View of culvert 110A (outlet) in good condition

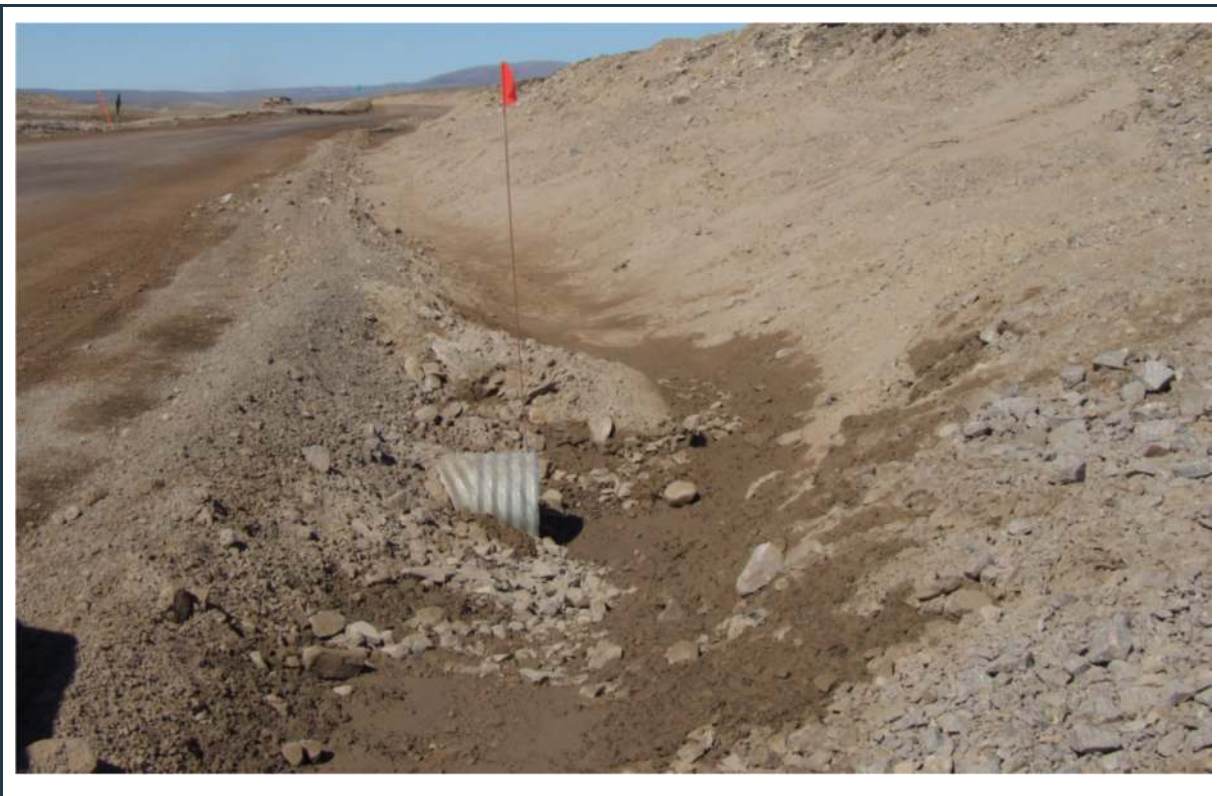
Figure 95: View of culvert 110A (inlet) in good condition

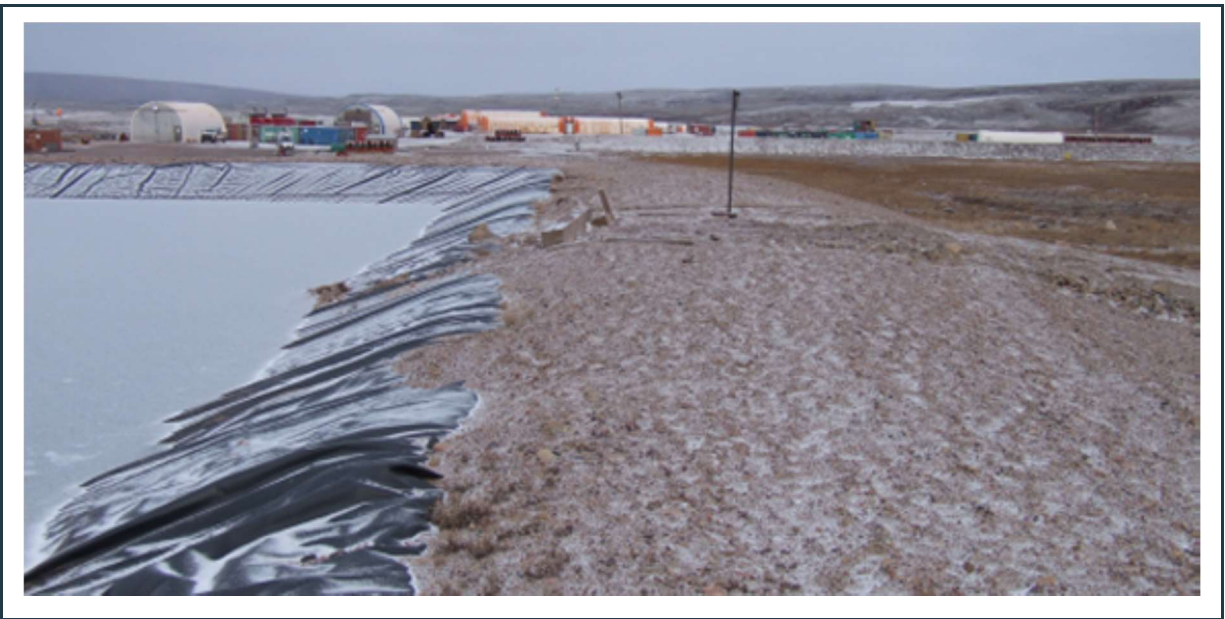
As shown in Figures 5 to 7, the berms around the three ponds are stable, having shallow downstream slopes. They were built by using non-frost-susceptible well compacted granular materials. Based on previous site observations, it appears that the subgrade beneath and around the berms comprise thaw-stable granular soils with trace to some fines. Hence, the berms are assumed to have stable foundations.

This assumption is further supported by the fact that there are no indications of differential settlements, sinkholes, sloughing, etc. at the perimeter berms. Previously, some minor truck-tire related damages (e.g., depression on the crest's surface and related densification) were observed at the top of the berms; however, most of these depressions have recently been backfilled by using sand and gravel, as shown in Figures 5 and 6.

Figure 6: PWS pond #2 – View of the berm and frozen water in the pond.

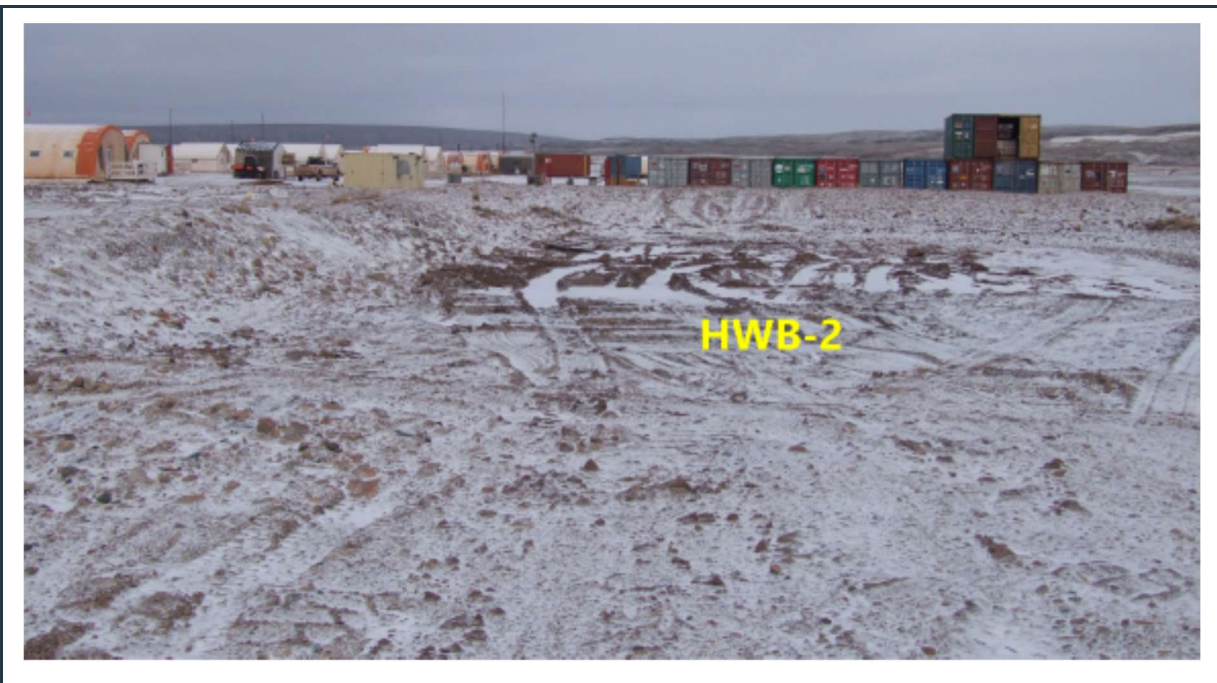
b) HWB-2

As shown in Figure 10, the perimeter berm around the HWB-2 cell appears to be stable. All previously stored materials have been removed and hence, no waste is currently stored in the cell.

Figure 10: View of HWB-2 – Currently the cell is empty.
