RE: Submission of 2019 Geotechnical Inspection Report No. 1 (July 2019)

Annual Geotechnical Inspections – 2019 Report 1. Mary River Iron Mine Complex – Nunavut

Annual Geotechnical Inspections – 2019 Report 2. Mary River Iron Mine – Nunavut

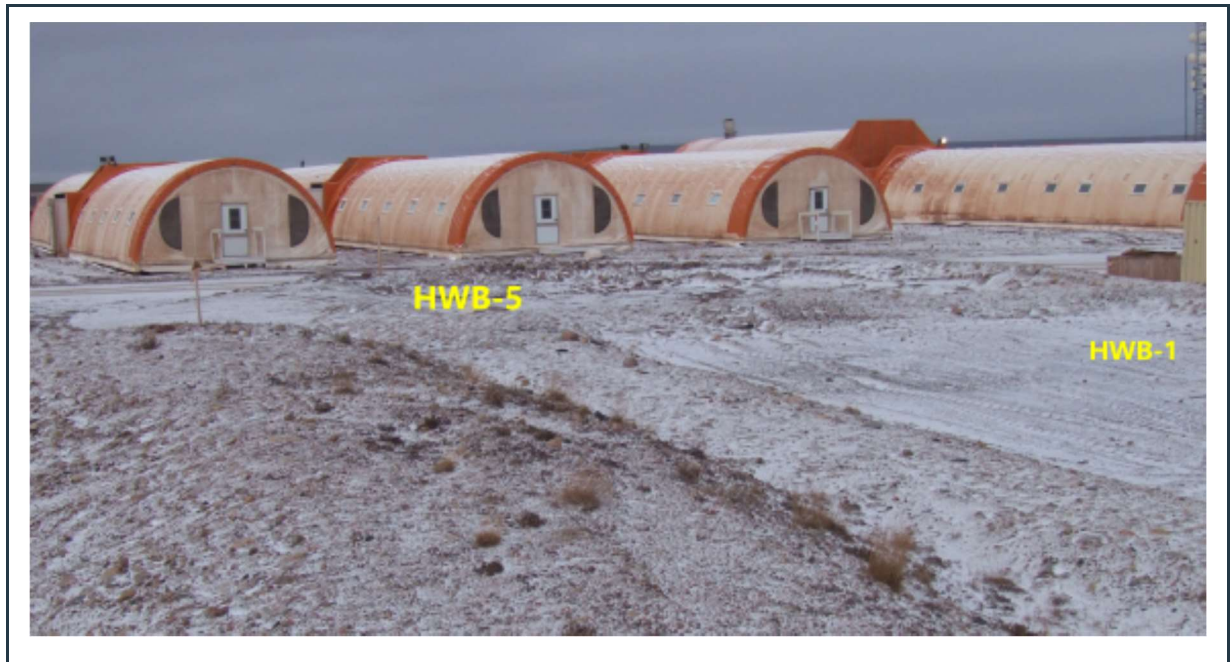
d) HWB-5

As shown in Figure 13, this cell is currently empty. The few totes of lubricants that were visible during the June 27 to July 2, 2019 inspection, have been removed from the cell. As pointed out in the earlier report, the berms around the cell appear to be stable and there is no visible liner damage.

Figure 13: View of HWB-5, located immediately adjacent to HWB-1. Both cells are currently empty.

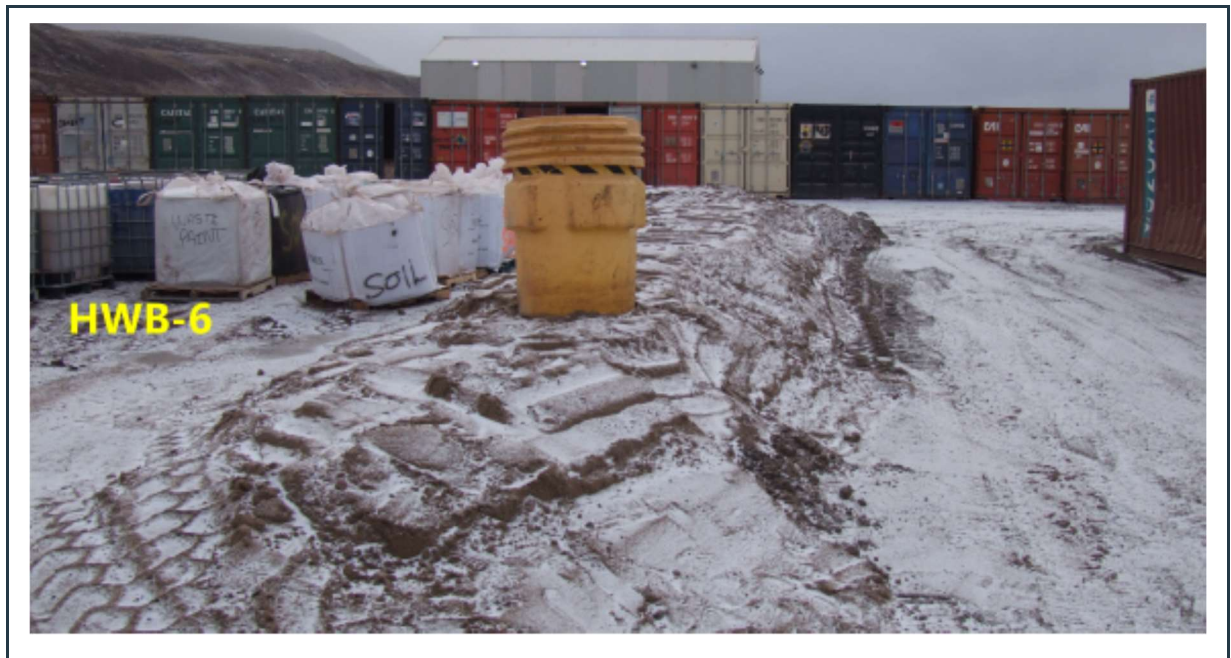
e) HWB-6

Following our recommendations, an extensive clean-up, repair and construction program was implemented at this cell. Reportedly, based on verbal information from William Bowden, Environmental Superintendent at the site, the damaged liner areas was patched and granular soil was brought to the site to cover the liner and improve the berm's profile. As specified in the August 31, 2019 report, a single ramped access point has also been provided to the cell, as shown in Figure 15. The images in Figures 14 and 15 indicate that the earthwork (fill placement on the crest and slopes of the berm) was undertaken using construction equipment (e.g., dozer and backhoe). Additional manual fine grading of the rough fill

Figure 14: View of the HWB-6 cell, with additional fill placed recently on the berm.

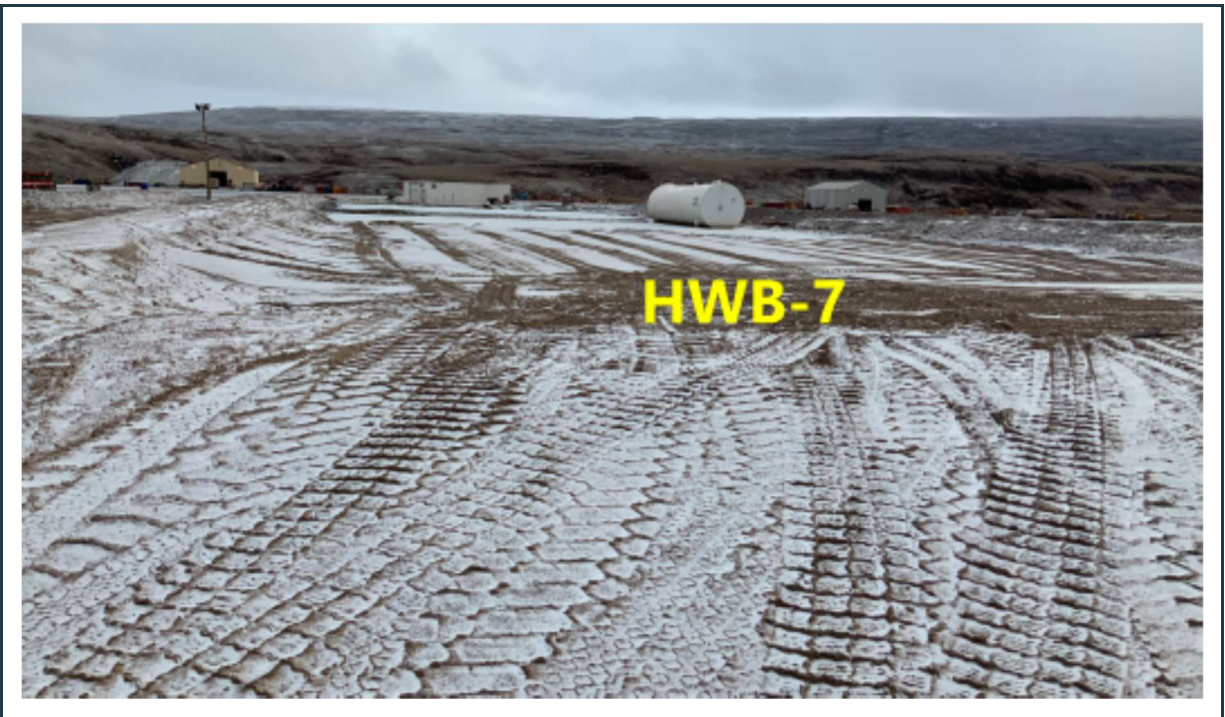
Based on information obtained from historic reports, the HWB-7 cell was a bulk fuel storage facility in the past. There were fuel barrels, lubricant totes and a large fuel tank visible in the cell during the June 27 to July 2, 2019 inspection. All items except the large fuel tank, have been removed from this cell, as shown in Figure 16. The perimeter berm around three sides of the cell has remained stable since the preceding inspection. There is an access ramp on the outer side of the cell with shallow slopes allowing safe truck access.

Figure 16: View of HWB-7, with only one fuel tank stored in the large cell.

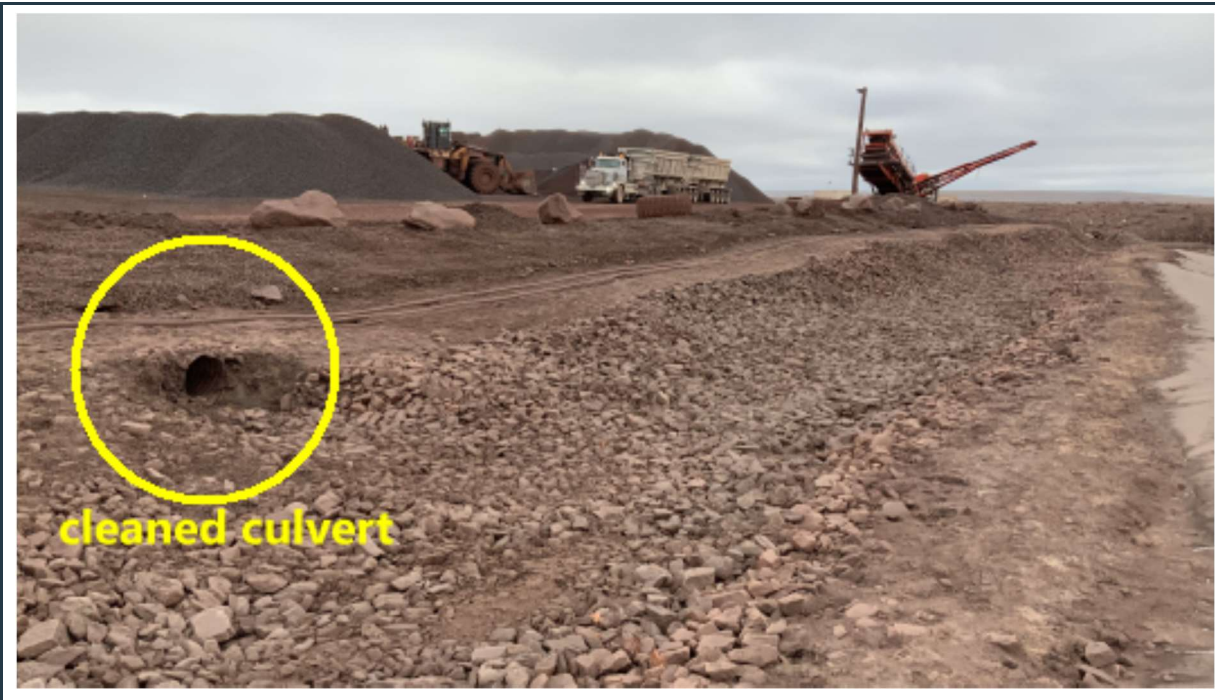
Figure 19: Surface water collection ditch, with recently cleaned culvert.

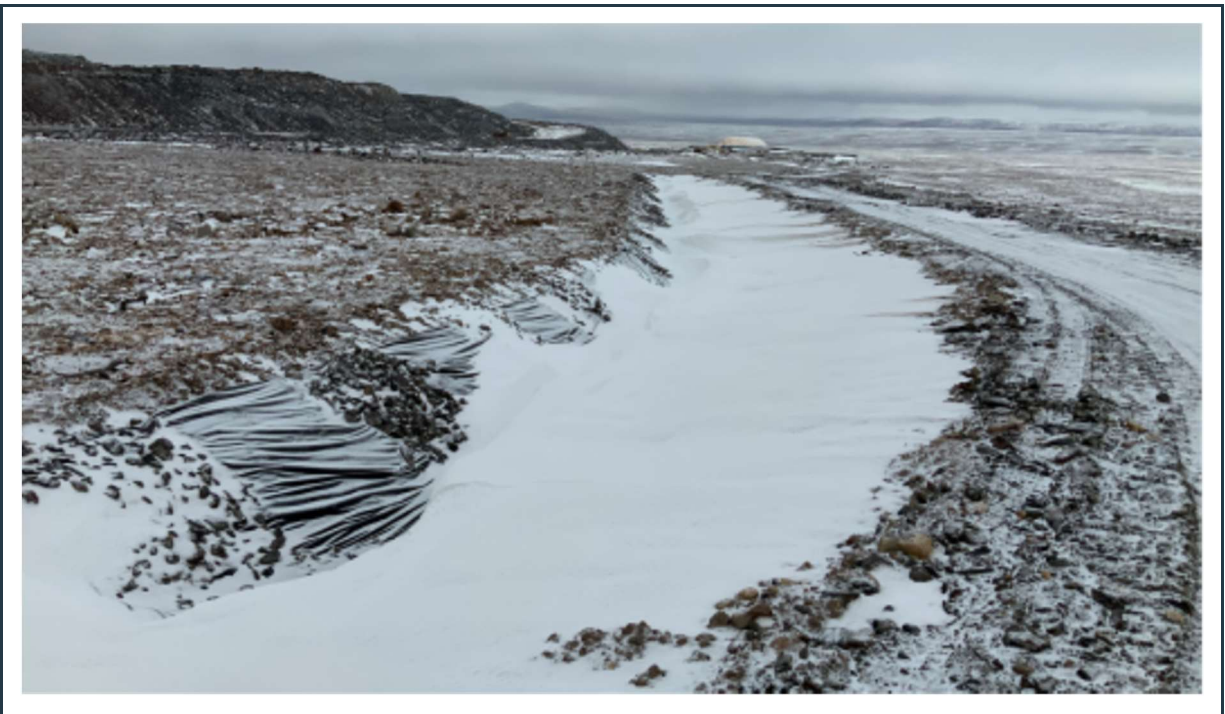
Figure 22: Snow-filled ditch under construction around the waste rock dump (south-east side).

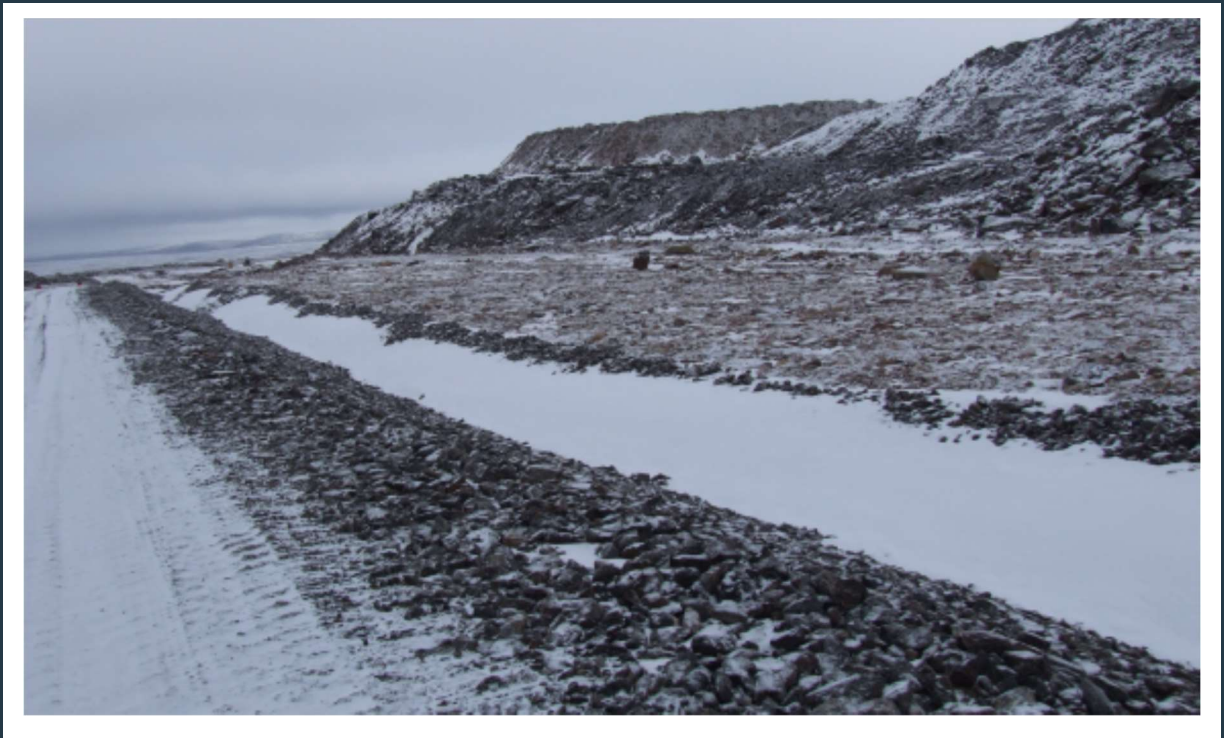
Figure 23: Snow-filled ditch under construction around the waste rock dump (north-west side).

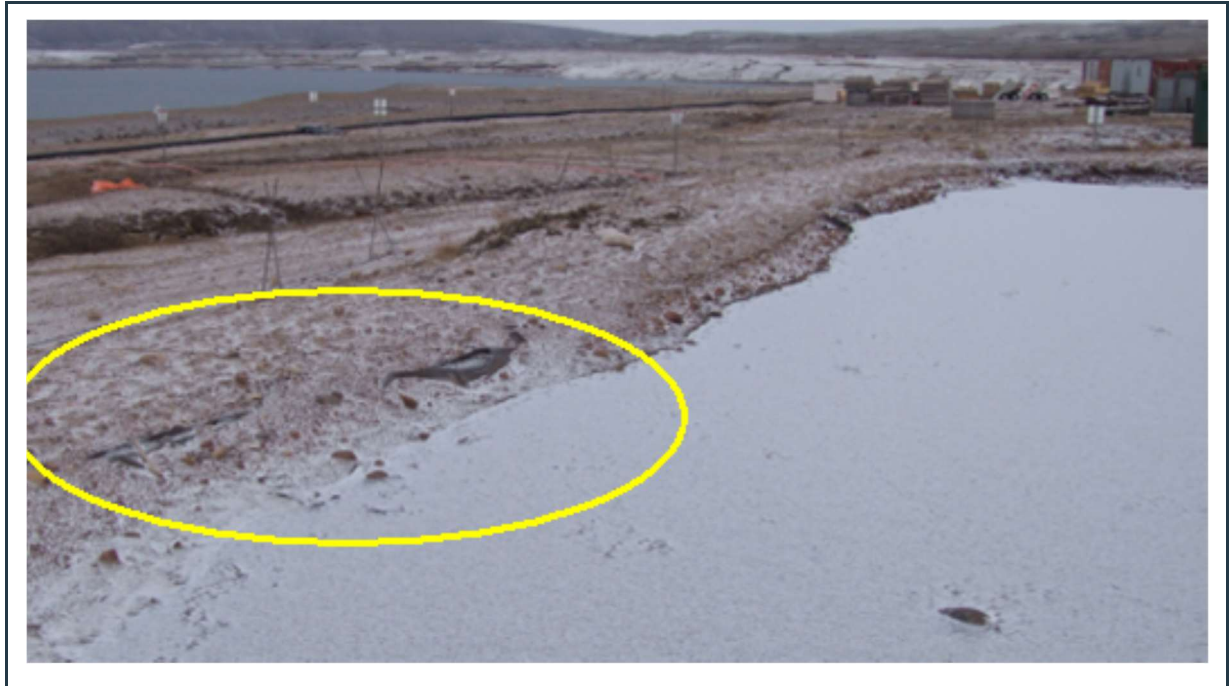
Figure 27: View of the locally low generator berm (high water level with frozen surface).

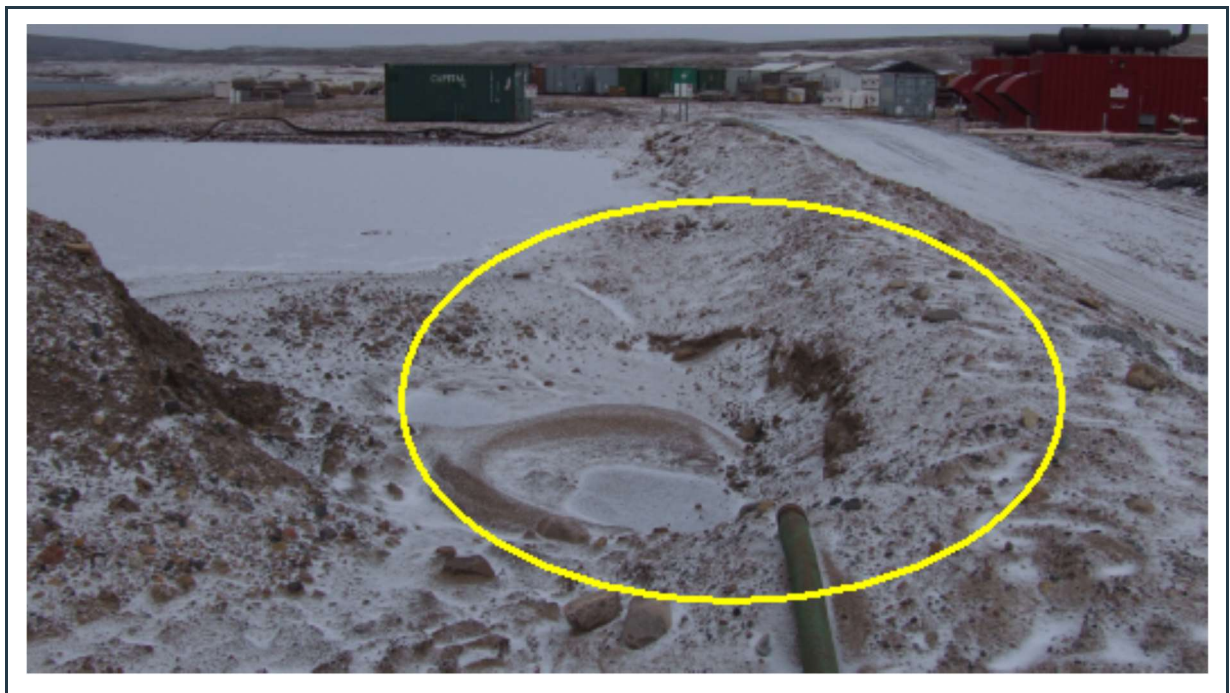
Figure 28: View of minor slope problem at the south-east corner of the generator berm.

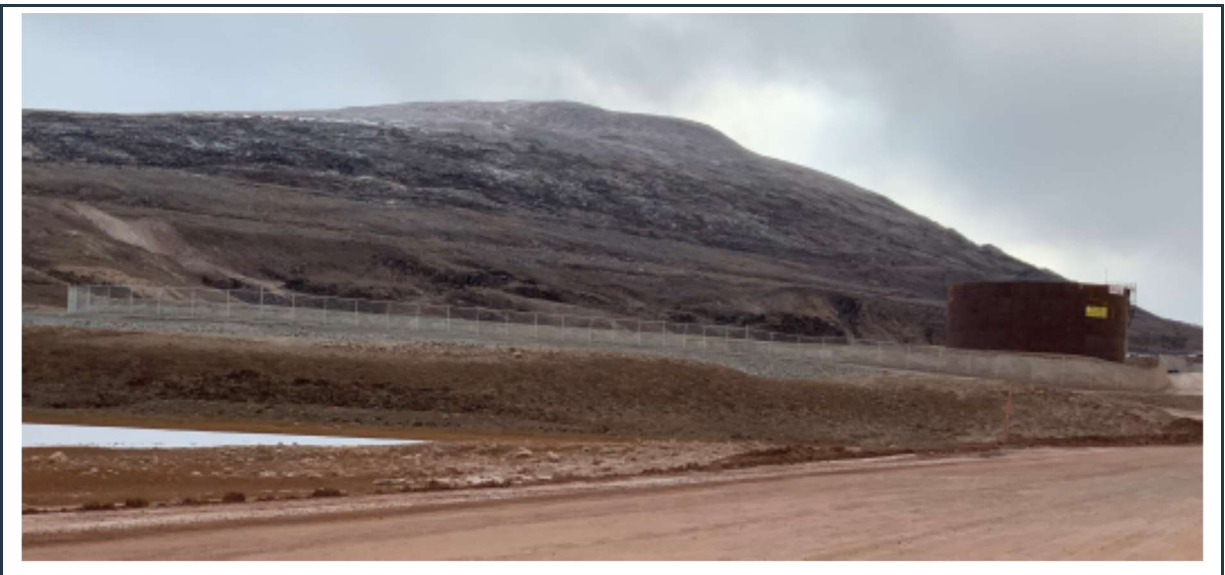
Figure 32: View of the recently completed new fuel storage.

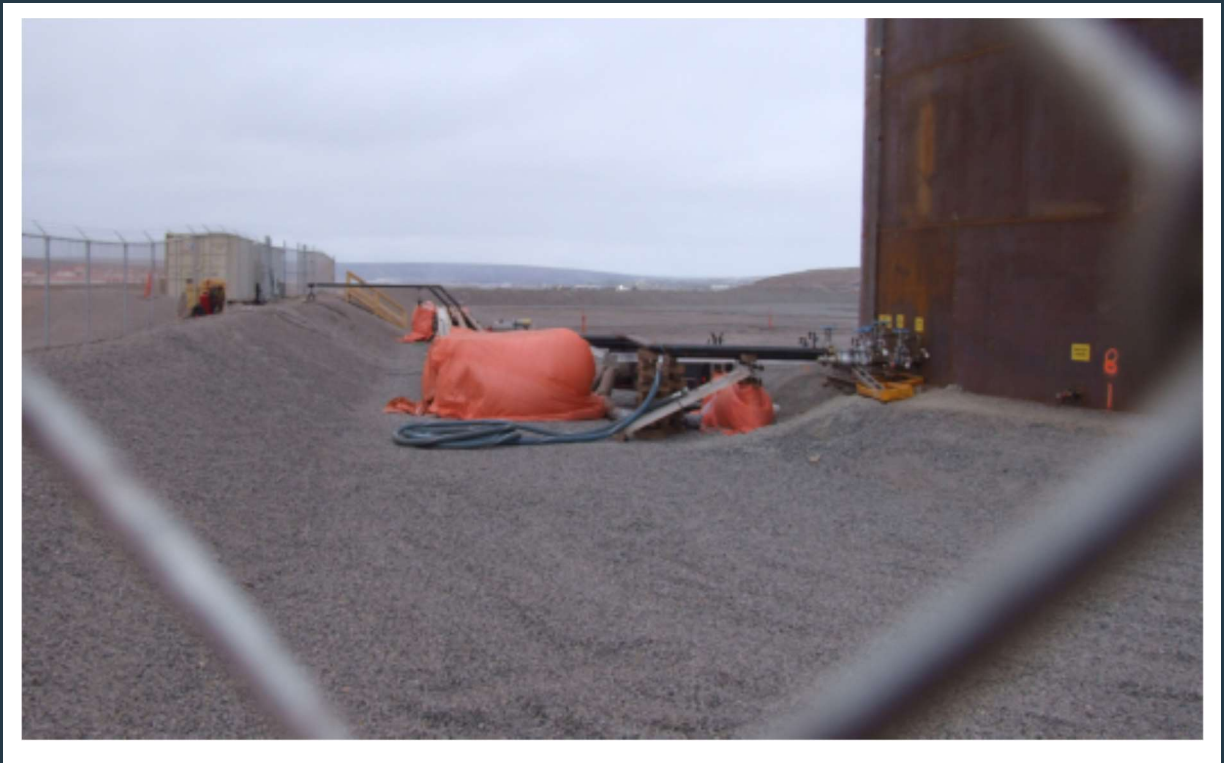
Figure 33: View of the recently completed new fuel storage at the Mary River site.

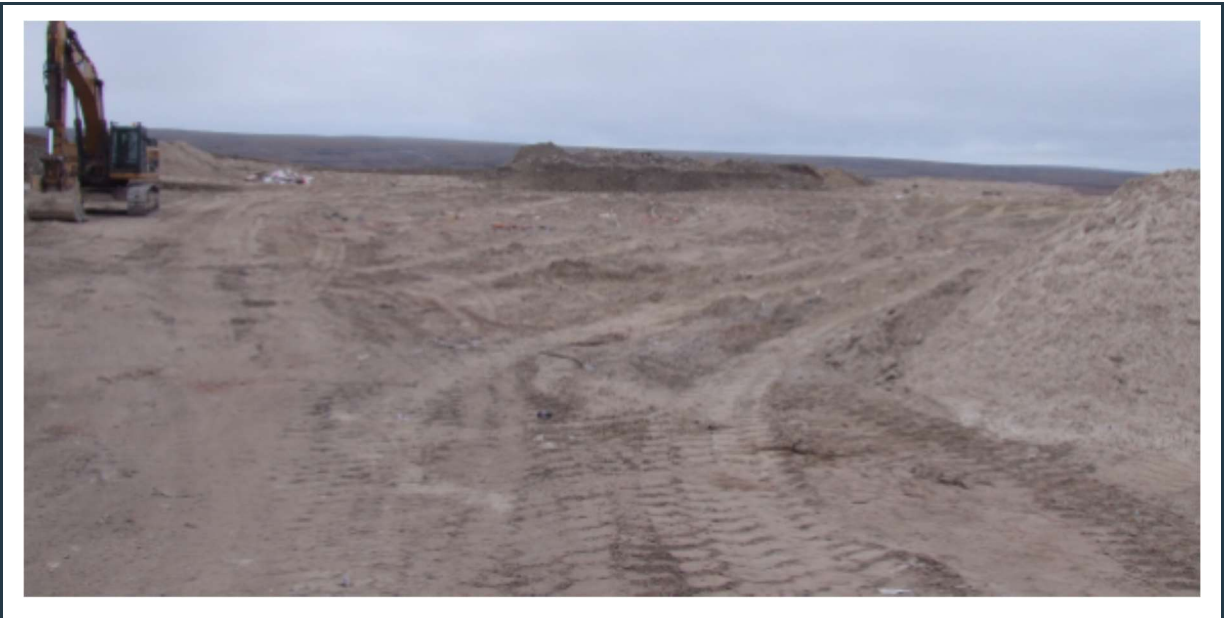
Figure 34: Solid waste disposal facility (waste continuously covered with clean soil fill).

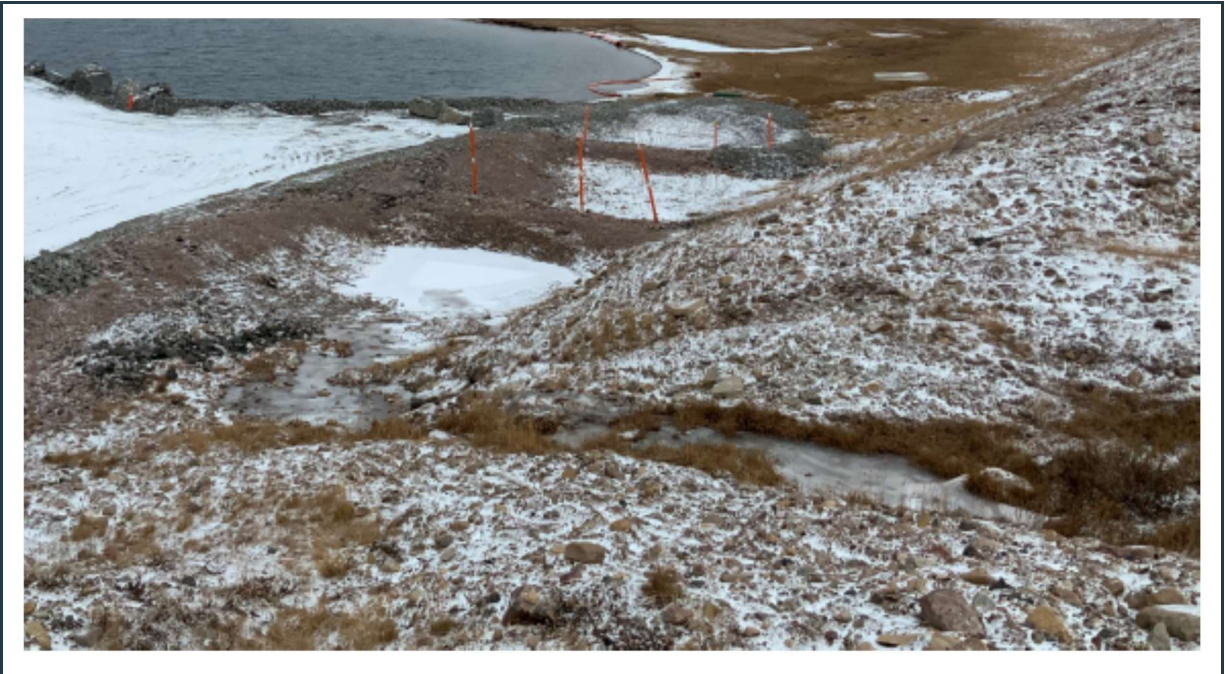
Figure 35: CLSP check berms and silt sedimentation cells.

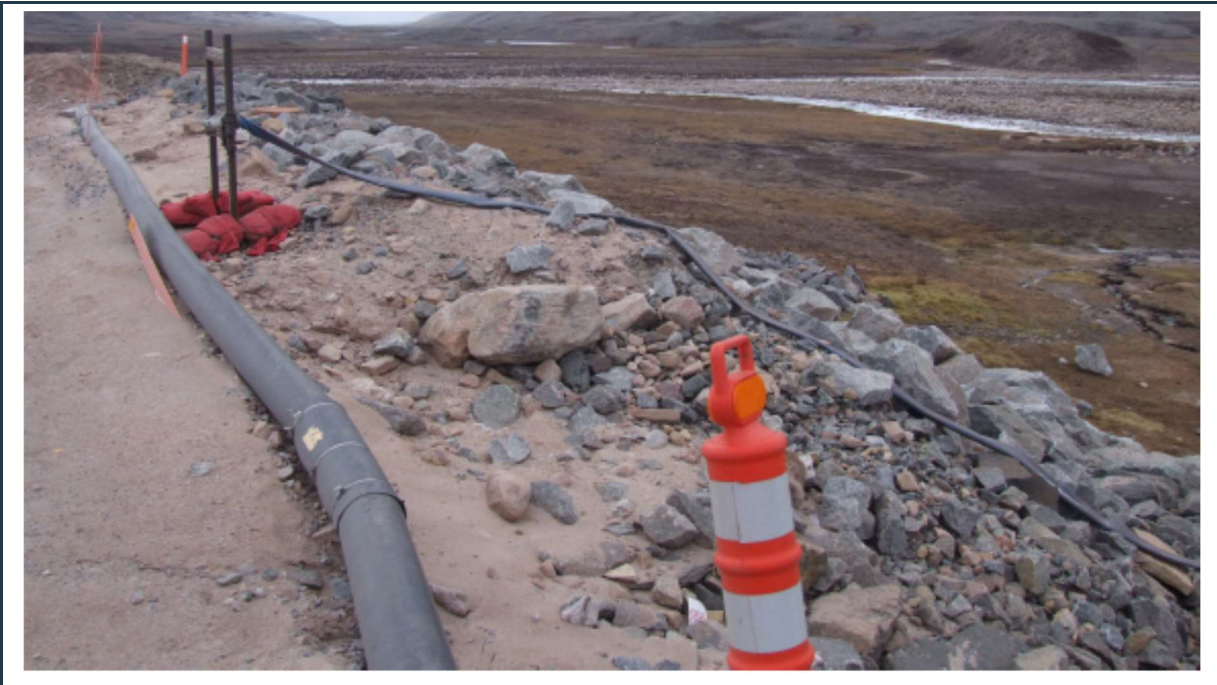
Figure 37: Water (effluent) discharge area. Stable slope, comprising a mix of crushed rock and soils.

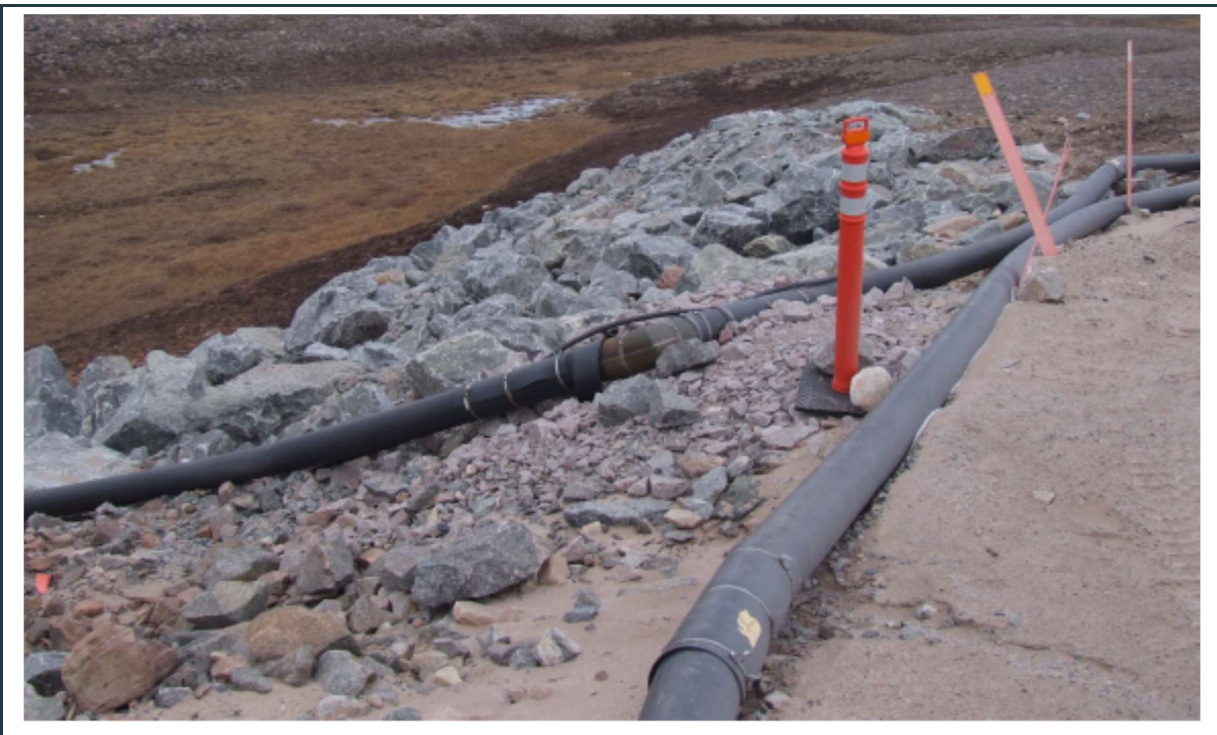
Figure 38: Recently stabilized slope erosion adjacent to the water (effluent) discharge site.

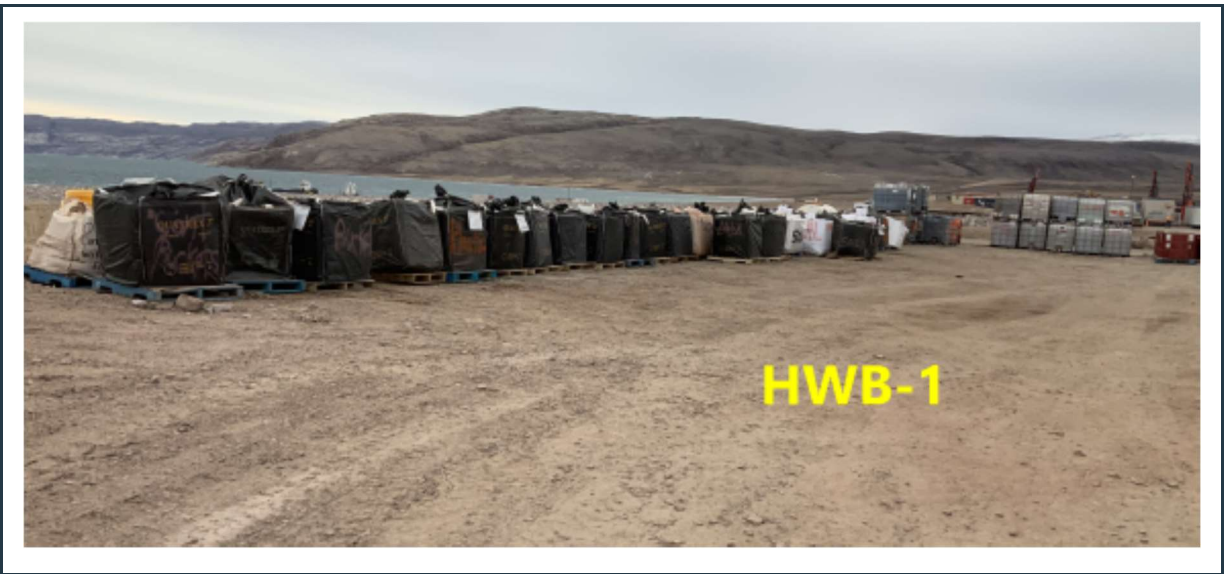
Figure 39: View of the HWB-1 cell, with large empty area in its center.

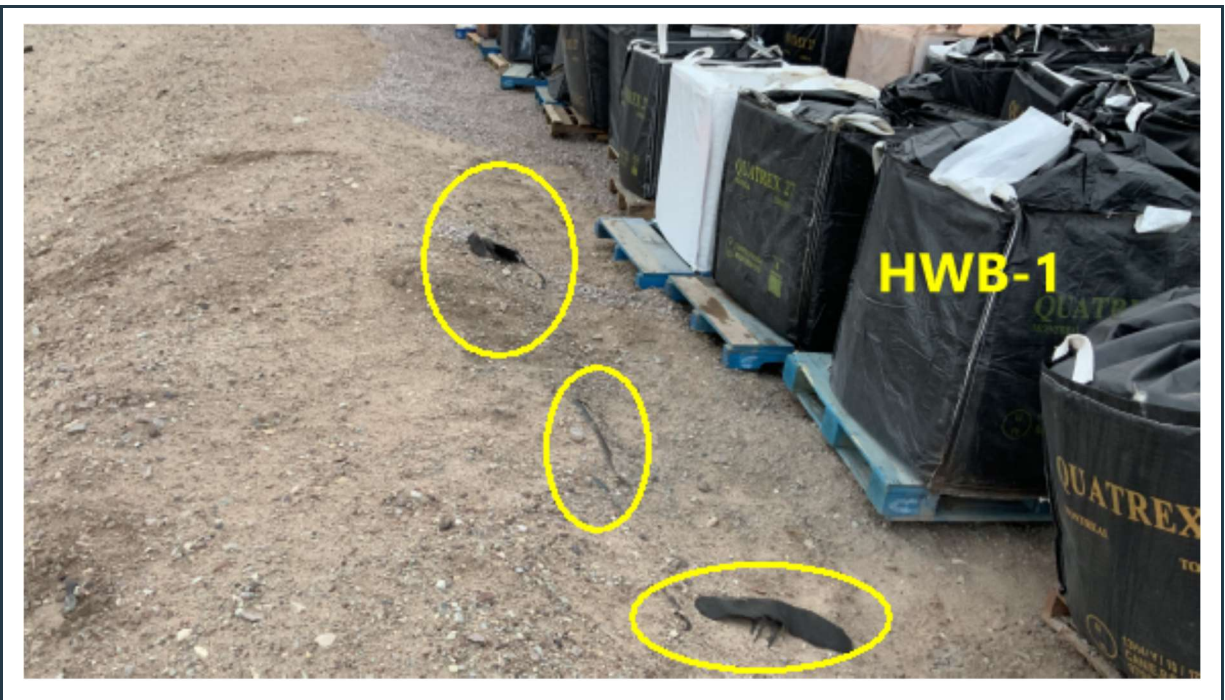
Figure 40: Ripped geotextile and exposed liner at the stable northern berm of the HWB-1 cell.

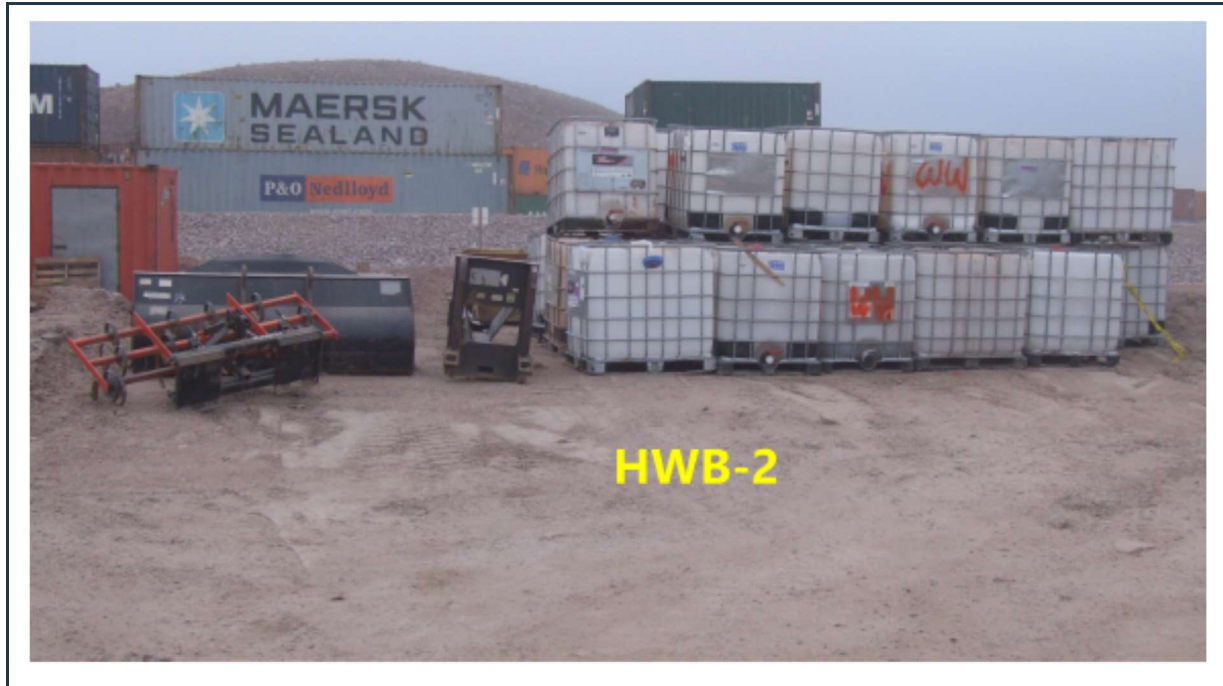
The HWB-2 is a relatively small cell with stable shallow berms that has recently been re-graded by using clean granular soils. As shown in Figure 41, only empty containers on wooden pallets and clean construction machine attachments are currently stored in this cell.

Figure 41: View of the HWB-2 cell (only empty containers and “clean” machine attachments are stored).

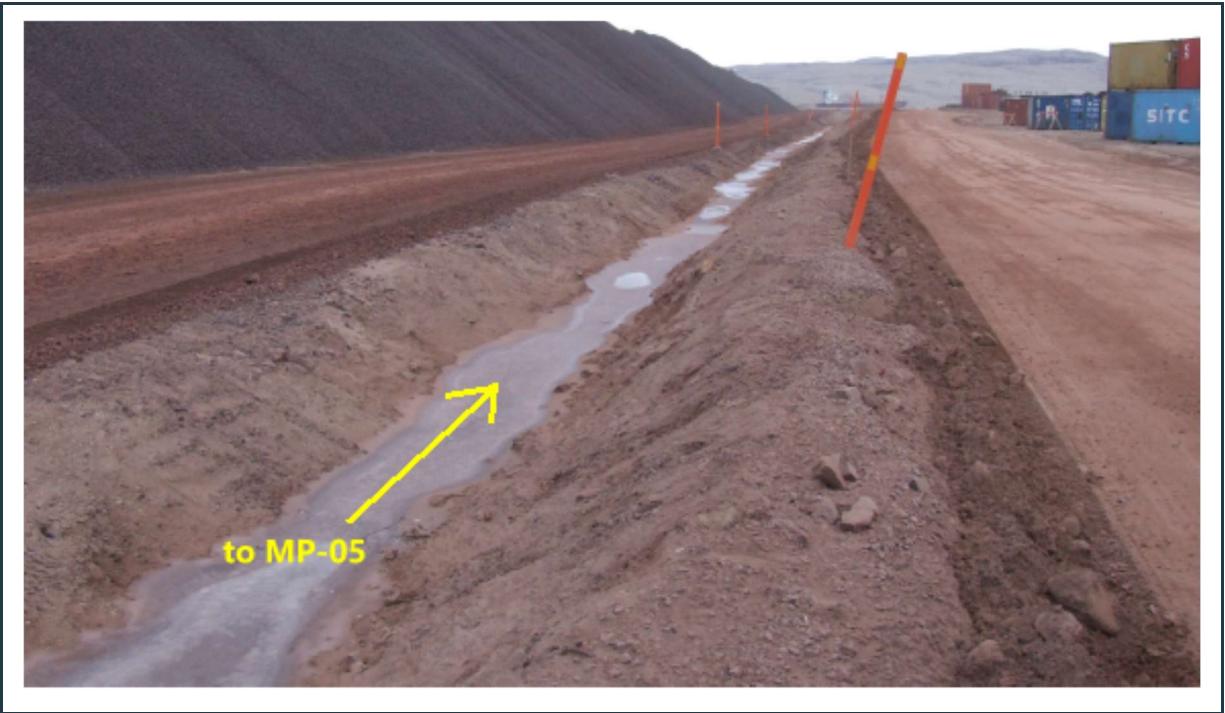
The high-grade iron ore that is mined, crushed, and screened at the Mary River site is transported to the Milne Inlet port, and stockpiled across a large flat area. Contact water in the area is collected along all sides of the ore stockpile in collection ditches and conveyed into two water collection ponds, MP-05 and 06 respectively (Figure 51).

Figure 51: Surface water collection ditch, adjacent to the ore stockpile (leading to the MP-05 pond).

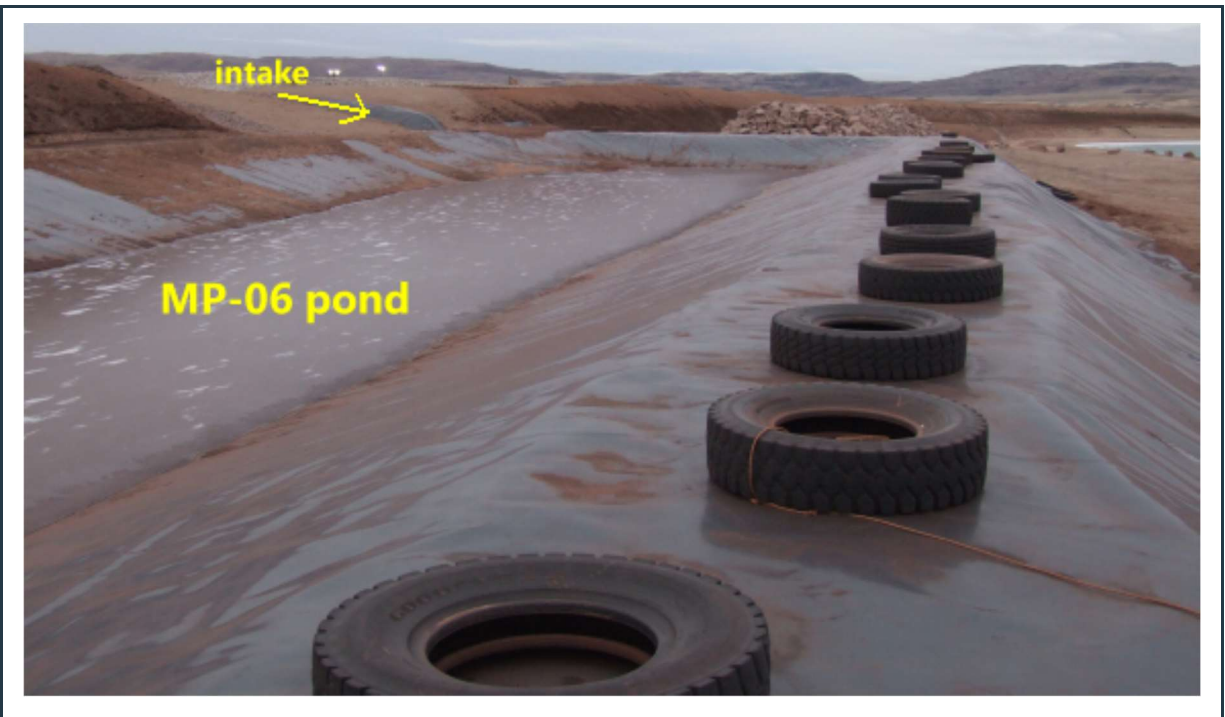
The MP-05 pond is located adjacent to the north-east corner of the stockpile, while MP-06 has been constructed at the north-west corner. Both ponds were observed to be functional with well-maintained containment berms and intact liners, exhibiting no visible signs of instability (e.g., erosion or settlement, etc.), as shown in Figures 50 and 52.

Figure 52: View of the MP-06 pond at the front of the north-west corner of the ore stockpile.

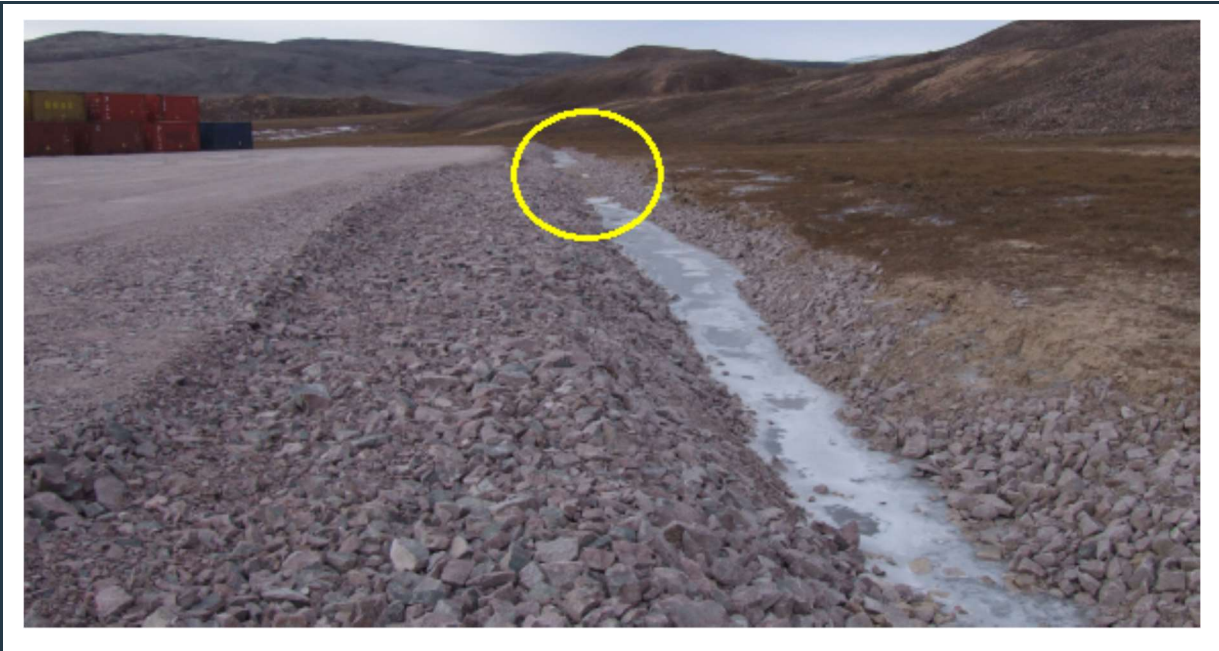
There are several water collection drainage ditches (listed above), most of them still under construction or continuous improvement, as shown in Figures 53 to 58. These open ditches are excavated partly into the native soils with their sides and inverts lined with erosion protection layers composed of fine crushed rock from the local quarry. It was noted during the inspection that geotextile have been used in areas where the native soil subgrade was composed of fine-grained material to prevent migration of fines into the voids of the rockfill. It is recommended that the condition of these ditches be monitored, particularly prior to the spring freshet, and that any slope deterioration be rectified to ensure an unobstructed functionality of the ditches. One such obstruction, a consequence of ditch side slope failure observed at the LP2 drainage ditch (see yellow circle in Figure 53) will require repair ahead of the spring freshet.

Figure 53: View of the LP2 surface water collection ditch – still under construction.

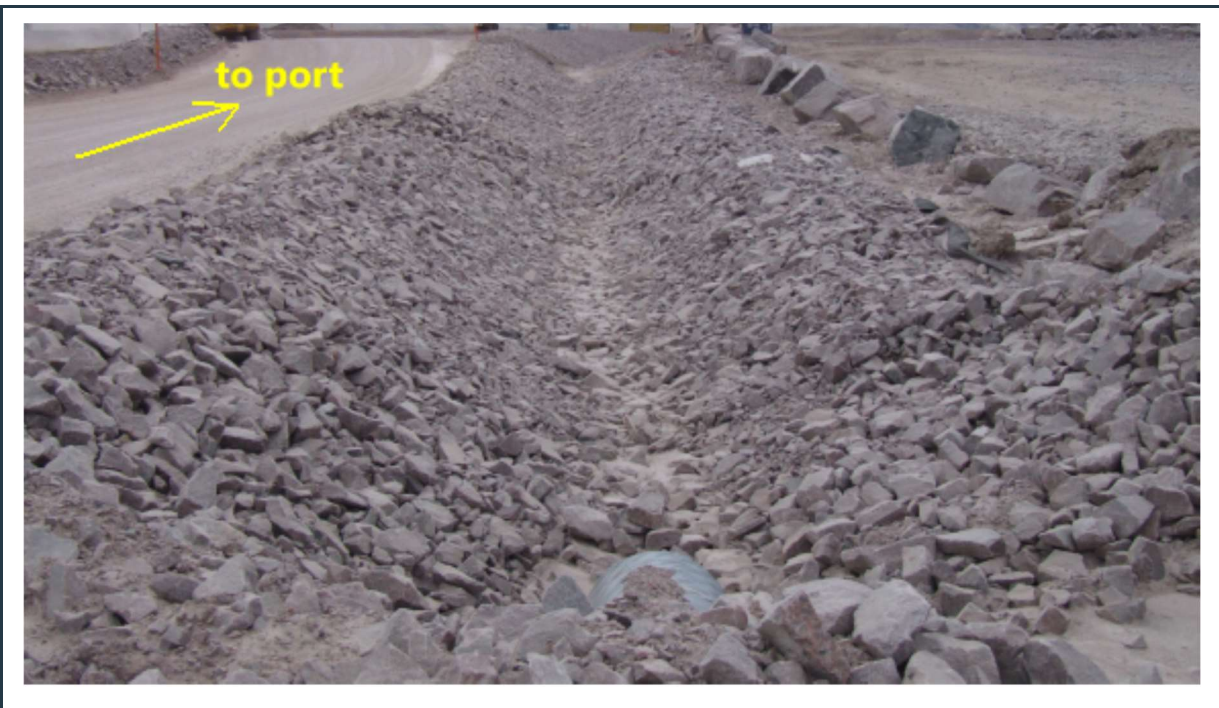
Figure 54: Well maintained "P-SWD-5 Q1 North" surface water collection ditch.

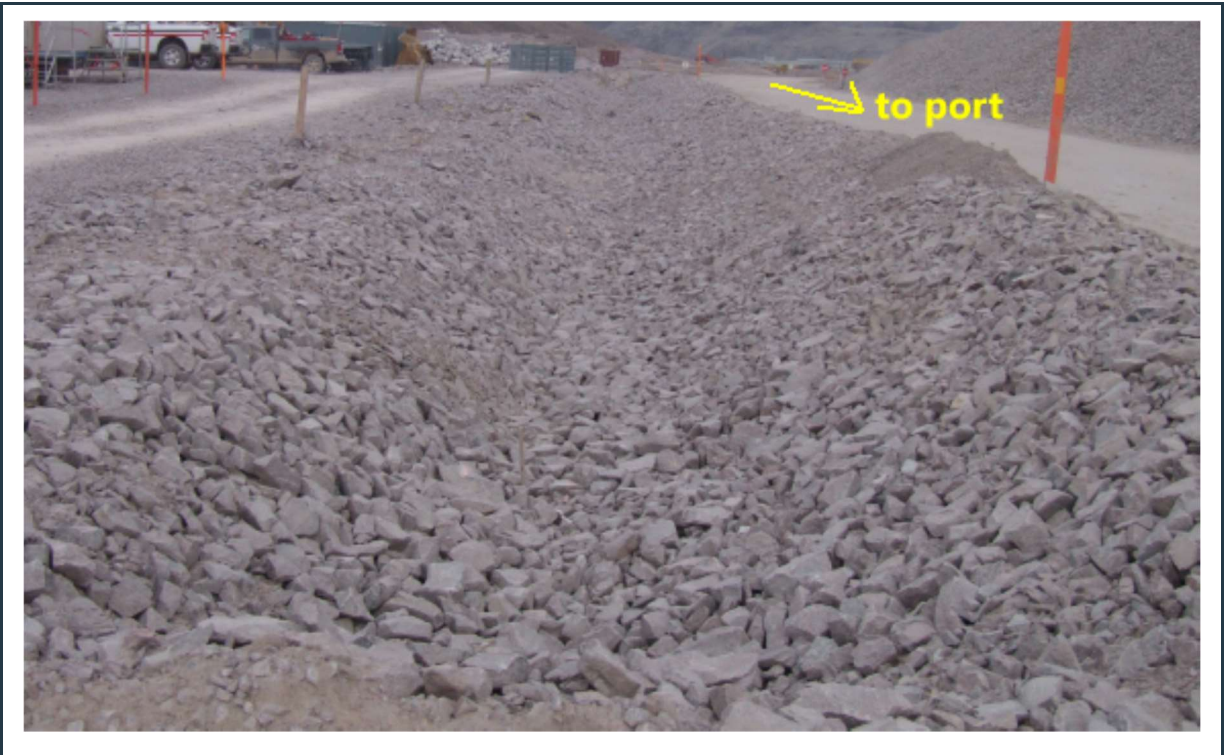
Figure 55: Well maintained "P-SWD-6 Q1 South" surface water collection ditch.

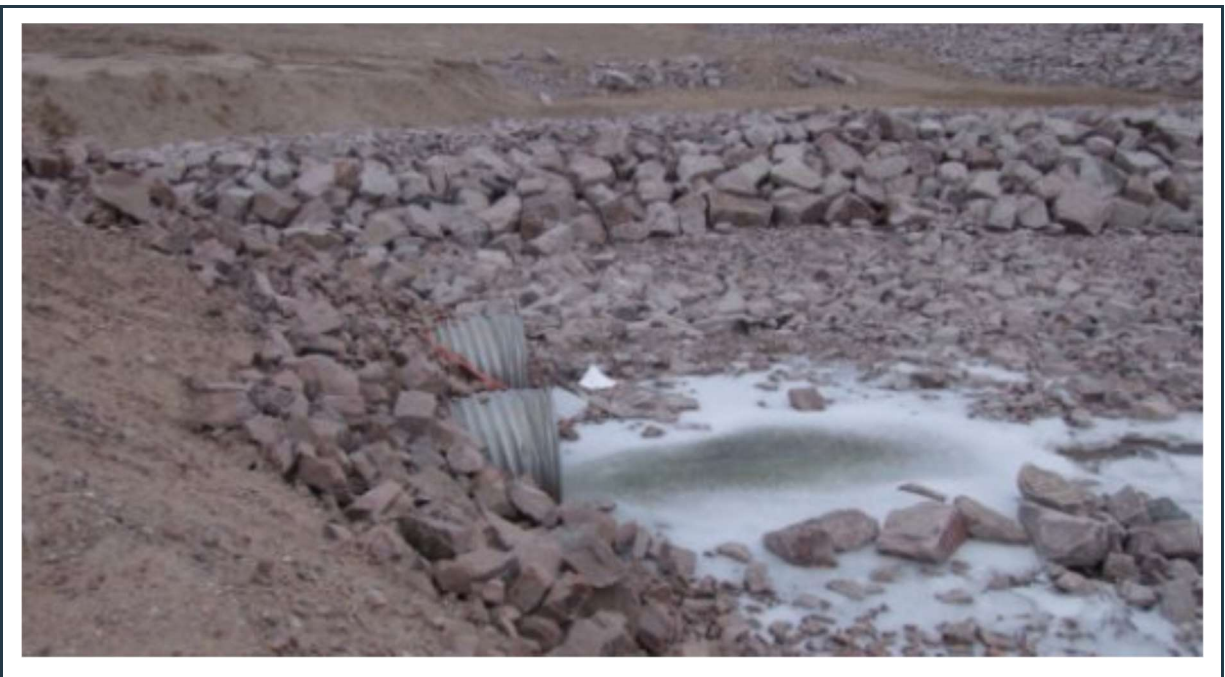
Figure 56: View of the P-SWD-7 surface water collection ditch and culverts, adjacent to the new freight dock (under construction).

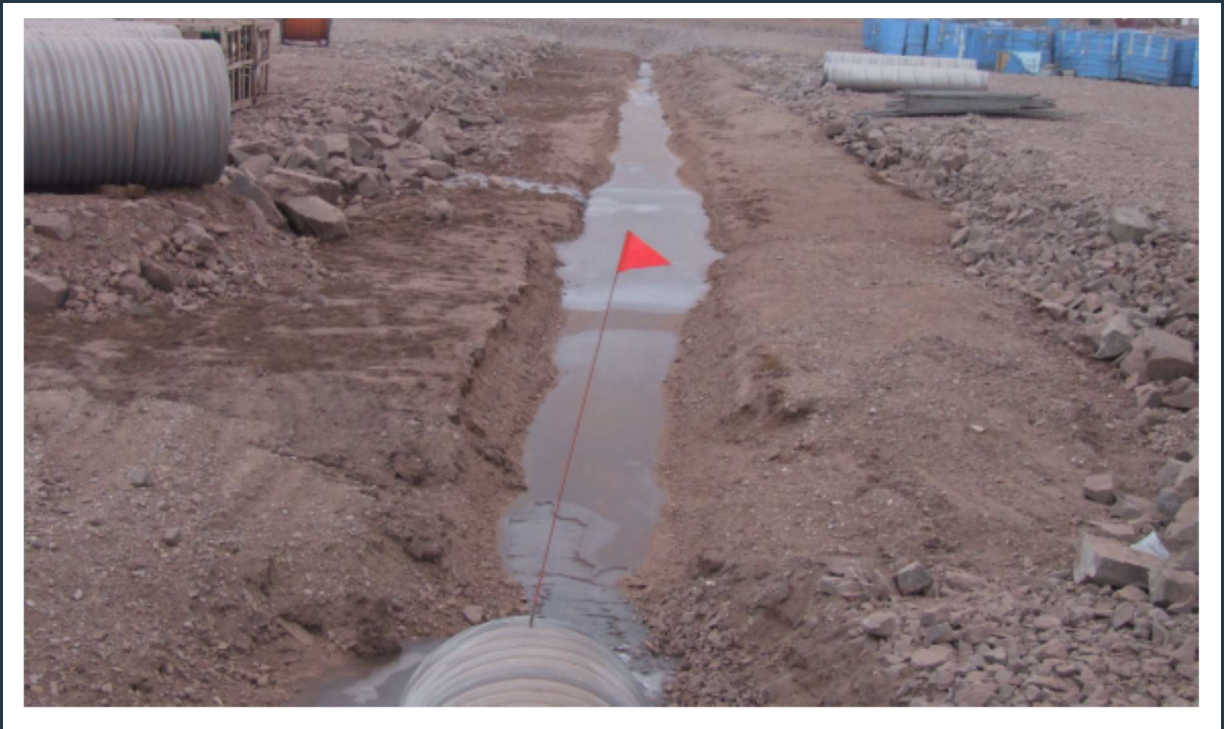
Figure 57: W3-W14 surface water collection ditch (still under construction).

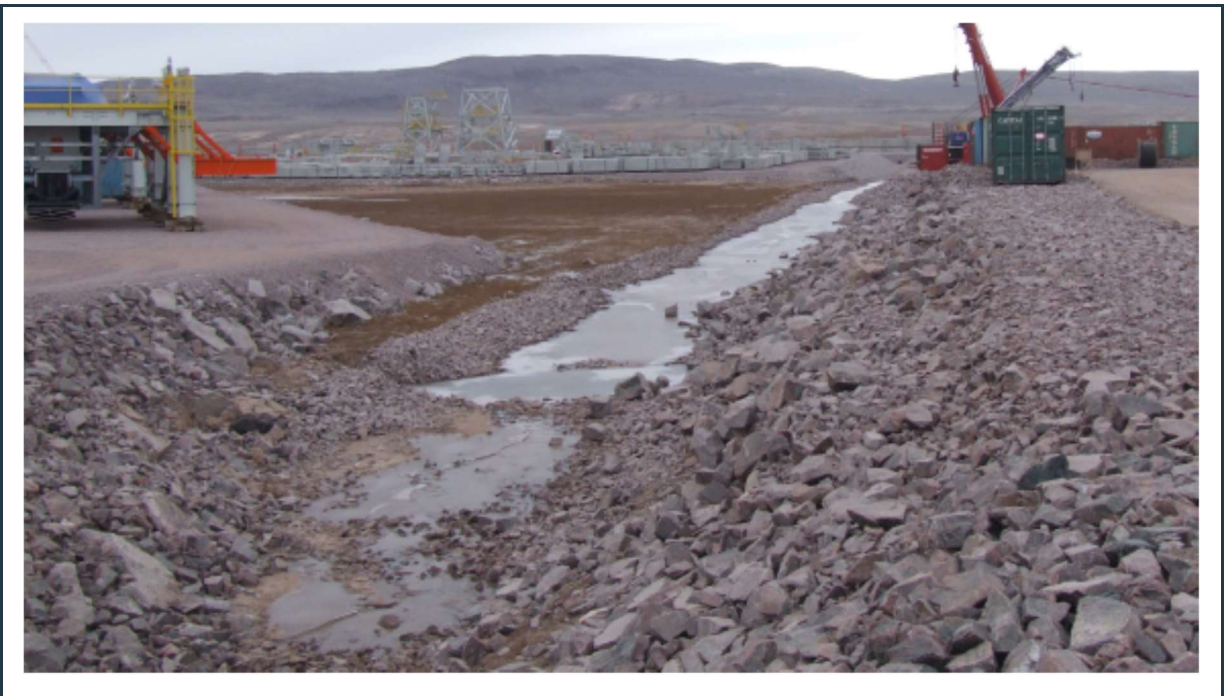
Figure 58: "380 M" surface water collection ditch (under construction).
