RE: Submission of 2019 Geotechnical Inspection Report No. 1 (July 2019)

Annual Geotechnical Inspections – 2019 Report 1. Mary River Iron Mine Complex – Nunavut

Annual Geotechnical Inspections – 2019 Report 2. Mary River Iron Mine – Nunavut

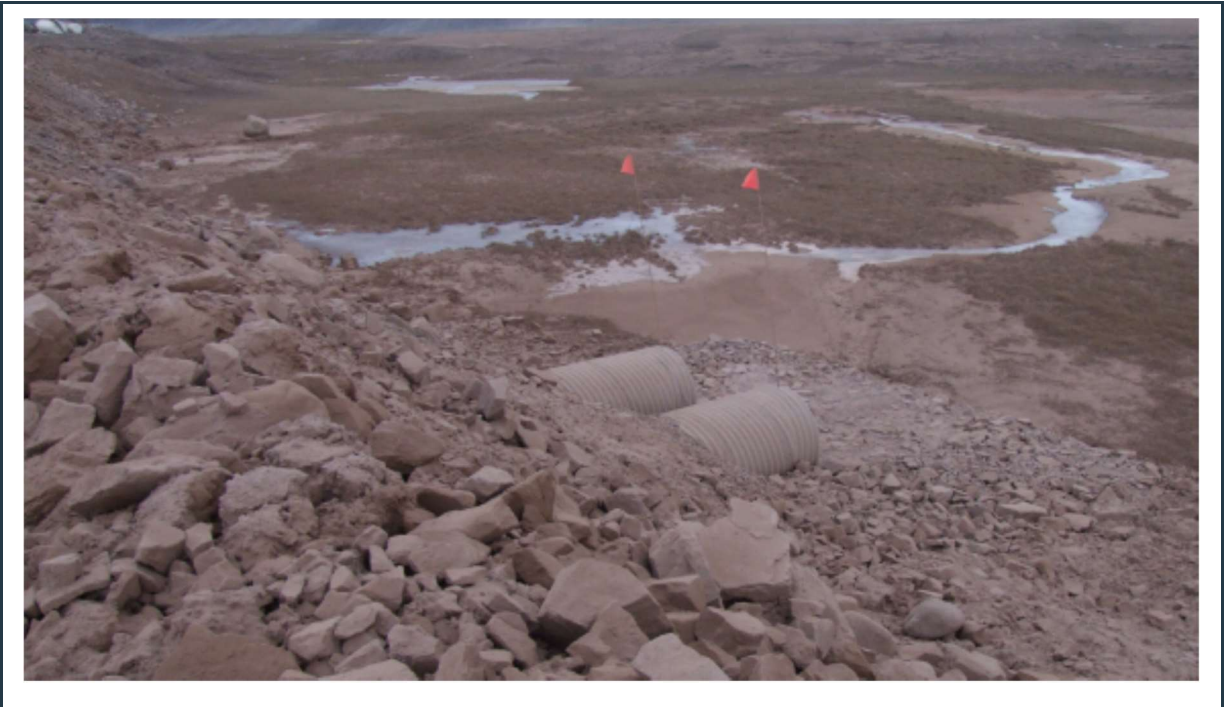
Surface water from higher elevation around the rock quarry is collected in drainage ditches and conveyed down the slope through corrugated galvanized steel culverts, installed under the quarry road and then under the Tote Road. The water in the ditches is then conveyed to small natural ponds, located along the west side of the Tote Road, as shown in Figure 59. As reported earlier, the fill in the area (road embankment and slope cover) comprises crushed rock fill, and therefore a portion of the surface water have the tendency to bypass the two culverts beneath the Tote Road embankment (through-flow) and finds its way to the nearby ponds (see Figure 59) in open, shallow channels. The flow of such water may

Figure 59: Water seepage through and beneath the road embankment near the tote road culverts.

soften the original native subgrade beneath the road embankment and potentially destabilize the road embankment. As recommended in the August 31, 2019 inspection report, and to increase the stability of the Tote Road's embankment in the affected areas, construction of a rock fill toe berm is recommended along the affected sections (approximately 50 m south and north from the twin culverts, shown in Figure 59) of the Tote Road.
