**BAFFINLAND IRON MINES CORPORATION  
MARY RIVER PROJECT**

**FISH HABITAT MONITORING  
2019 ANNUAL REPORT  
EARLY REVENUE PHASE - TOTE ROAD UPGRADES**

2019-12-31	0

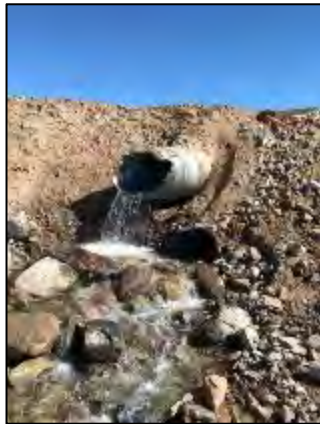
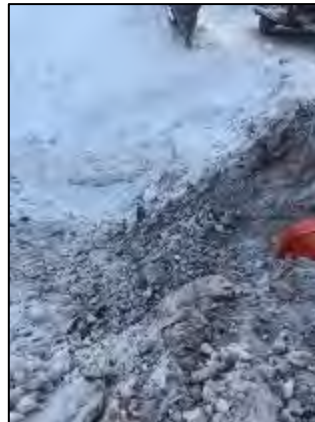
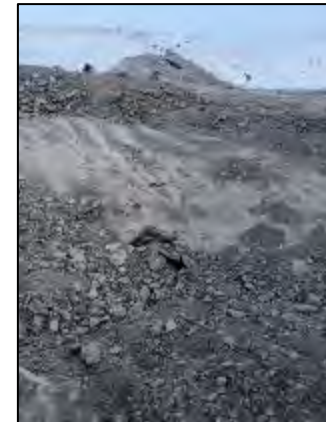
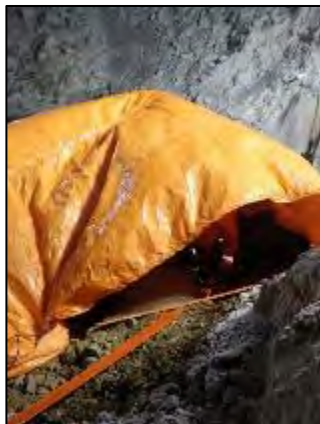
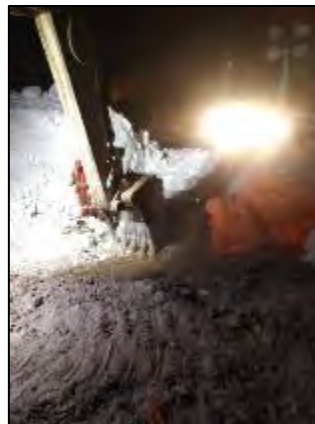
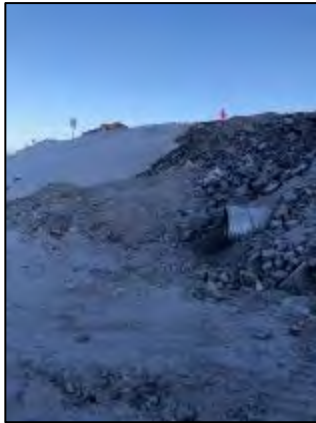
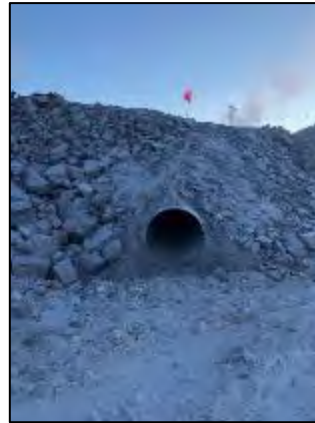
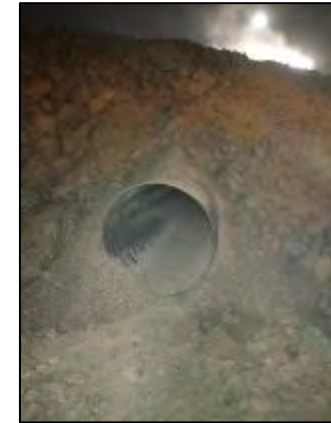
2018/2019 Tote Road Culvert Works – CV-111 at KM 32

Remediation could not be completed at two sites (CV-111 and CV-225) in 2019 (Table 6; Appendix D). The culvert at CV-111 was reinstalled during winter 2018/2019 to replace two culverts with a single culvert and reduce erosion of the embankment. However, the new culvert had a 0.25 m perch, preventing upstream access for fish. A rocky ramp was constructed to improve fish access to the culvert and upstream habitat in fall 2019. Unfortunately, though access has likely been improved, due to the height of the original perch, such a drop could not be completely eliminated by this method. Additional/alternative works may be required for all of the size classes of juvenile Arctic Char found downstream of this crossing to have full access to upstream habitat.

**Photos 1:** Photographs of the culvert crossing at CV-111 (KM 32) (A-C) before, (D-H) during, and (I-L) after construction works to replace existing culverts with a single new culvert. Work was completed on 19 February 2019.

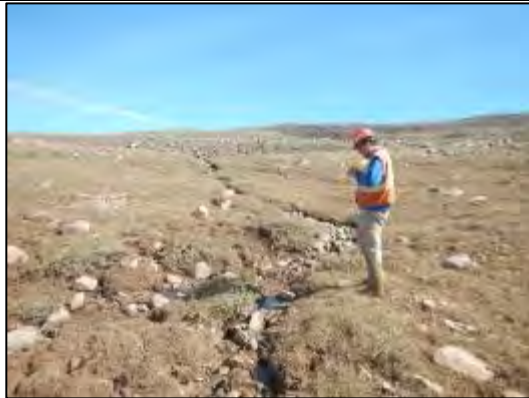
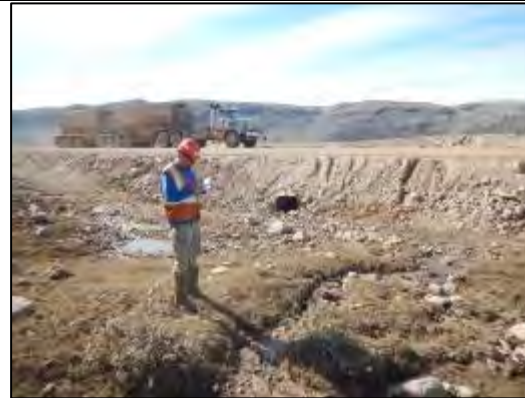
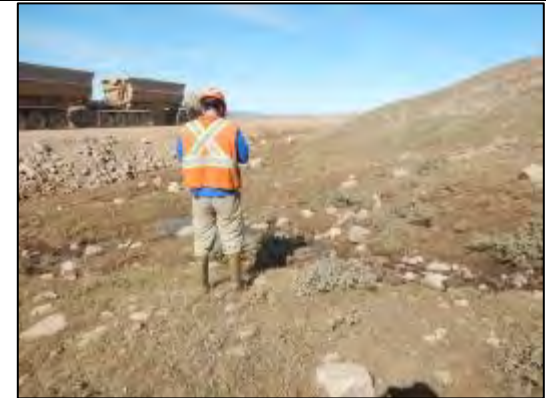
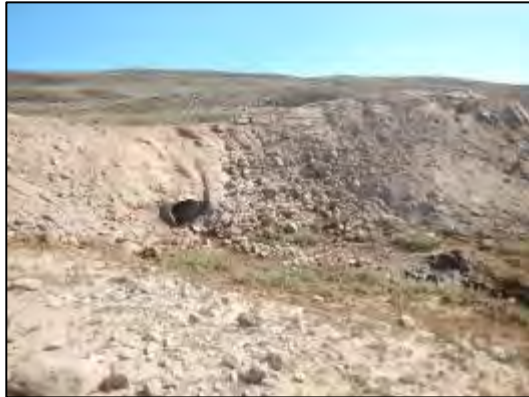
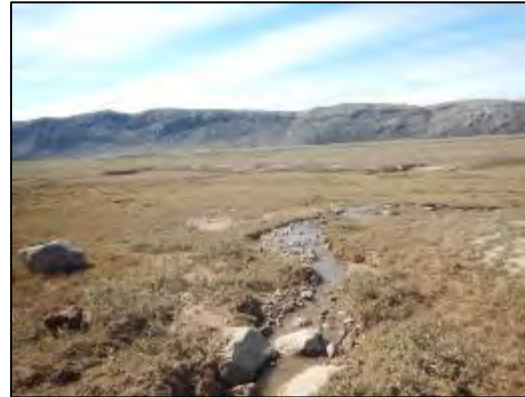
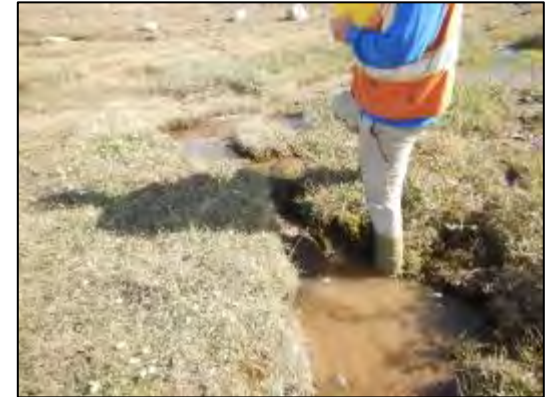
**Summary:** This small stream has several natural steep gradient and vertical drop barriers downstream that prevent fish access to the crossing area from Phillips Creek. There is no upstream overwintering habitat.

**Photos 1.** Photographs upstream of the Tote Road crossing CV-170: (A) looking upstream; (B) looking downstream; (C) looking across; and photographs downstream of the Tote Road: (D) looking upstream; (E) looking downstream; and (F) a vertical barrier preventing fish access.

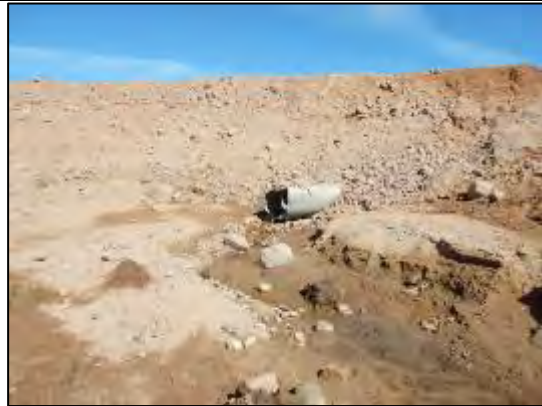
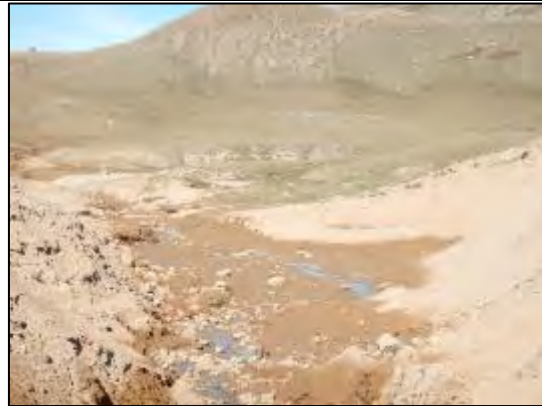
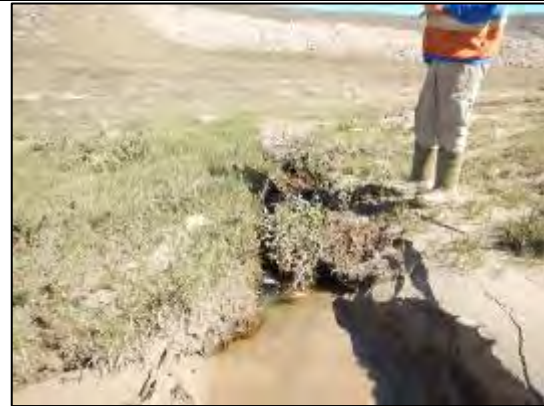
**Summary:** This small stream has several natural steep gradient and vertical drop barriers downstream that prevent fish access to the crossing area from Phillips Creek. There is no upstream overwintering habitat.

**Photos 1.** Photographs downstream of the Tote Road crossing CV-159: (A) looking upstream; (B) looking downstream; and (C) a vertical barrier preventing fish access to the crossing.

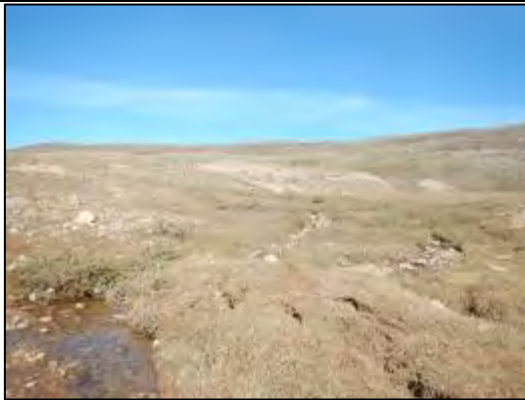
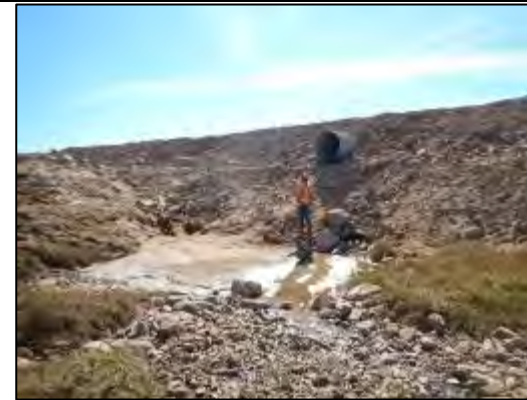
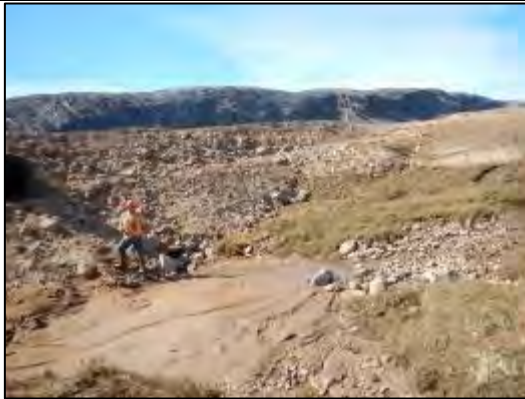
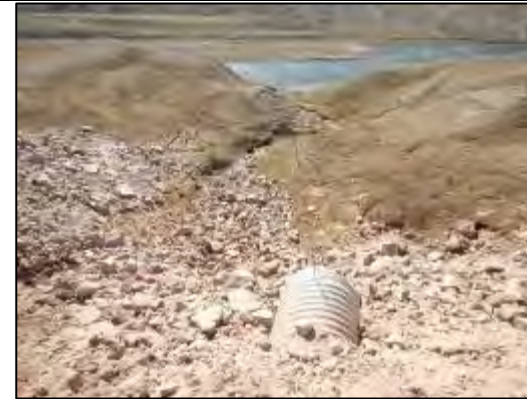
**Summary:** This small stream has several natural steep gradient and vertical drop barriers downstream that prevent fish access to the crossing area from Phillips Creek. There is no upstream overwintering habitat.

**Photos 1.** Photographs upstream of the Tote Road crossing CV-157: (A) looking upstream; (B) looking downstream; (C) looking across; and (D) photograph downstream of the Tote Road looking downstream.

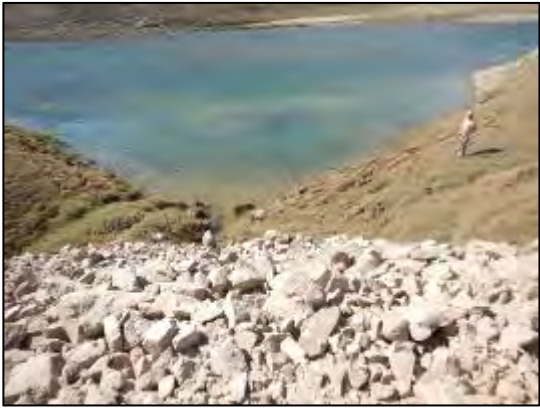
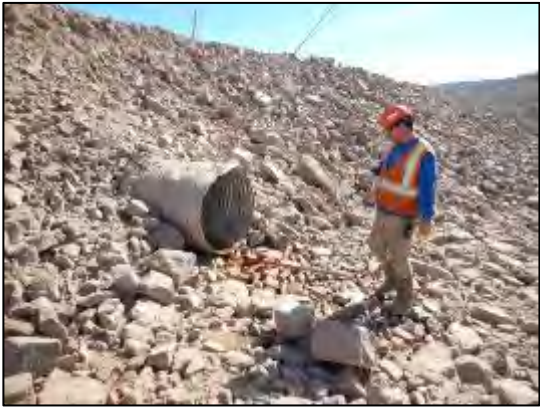
Tote Road Site CV-156				
UTM Coordinates: 17W 507531 E 7970286 N		Date Surveyed: 28-Jun-19		
<p><b>Summary:</b> This small runoff stream is typically dry and has several natural steep gradient and vertical drop barriers downstream that prevent fish access to the crossing area from Phillips Creek. There is no upstream overwintering habitat.</p>

<p><b>B</b></p>			
<p><b>Photos 1.</b> Photographs downstream of the Tote Road crossing CV-156: (A) looking downstream; and (B) looking across.</p>				
<p><b>Baffinland Iron Mines</b> <b>Mary River Project</b></p>

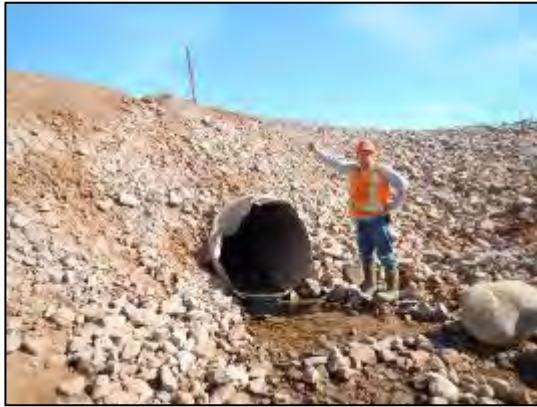
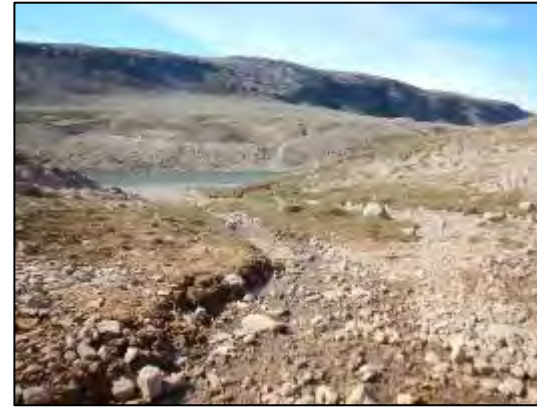
**Summary:** This small stream typically has low natural water levels and lacks connectivity at the confluence with Phillips Creek, preventing fish access to the crossing. There is no upstream overwintering habitat.

**Photos 1.** Photographs downstream of the Tote Road crossing CV-154: (A) looking upstream; and (B) looking downstream.

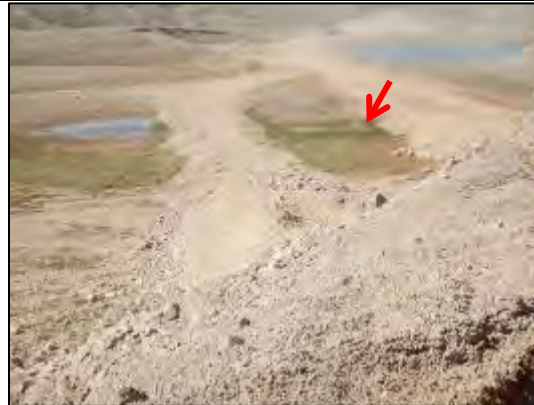
**Summary:** This small runoff stream typically has minimal natural surface flow or is dry and permanently lacks connectivity to Phillips Creek. There is no upstream overwintering habitat.

**Photos 1.** Photograph of the Tote Road crossing CV-153 (red arrow). Note distance from crossing due to lack of areas to safely access the site from the road.

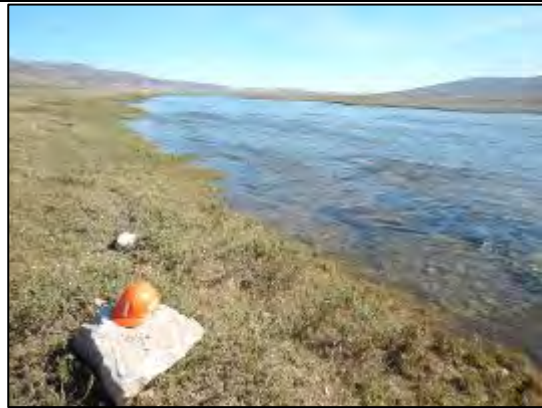
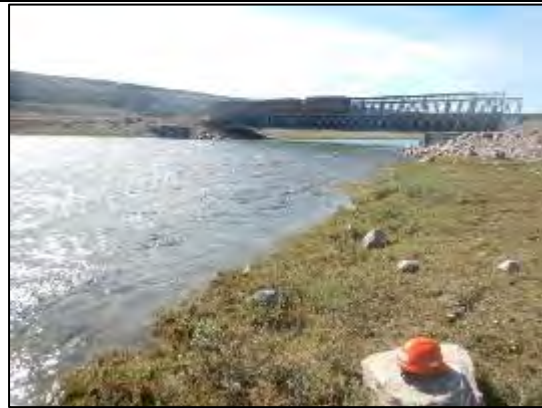
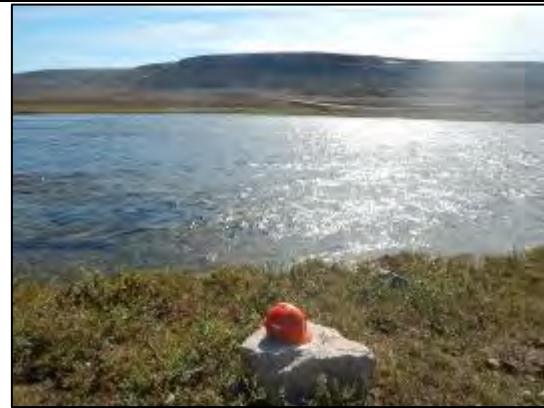
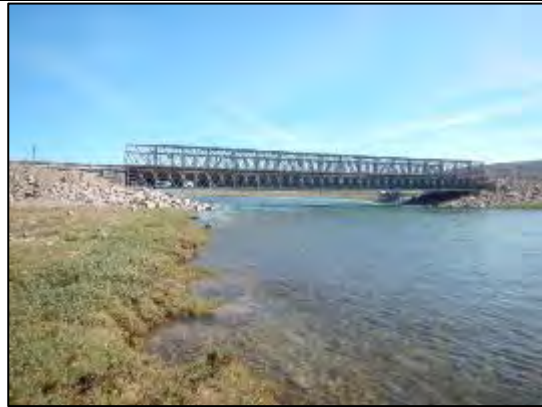
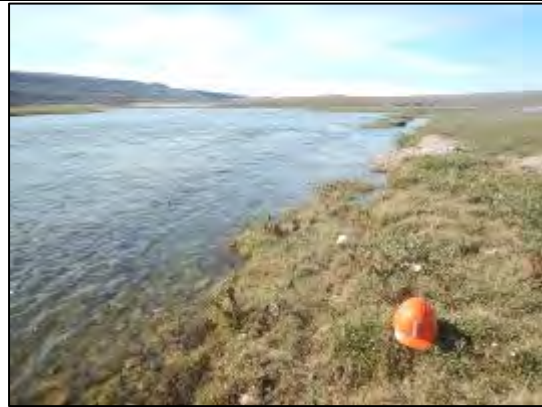
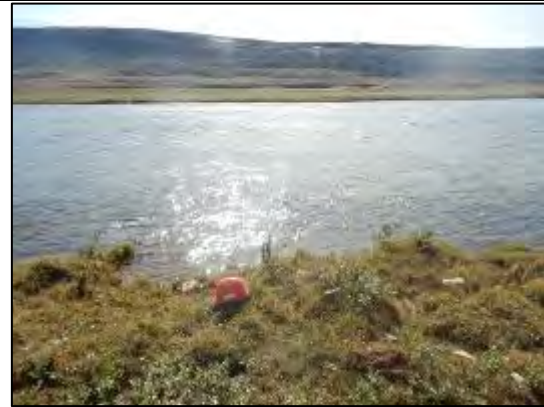
**Summary:** A bridge crossing of a major river that has consistently provided abundant fish habitat with no passage issues.

**Photos 1.** Photographs upstream of the Tote Road crossing CV-128: (A) looking upstream; (B) looking downstream; (C) looking across; and photographs downstream of the Tote Road: (D) looking upstream; (E) looking downstream; and (F) looking across.

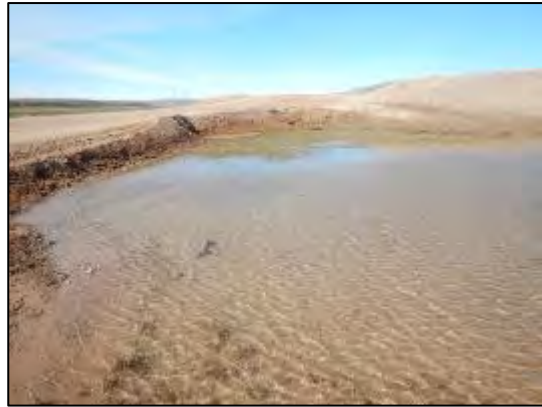
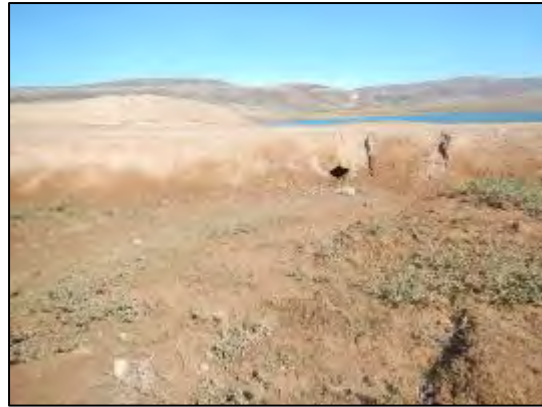
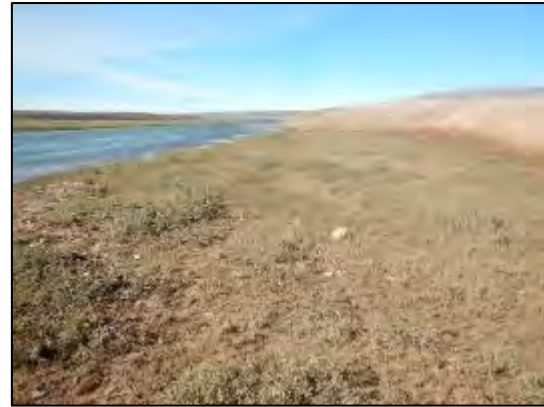
**Summary:** Some ponding upstream of the Tote Road culvert, but no channel and no surface water downstream. There is no access from Phillips Creek.

**Photos 1.** (A) Photograph upstream of the Tote Road crossing CV-125 looking upstream; and photographs downstream of the Tote Road crossing CV-125: (B) looking upstream; and (C) looking downstream.

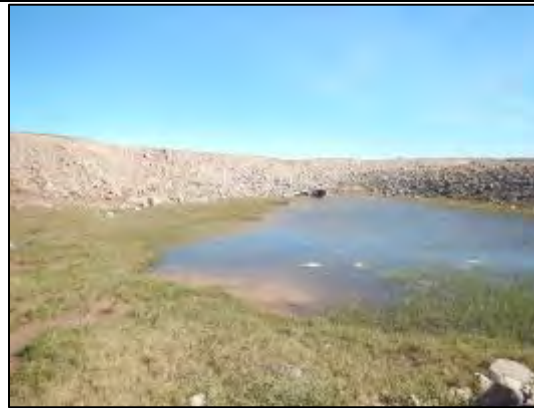
**Summary:** Some ponding upstream of the Tote Road culvert, but no channel and no surface water downstream. There is no connection to or access from Phillips Creek.

**Photos 1.** Photograph of the Tote Road crossing CV-120 from downstream.

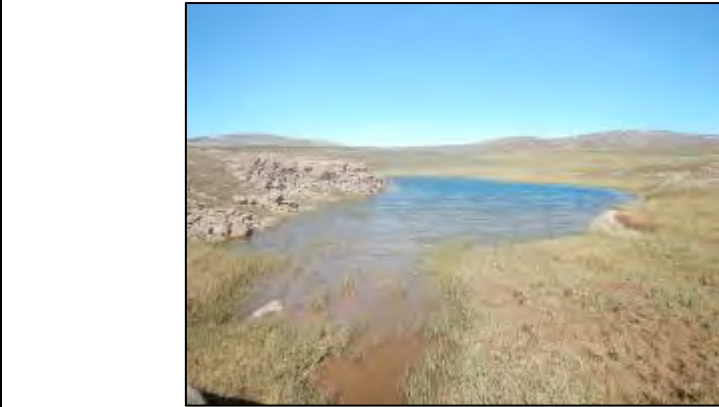
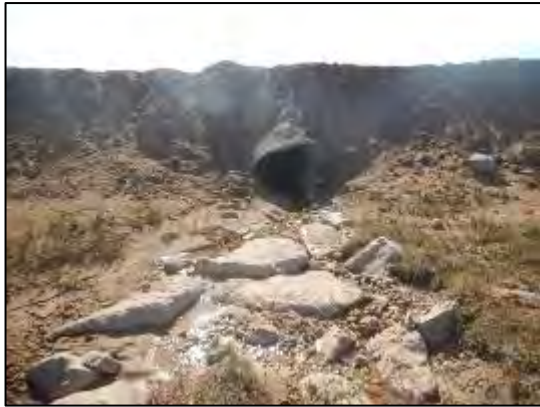
**Summary:** No channel downstream of the Tote Road and surface water shallow and dispersed over terrestrial grasses. No natural connectivity to Phillips Creek.

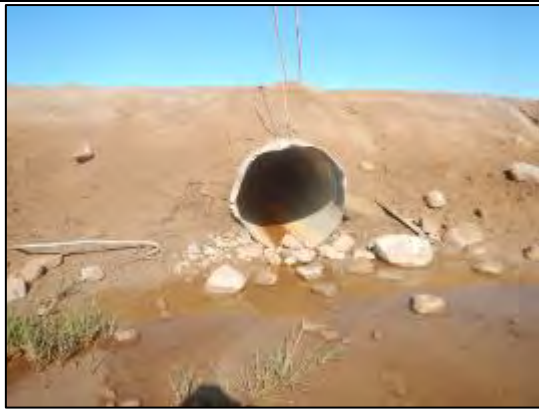
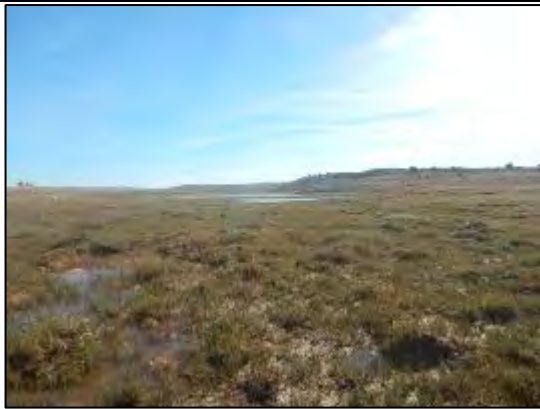
**Photos 1.** Photographs upstream of the Tote Road crossing CV-119: (A) looking upstream; (B) looking downstream; and photographs downstream of the Tote Road: (C) looking upstream; and (D) looking downstream.

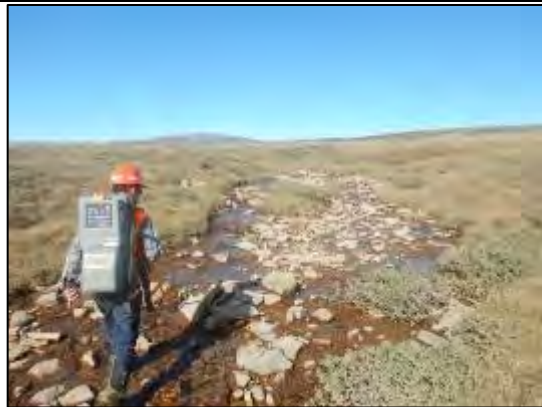
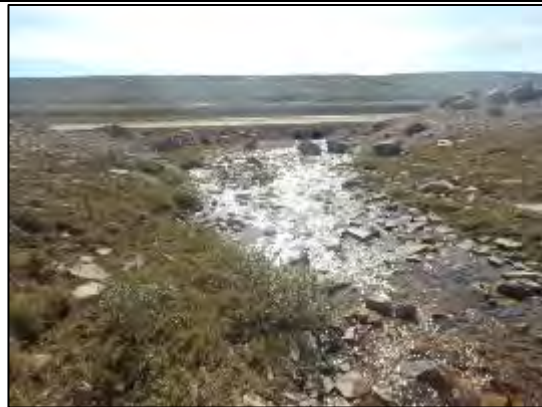
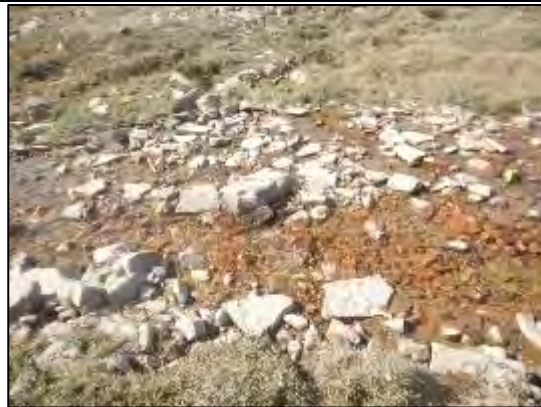
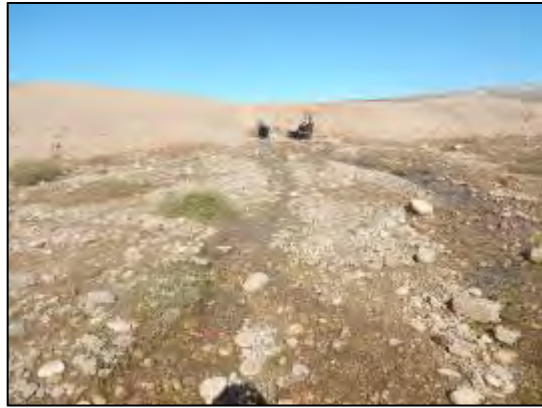
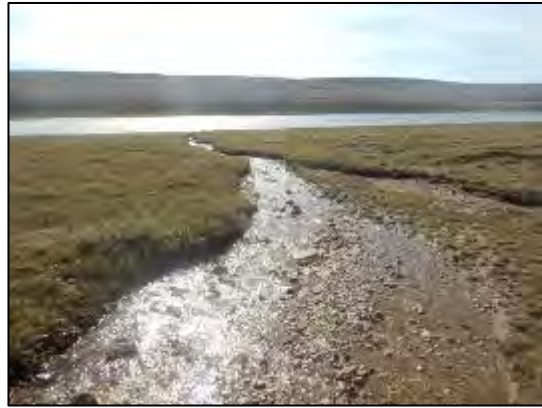
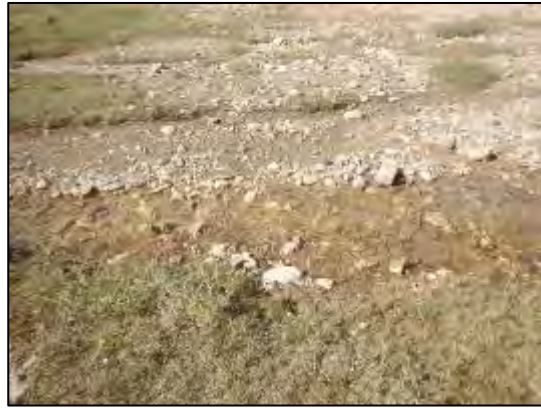
**Summary:** This stream provides habitat for juvenile Arctic Char. Perched culverts that may affect upstream access were remediated in fall 2019, but may require additional work.

**Photos 1.** Photographs upstream of the Tote Road crossing CV-114: (A) looking upstream; (B) looking downstream; (C) looking across; and photographs downstream of the Tote Road: (D) looking upstream; (E) looking downstream; and (F) looking across.

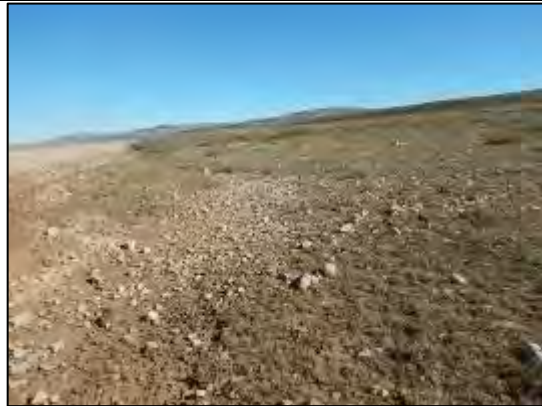
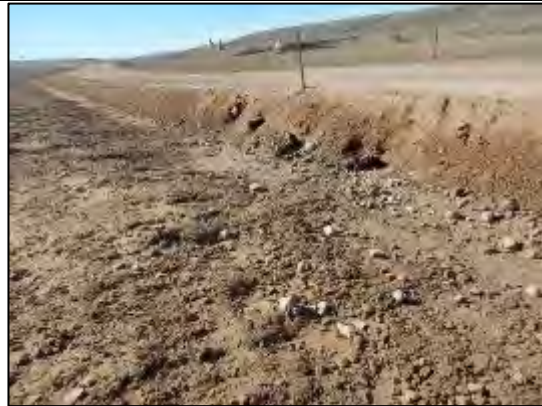
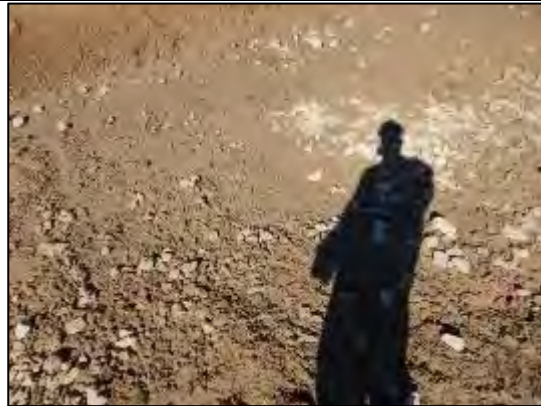
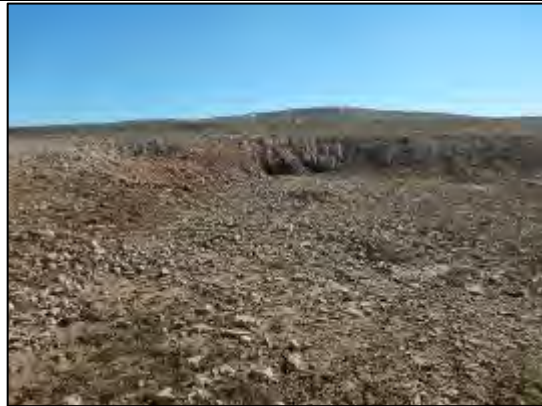
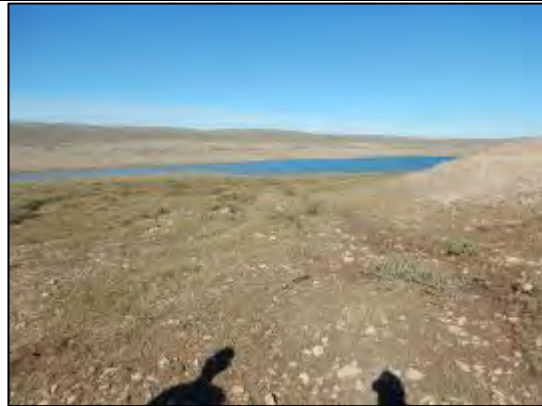
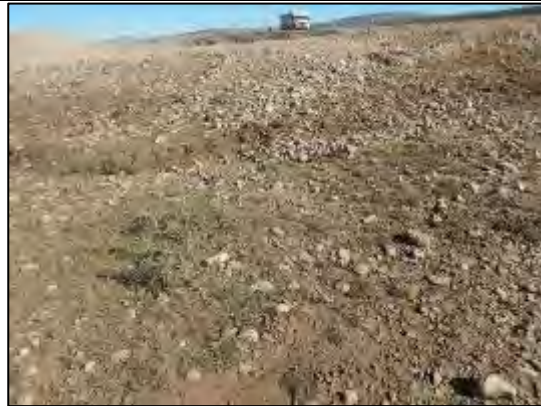
**Summary:** Site is dry with no natural channel and never has connectivity with Phillips Creek.

**Photos 1.** Photographs upstream of the Tote Road crossing CV-113: (A) looking upstream; (B) looking downstream; (C) looking across; and photographs downstream of the Tote Road: (D) looking upstream; (E) looking downstream; and (F) looking across.

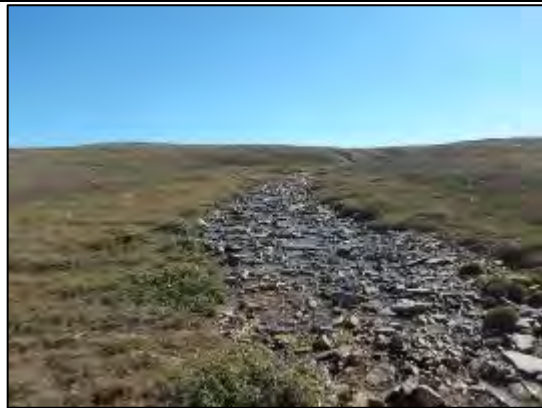
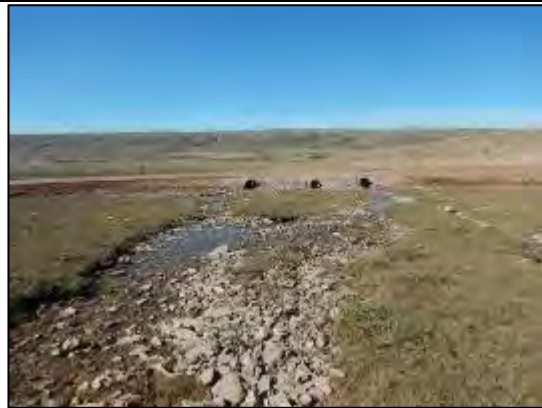
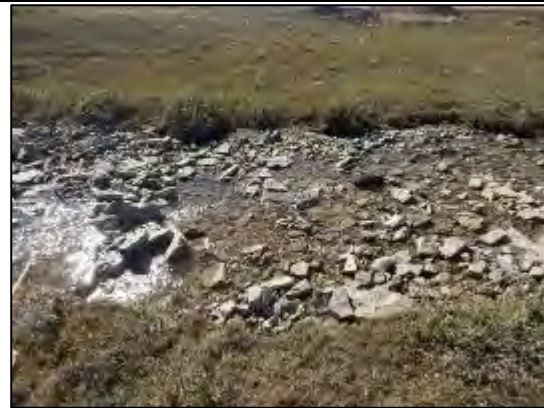
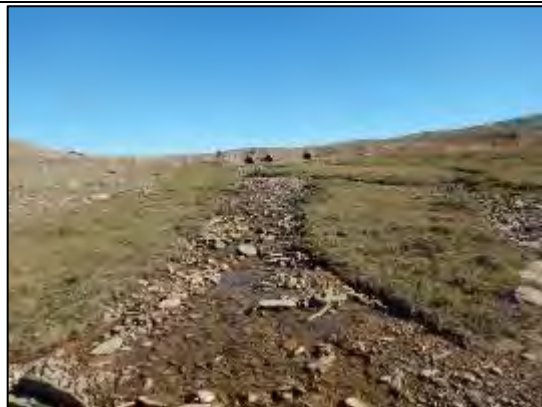
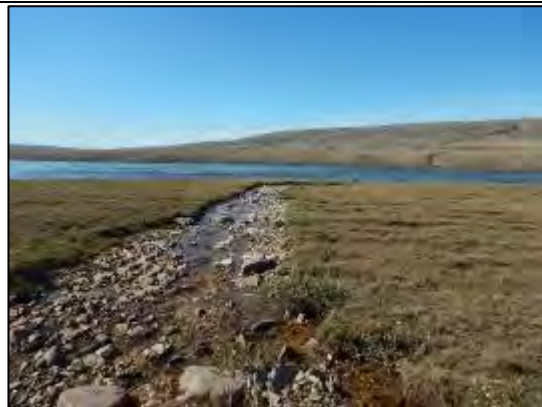
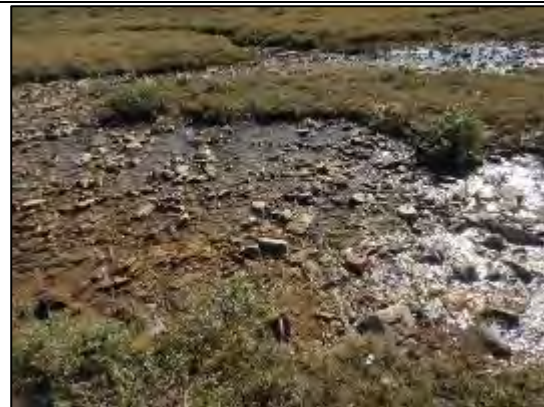
**Summary:** This stream provides summer rearing habitat for juvenile Arctic Char. There are no fish passage issues.

**Photos 1.** Photographs upstream of the Tote Road crossing CV-112: (A) looking upstream; (B) looking downstream; (C) looking across; and photographs downstream of the Tote Road: (D) looking upstream; (E) looking downstream; and (F) looking across.

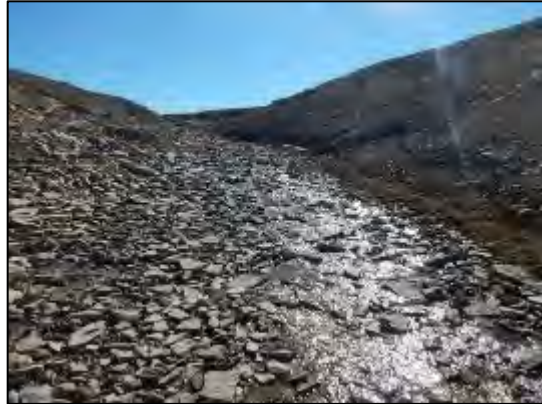
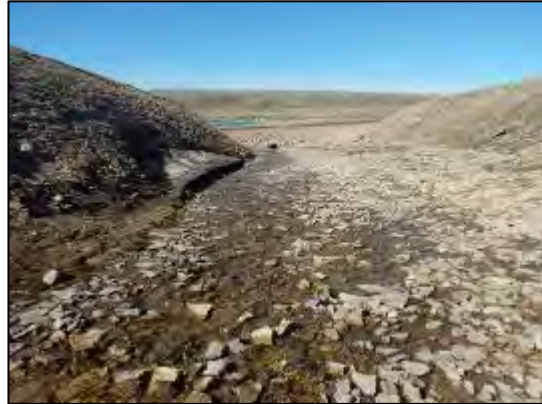
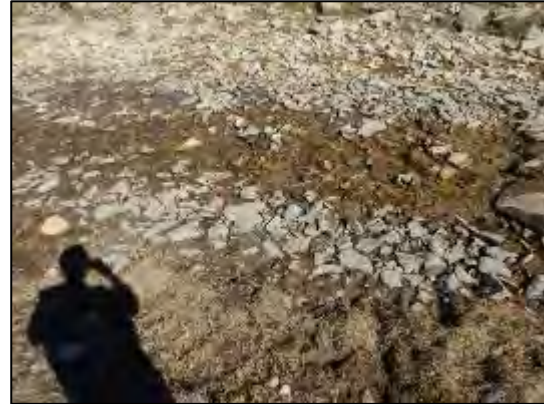
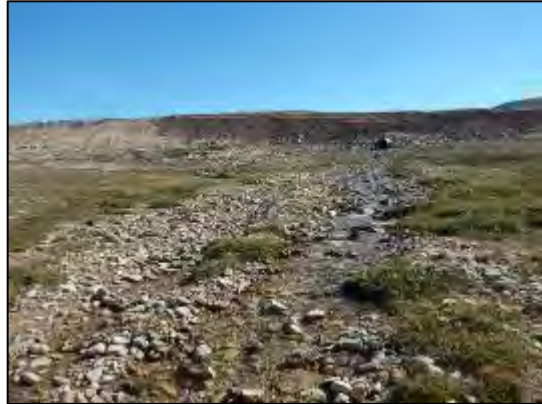
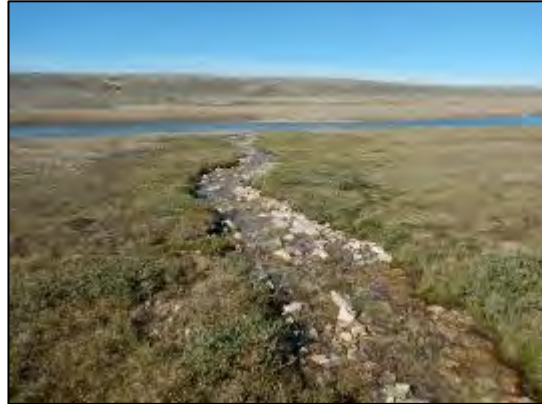
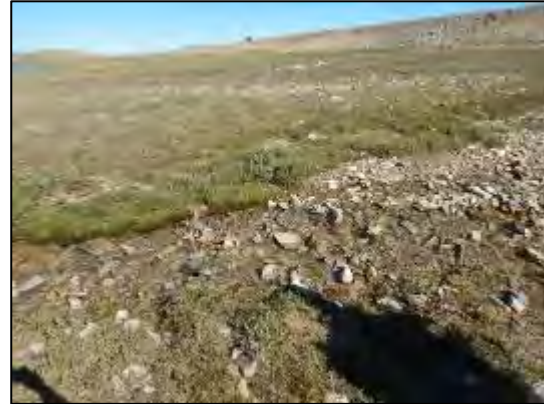
Location ID	Fish Habitat at Crossing (Y/N)	Fish Captured / Observed DS in 2019	Fish Captured / Observed US in 2019	Potential Project-Related Fish Passage or Habitat Issues	Fall 2019 Remediation Actions
CV-111	Y	Y	N	YES - Culvert recently reinstalled with a 0.25 m perch and no fish captured upstream.	Gravel was added to the pool at the downstream end of the culvert to provide a solid surface for the construction of a rocky ramp out of cobble and boulders. However, this remediation action was insufficient to eliminate the perch. The height of the drop from the culvert may be too great for a ramp or creation of backwater to be effective at this site. May require reinstallation of culvert.
CV-202	N	N	N	NONE - No natural access to crossing	N/A
CV-106	Y	Y	N	YES - Ramp installed in 2018 to mitigate a slight perch was not designed to maintain surface flows during periods of low water, resulting in intermittent access to the culvert.	Moved rock off surface of ramp downstream of the culvert to eliminate sub-surface flow. Created small pools as steps up to culvert. As the stream was dry at the time of remediation, effectiveness of the remediation actions could not yet be assessed. Will require assessment during spring 2020.

**Summary:** This stream provides summer rearing habitat for juvenile Arctic Char. Culvert was recently reinstalled and is now perched. See remediation Appendix for details.

**Photos 1.** Photographs upstream of the Tote Road crossing CV-111: (A) looking upstream; (B) looking downstream; (C) looking across; and photographs downstream of the Tote Road: (D) looking upstream; (E) looking downstream; and (F) looking across.

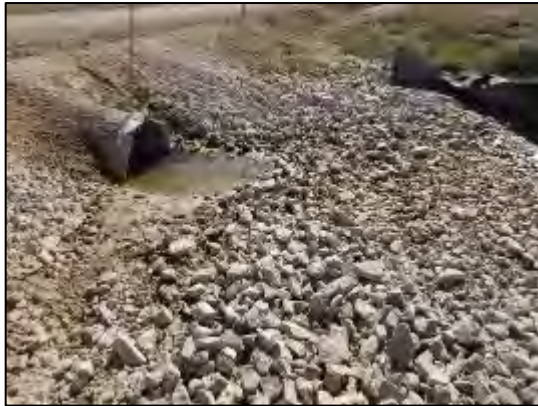
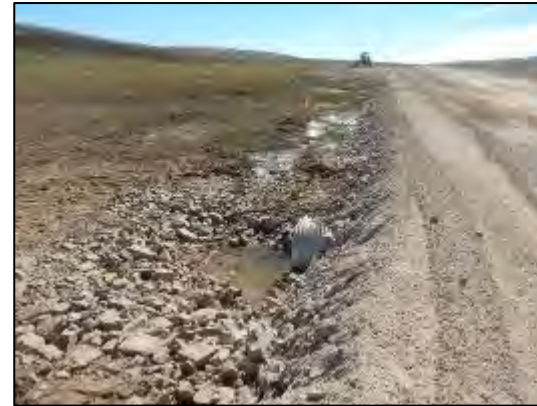
**Summary:** Site has no natural channel downstream, little surface flow, and is never connected to Phillips Creek.

**Photos 1.** Photographs of the Tote Road crossing CV-202: (A) upstream end of culvert; and (B) downstream end of culvert.

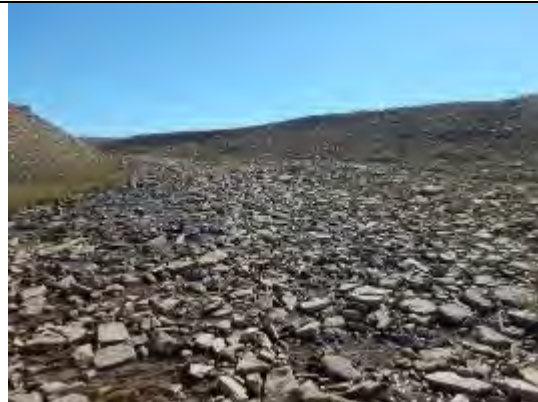
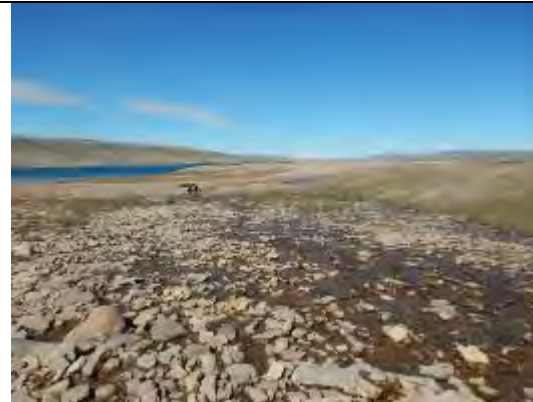
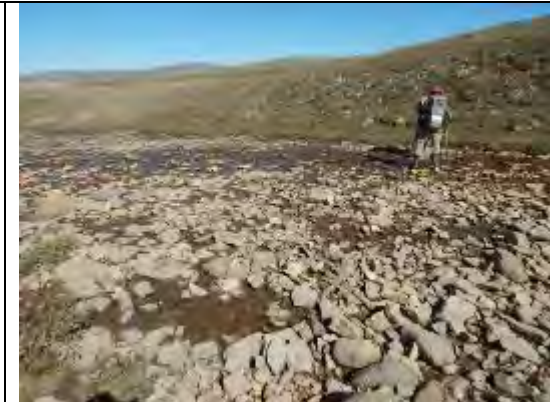
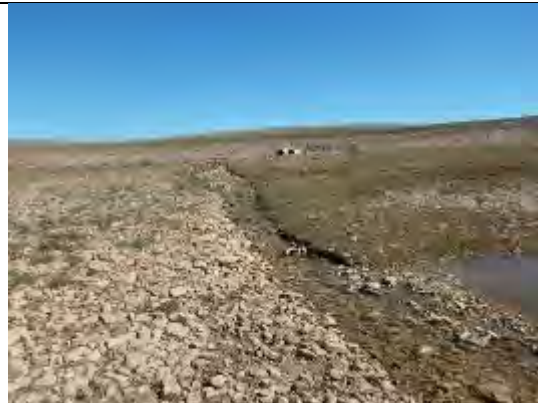
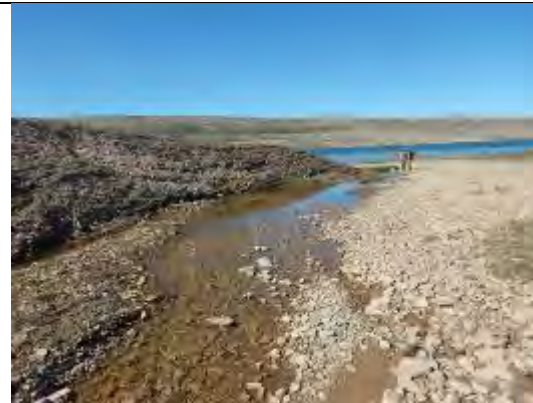
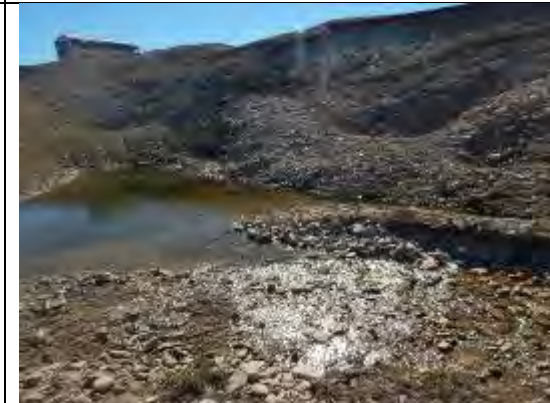
CV-104	Y	Y	N	NONE - Fish observed swimming up the culvert. Despite a lack of fish captured upstream, there are no obvious restrictions to movement.	N/A
CV-203	N	N	N	NONE - Always dry	N/A
CV-102	Y	N	N	NONE - Stream dry in 2019 following weak freshet, but no culvert issues.	N/A
CV-099	Y	Y	Y	NONE	N/A
CV-094	N	N	N	NONE - No natural access to crossing	N/A
CV-086	N	N	N	NONE - Always dry	N/A
CV-082	N	N	N	NONE - No natural access to crossing	N/A
CV-079	Y	Y	Y	NONE	N/A
CV-078	Y	Y	Y	NONE	N/A
CV-076	Y	Y	Y	NONE	N/A
CV-072	Y	Y	Y	NONE	N/A
CV-060	Y	Y	Y	NONE	N/A
CV-059	Y	Y	Y	NONE	N/A

**Summary:** Though water levels are occasionally low (as in 2019), this stream provides summer rearing habitat for juvenile Arctic Char. No passage issues were identified in spring 2019.

**Photos 1.** Photographs upstream of the Tote Road crossing CV-104: (A) looking upstream; (B) looking downstream; (C) looking across; and photographs downstream of the Tote Road: (D) looking upstream; (E) looking downstream; and (F) looking across.

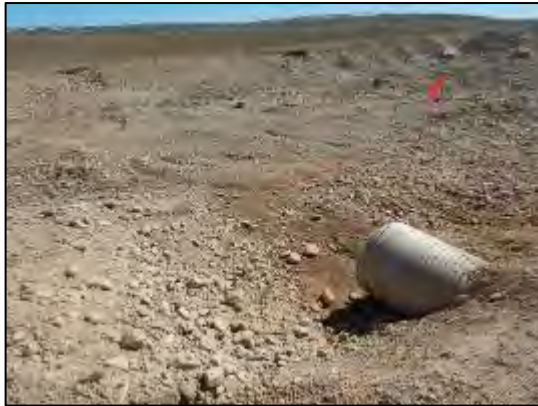
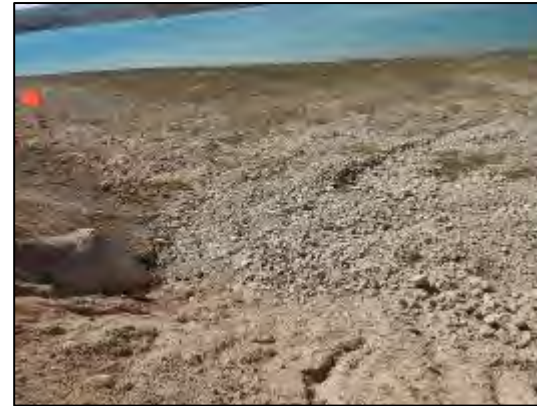
**Summary:** Stream has been typically dry when surveyed and has no natural channel or habitat downstream and no connectivity to Phillips Creek.

**Photos 1.** Photographs of the Tote Road crossing CV-203: (A) upstream end of culvert; and (B) downstream end of culvert.

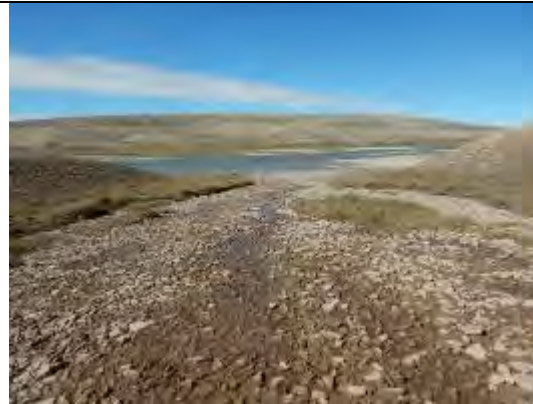
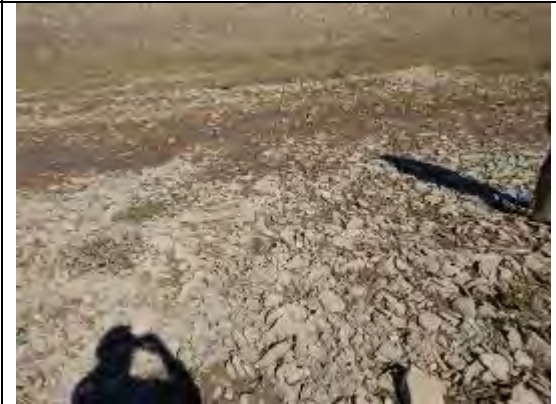
**Photos 1.** Photographs upstream of the Tote Road crossing CV-102: (A) looking upstream; (B) looking downstream; (C) looking across; and photographs downstream of the Tote Road: (D) looking upstream; (E) looking downstream; and (F) looking across.

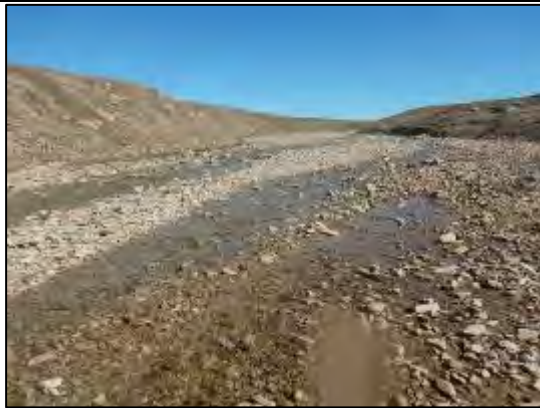
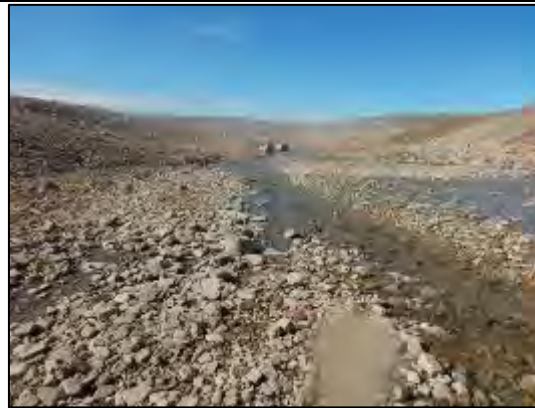
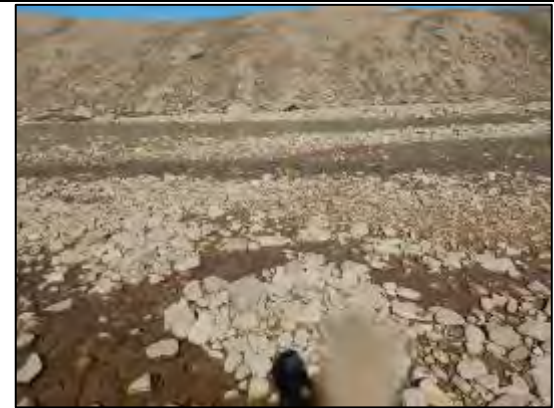
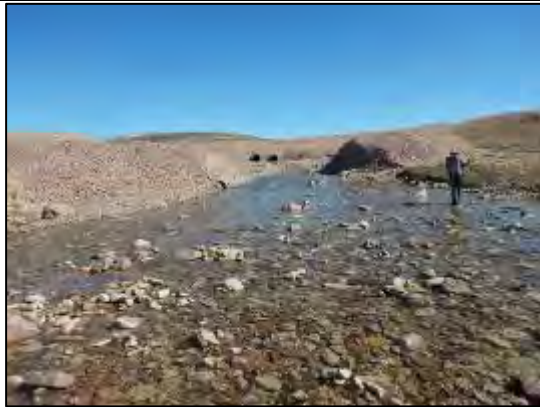
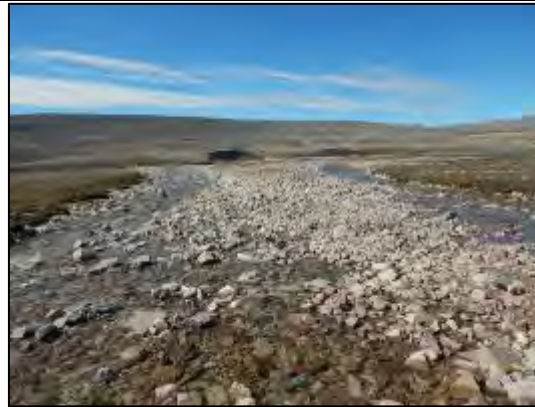
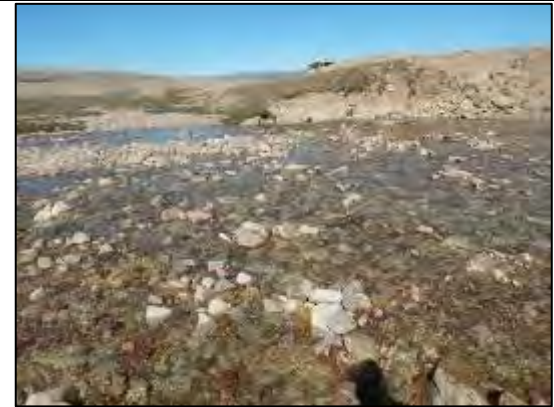
## Tote Road Site CV-099

**Summary:** A large stream with abundant fish habitat. Water velocities in the culverts appeared to have restricted upstream access to larger juveniles during some annual surveys, but no fish passage issues were identified in spring 2019.

**Photos 1.** Photographs upstream of the Tote Road crossing CV-099: (A) looking upstream; (B) looking downstream; (C) looking across; and photographs downstream of the Tote Road: (D) looking upstream; (E) looking downstream; and (F) looking across.

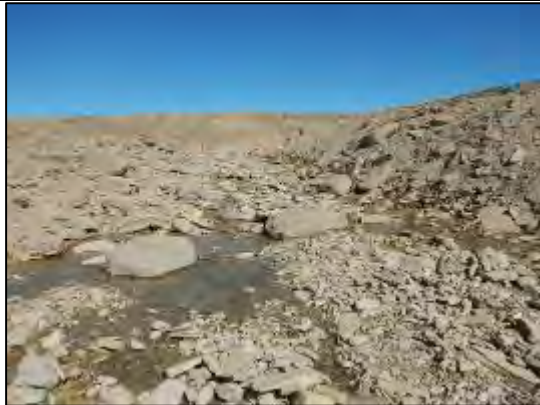
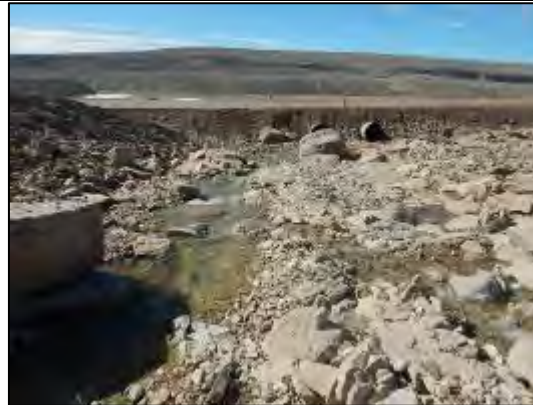
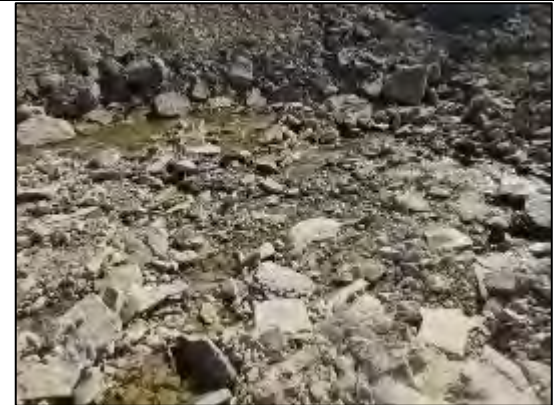
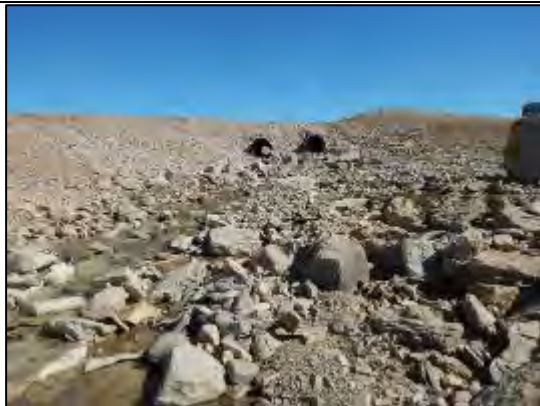
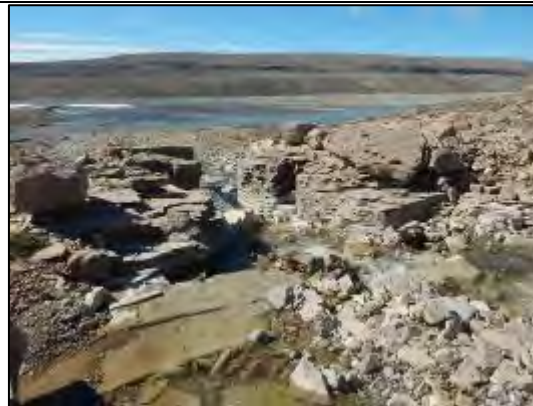
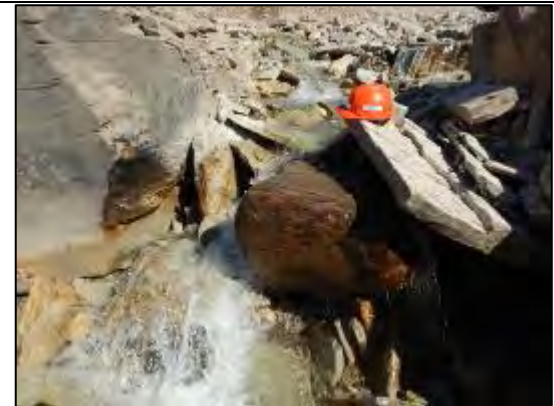
**Summary:** Site provides good quality summer rearing habitat for juvenile Arctic Char but a natural downstream vertical barrier prevents access from overwintering habitat. Fish cannot naturally access upstream habitat.

**Photos 1.** Photographs upstream of the Tote Road crossing CV-094: (A) looking upstream; (B) looking downstream; (C) looking across; and photographs downstream of the Tote Road: (D) looking upstream; (E) looking downstream; and (F) a vertical barrier preventing fish access.

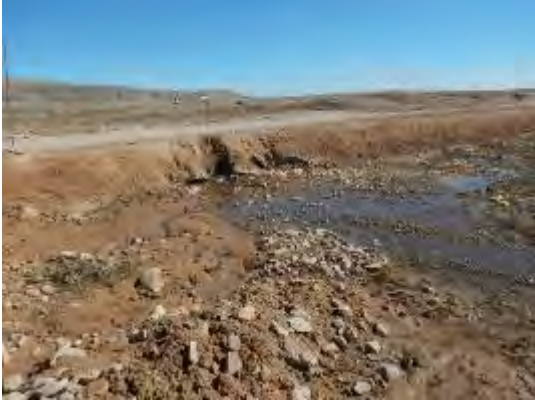
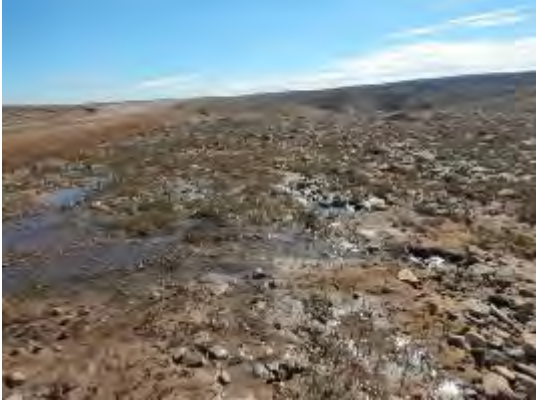
Tote Road Site CV-082			
UTM Coordinates: 17W 525254 E 7938131 N		Date Surveyed: 29-Jun-19	
<p><b>Summary:</b> There is consistently very little water, no natural channel, and a steep downstream gradient all of which prevent access from overwintering habitat.</p>			
<b>A</b>

<p><b>Photos 1.</b> Photographs downstream of the Tote Road crossing CV-082: (A) looking upstream; and (B) looking downstream at subflow barrier.</p>			
<p><b>Baffinland Iron Mines</b> <b>Mary River Project</b></p>
