**BAFFINLAND IRON MINES CORPORATION  
MARY RIVER PROJECT**

**FISH HABITAT MONITORING  
2019 ANNUAL REPORT  
EARLY REVENUE PHASE - TOTE ROAD UPGRADES**

2019-12-31	0

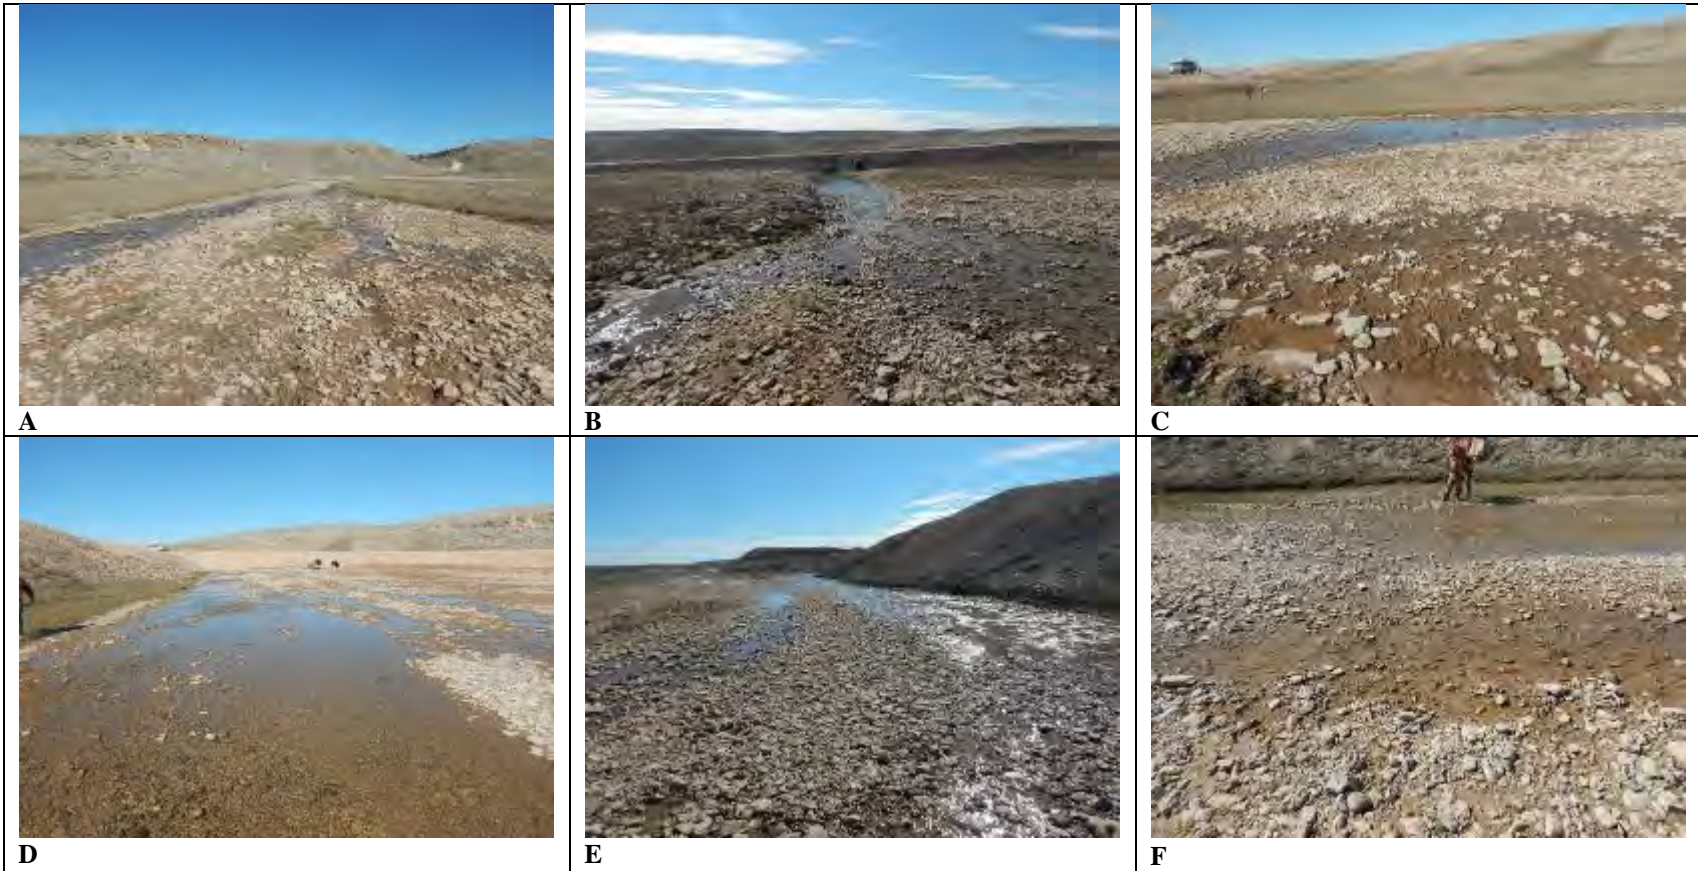
**Summary:** Site provides abundant summer rearing habitat for juvenile Arctic Char. There were no fish passage issues identified in spring 2019.

**Photos 1.** Photographs upstream of the Tote Road crossing CV-079: (A) looking upstream; (B) looking downstream; (C) looking across; and photographs downstream of the Tote Road: (D) looking upstream; (E) looking downstream; and (F) looking across.

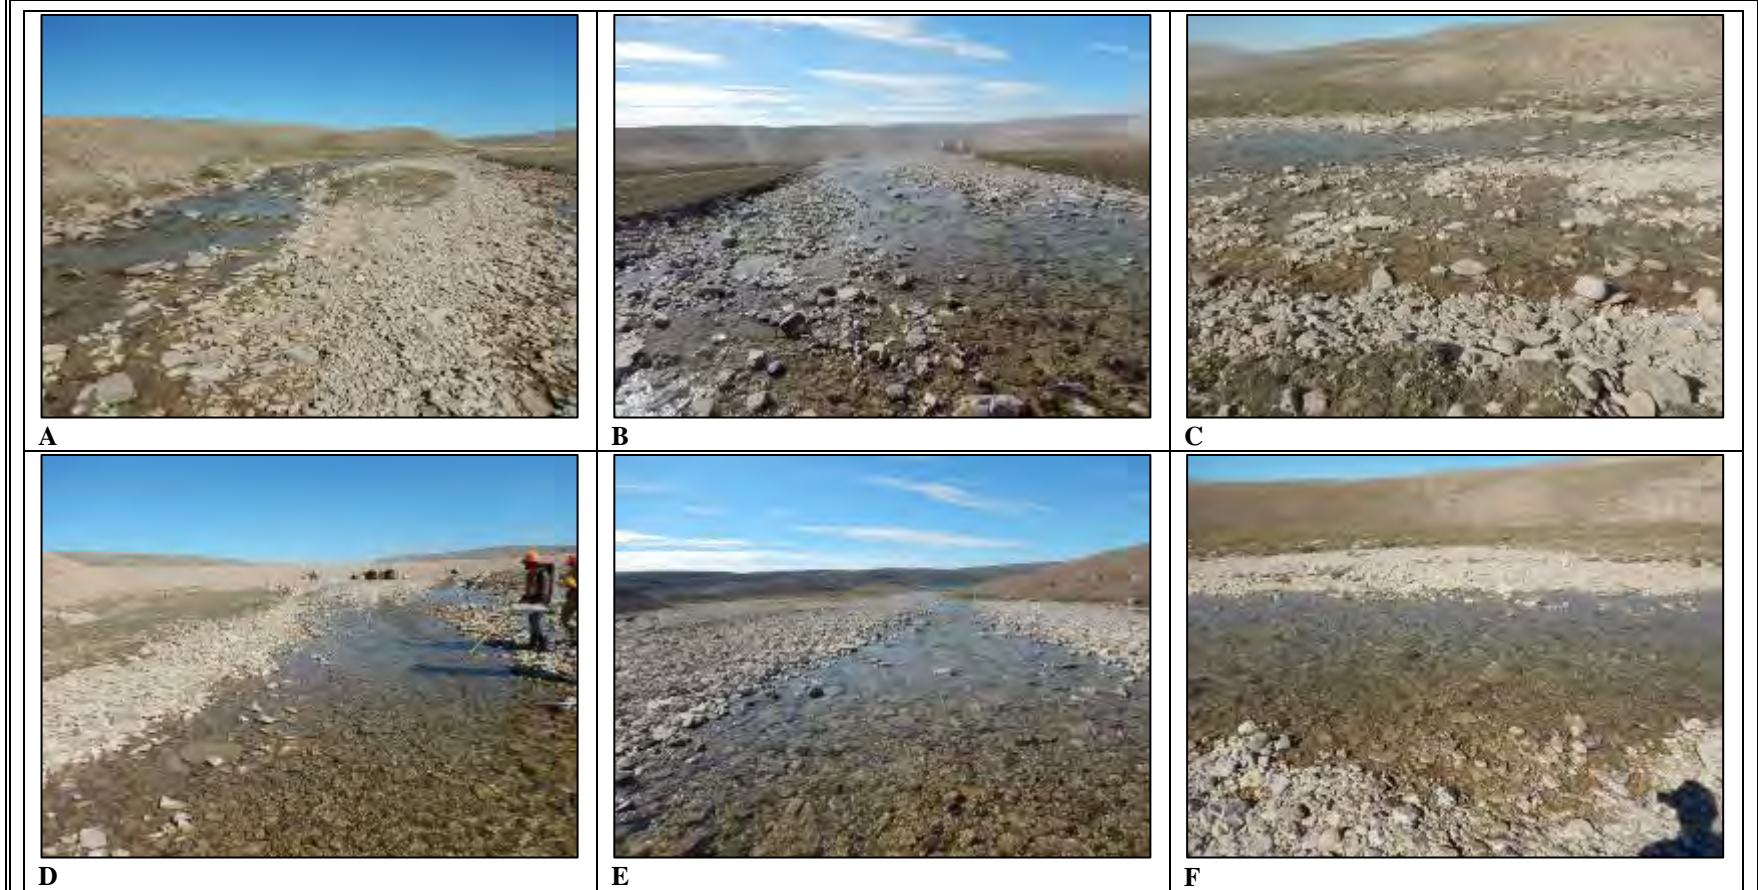
**Summary:** Site provides abundant summer rearing habitat for juvenile Arctic Char. There were no fish passage issues identified in spring 2019.

**Photos 1.** Photographs upstream of the Tote Road crossing CV-078: (A) looking upstream; (B) looking downstream; (C) looking across; and photographs downstream of the Tote Road: (D) looking upstream; (E) looking downstream; and (F) looking across.

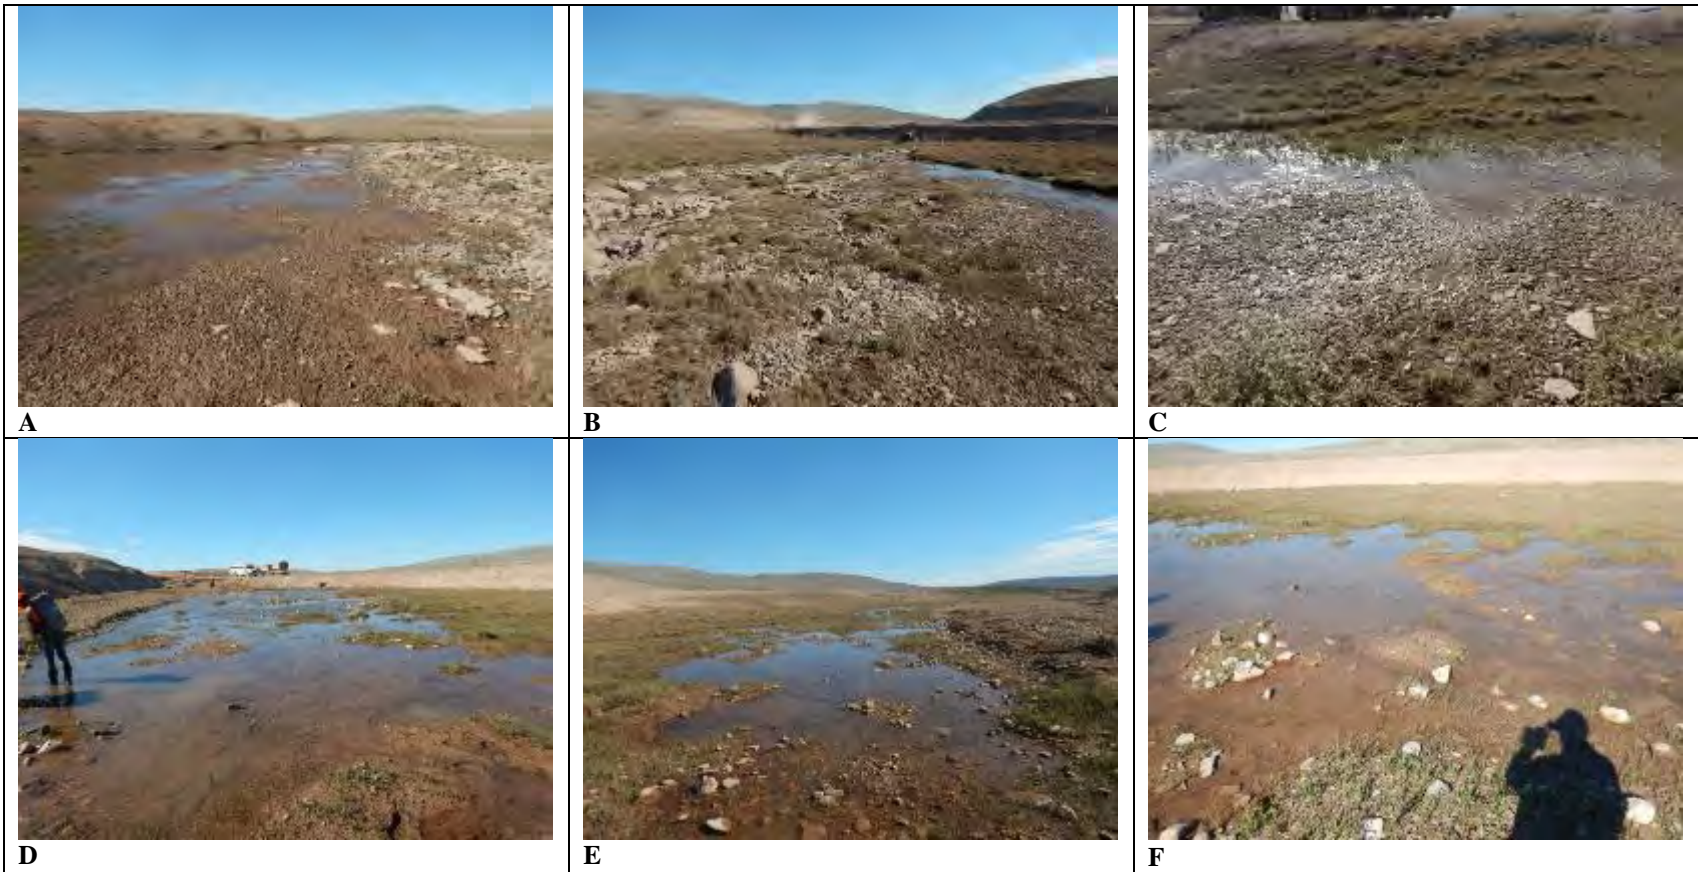
**Summary:** Small stream providing summer rearing habitat for juvenile Arctic Char. There were no fish passage issues identified in spring 2019.

**Photos 1.** Photographs upstream of the Tote Road crossing CV-076: (A) looking upstream; (B) looking downstream; (C) looking across; and photographs downstream of the Tote Road: (D) looking upstream; (E) looking downstream; and (F) looking across.

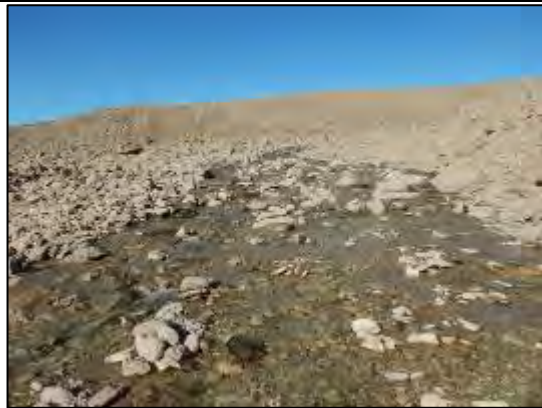
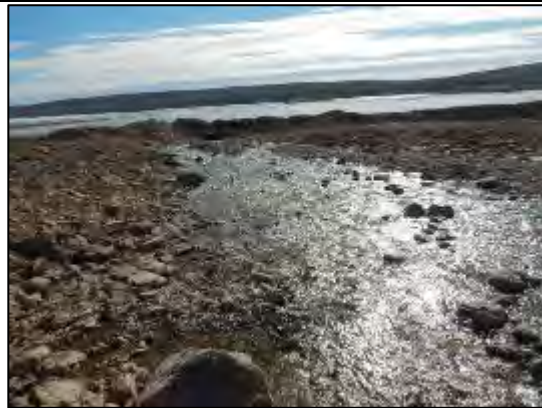
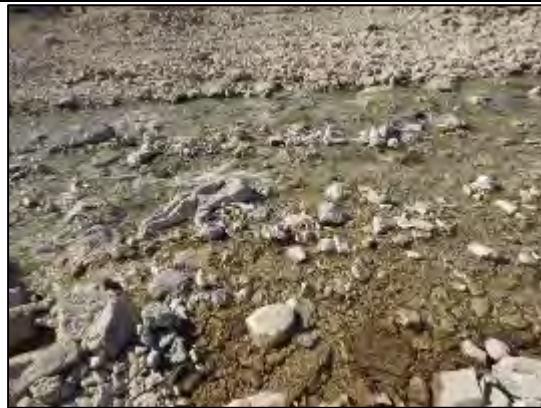
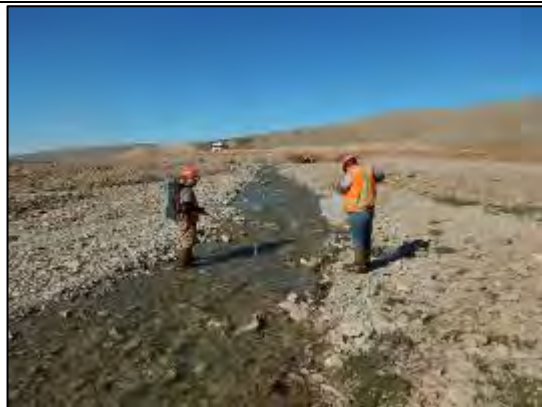
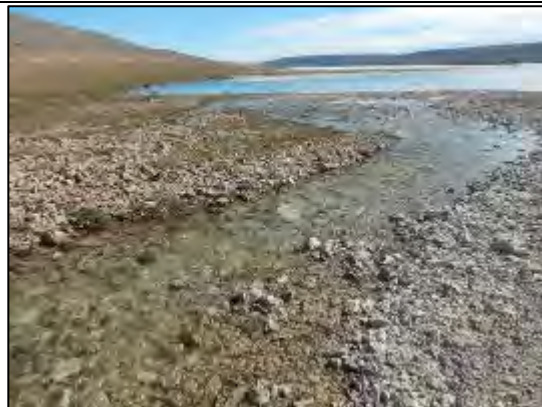
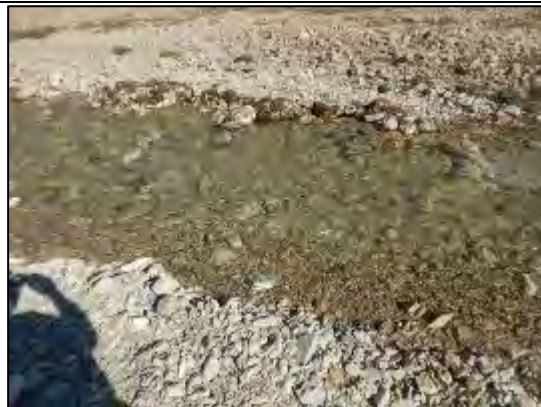
**Summary:** Site provides abundant summer rearing habitat for juvenile Arctic Char. There were no fish passage issues identified in spring 2019.

**Photos 1.** Photographs upstream of the Tote Road crossing CV-072: (A) looking upstream; (B) looking downstream; (C) looking across; and photographs downstream of the Tote Road: (D) looking upstream; (E) looking downstream; and (F) looking across.

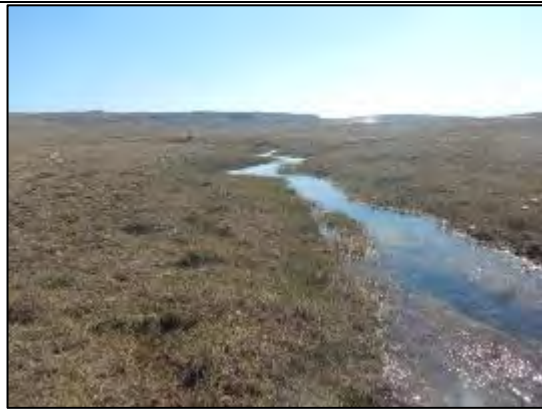
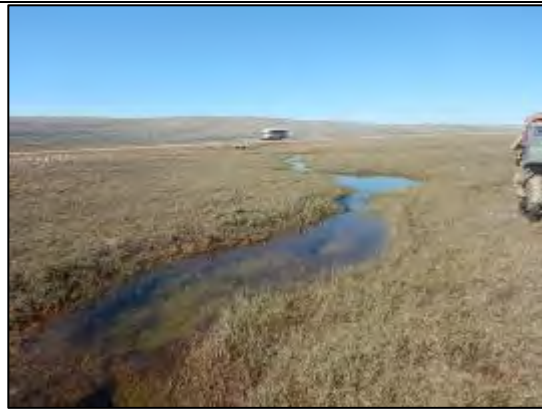
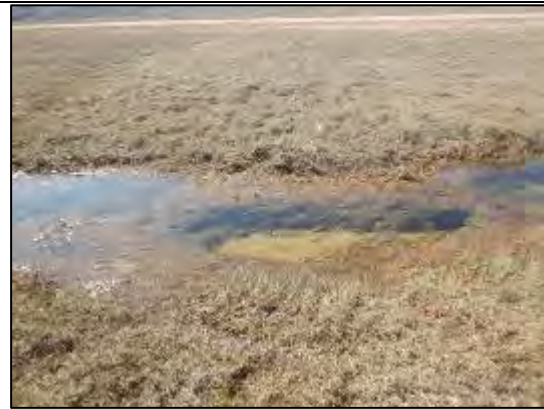
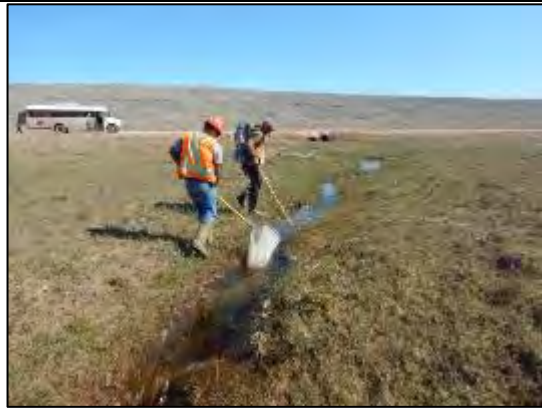
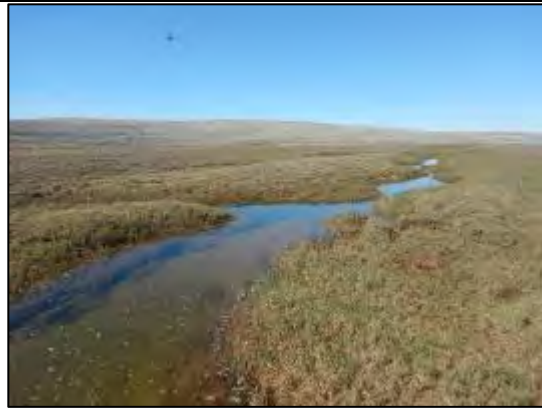
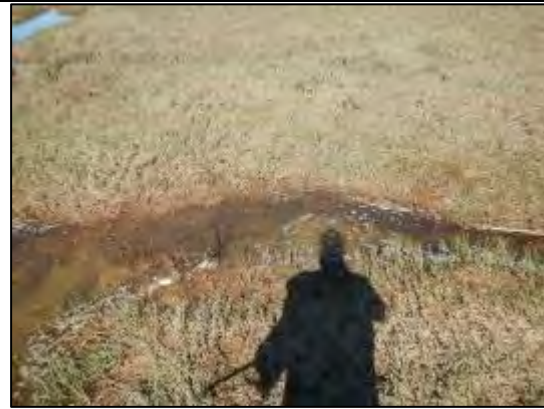
**Summary:** Site provides abundant summer rearing habitat for juvenile Arctic Char. There were no fish passage issues identified in spring 2019.

**Photos 1.** Photographs upstream of the Tote Road crossing CV-060: (A) looking upstream; (B) looking downstream; (C) looking across; and photographs downstream of the Tote Road: (D) looking upstream; (E) looking downstream; and (F) looking across.

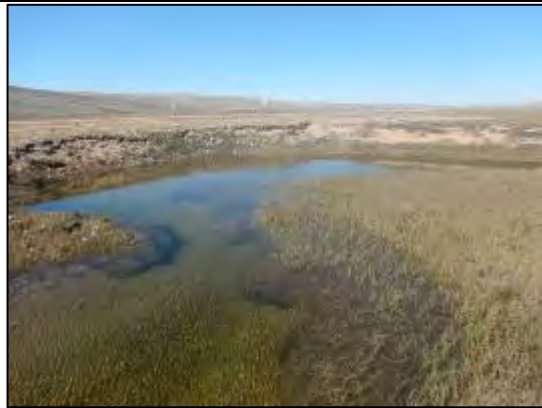
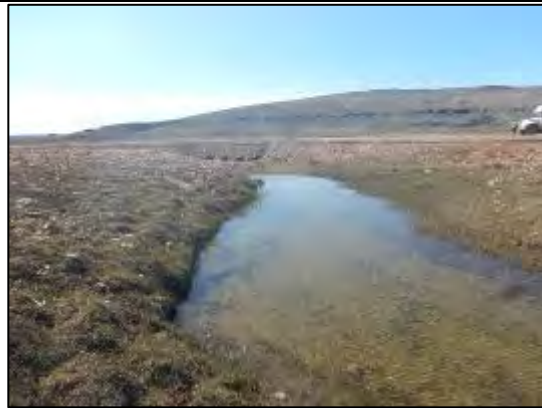
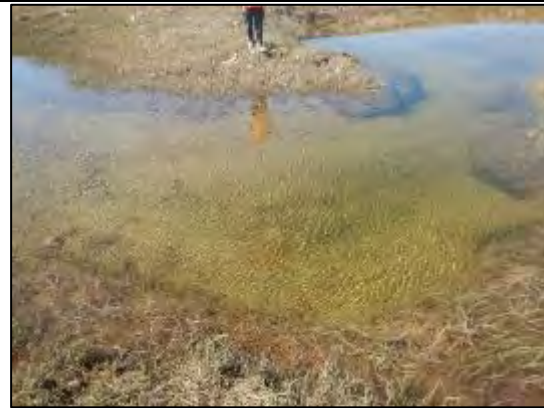
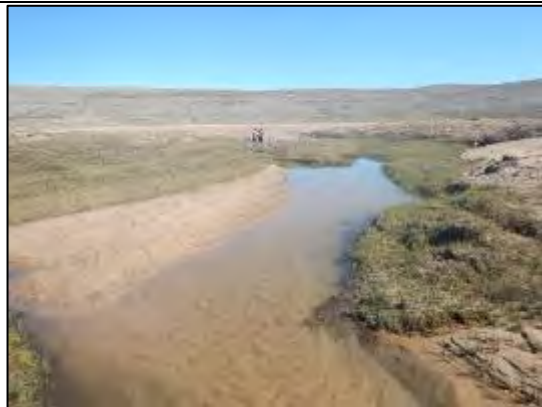
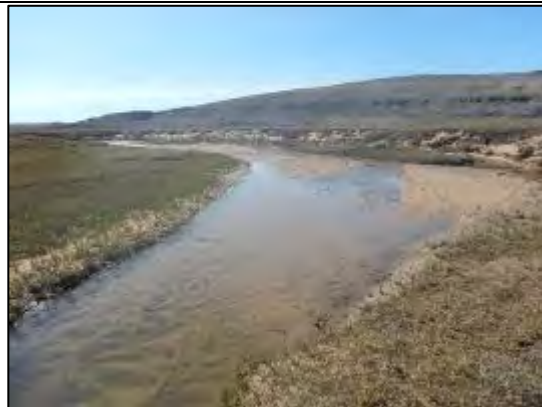
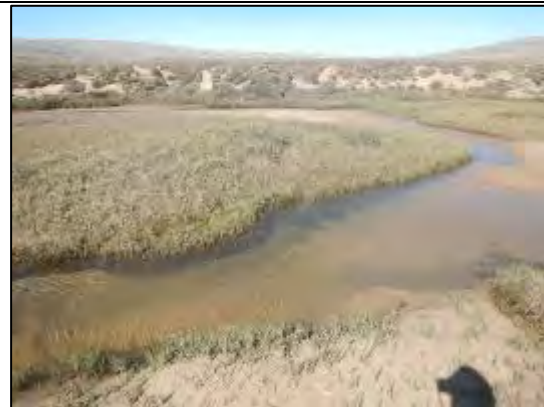
**Summary:** Site provides abundant summer rearing habitat for juvenile Arctic Char. There were no fish passage issues identified in spring 2019.

**Photos 1.** Photographs upstream of the Tote Road crossing CV-059: (A) looking upstream; (B) looking downstream; (C) looking across; and photographs downstream of the Tote Road: (D) looking upstream; (E) looking downstream; and (F) looking across.

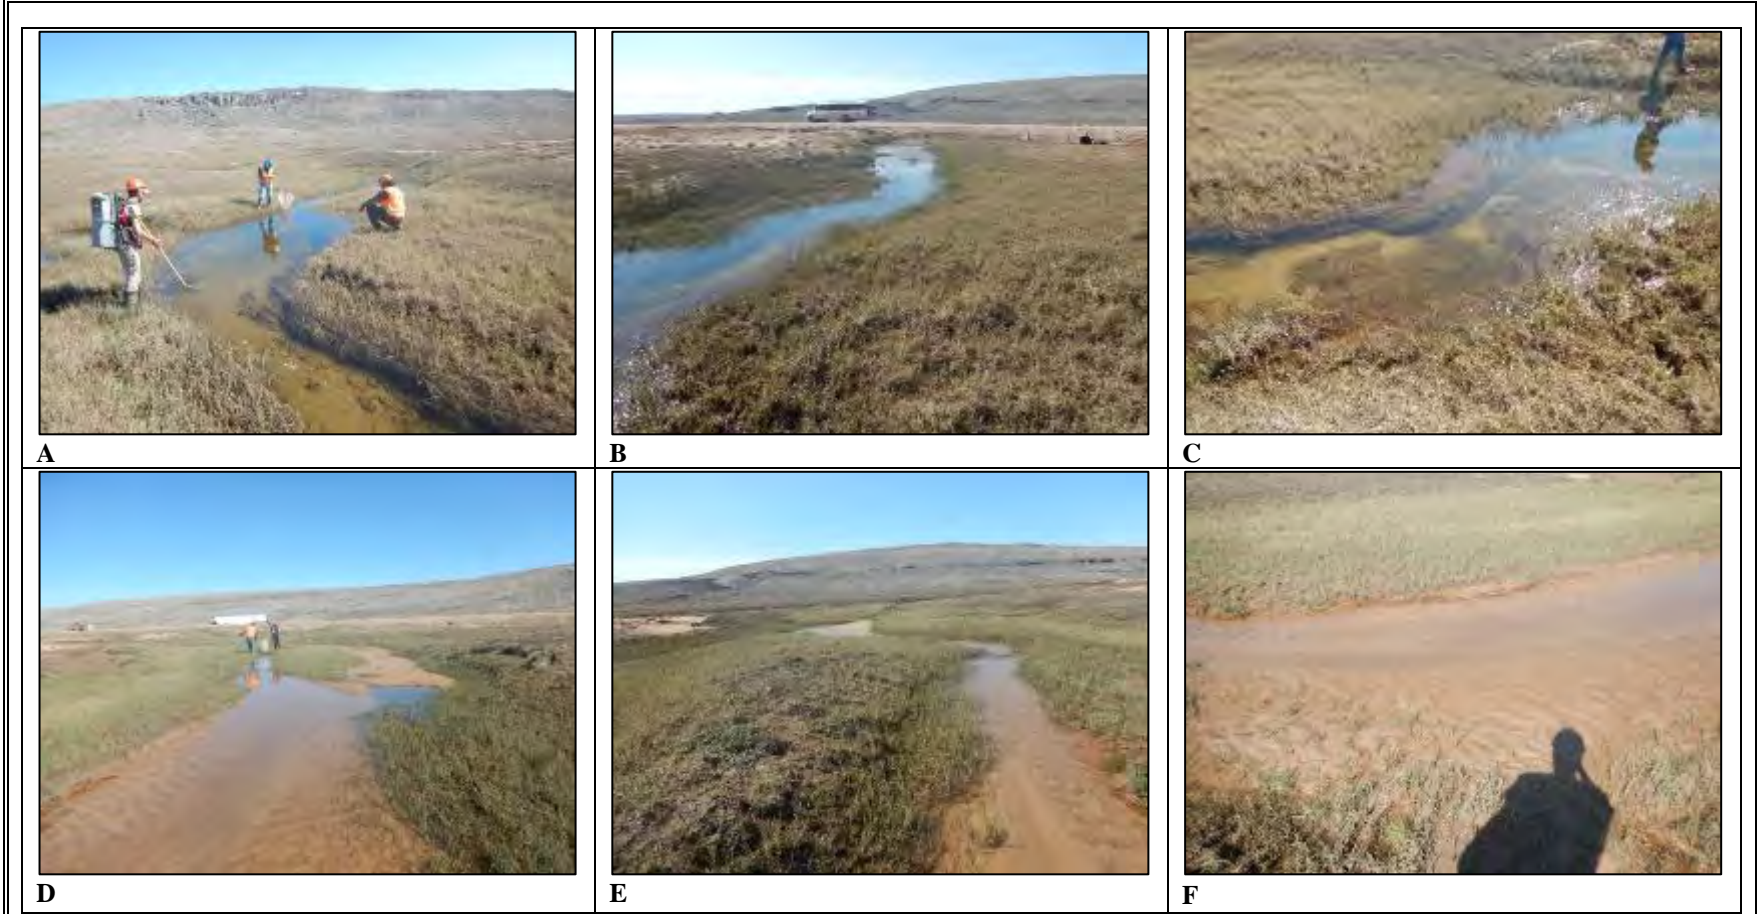
**Summary:** Site provides abundant summer rearing habitat for juvenile Arctic Char. There were no fish passage issues identified in spring 2019.

**Photos 1.** Photographs upstream of the Tote Road crossing CV-058: (A) looking upstream; (B) looking downstream; (C) looking across; and photographs downstream of the Tote Road: (D) looking upstream; (E) looking downstream; and (F) looking across.

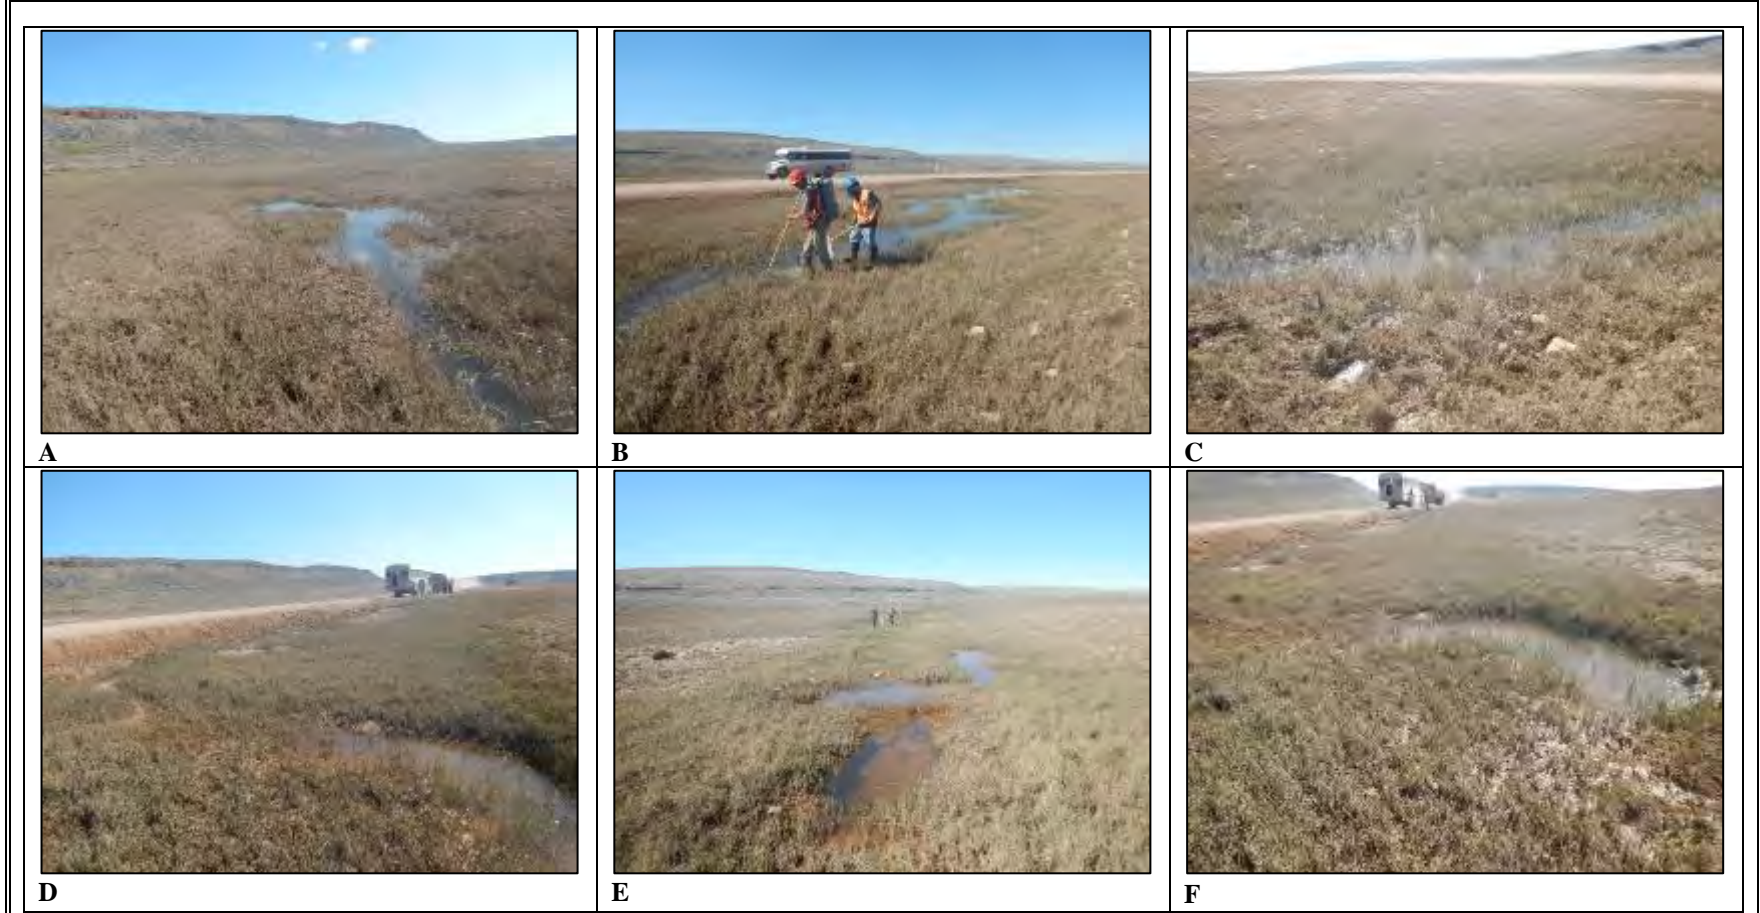
**Summary:** Site provides some summer rearing habitat for juvenile Arctic Char. There were no fish passage issues identified in spring 2019.

**Photos 1.** Photographs upstream of the Tote Road crossing CV-057: (A) looking upstream; (B) looking downstream; (C) looking across; and photographs downstream of the Tote Road: (D) looking upstream; (E) looking downstream; and (F) looking across.

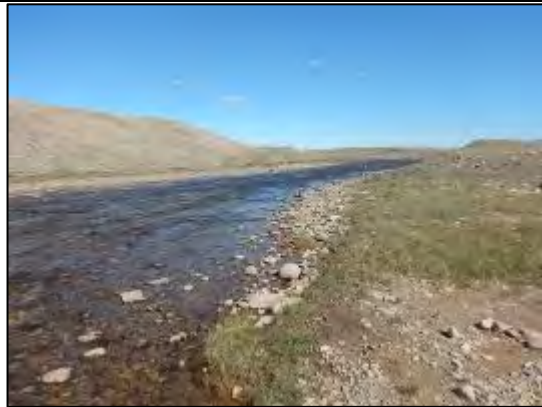
**A**

**Summary:** Large river with abundant habitat for both species. One channel is crossed by a bridge and the other with two culverts. Culverts were perched, blocking fish movements, in spring 2019 and remediation work was conducted in fall 2019.

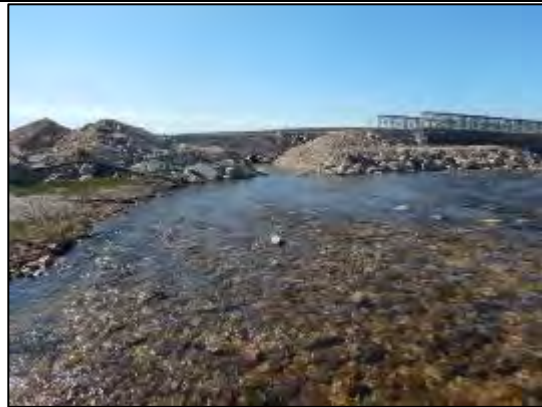
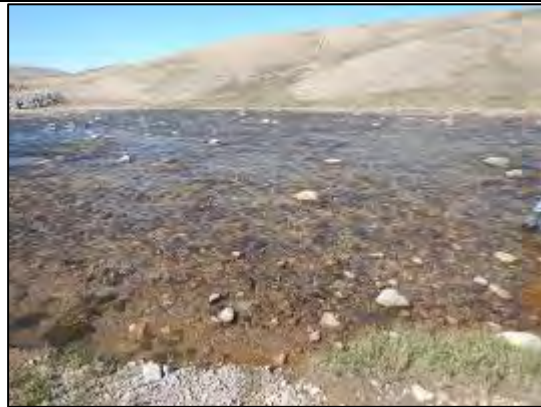
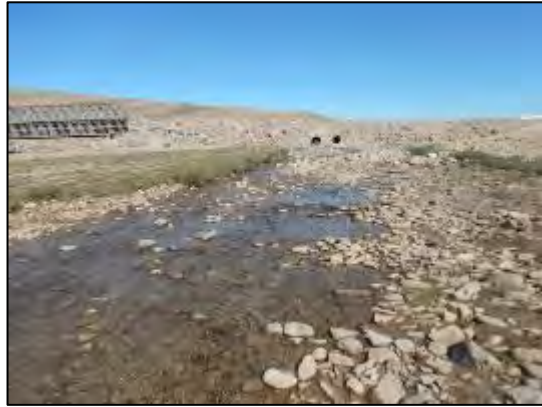
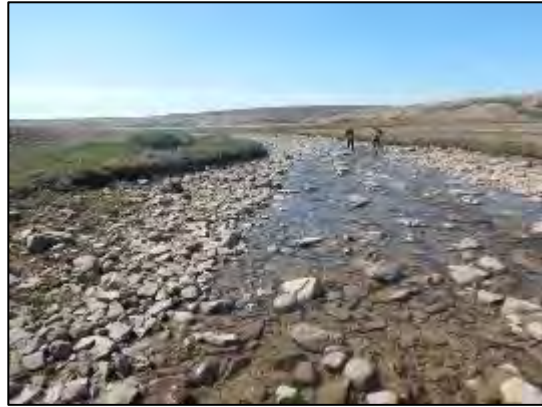
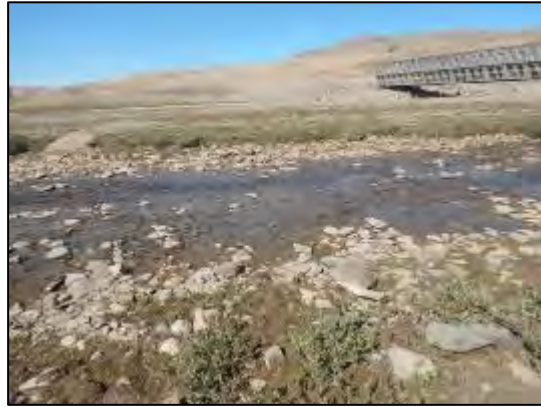
**Photos 1.** Photographs upstream of the Tote Road crossing BG-50: (A) looking upstream; (B) looking downstream; (C) looking across; and photographs downstream of the Tote Road: (D) looking upstream; (E) looking downstream; and (F) looking across.

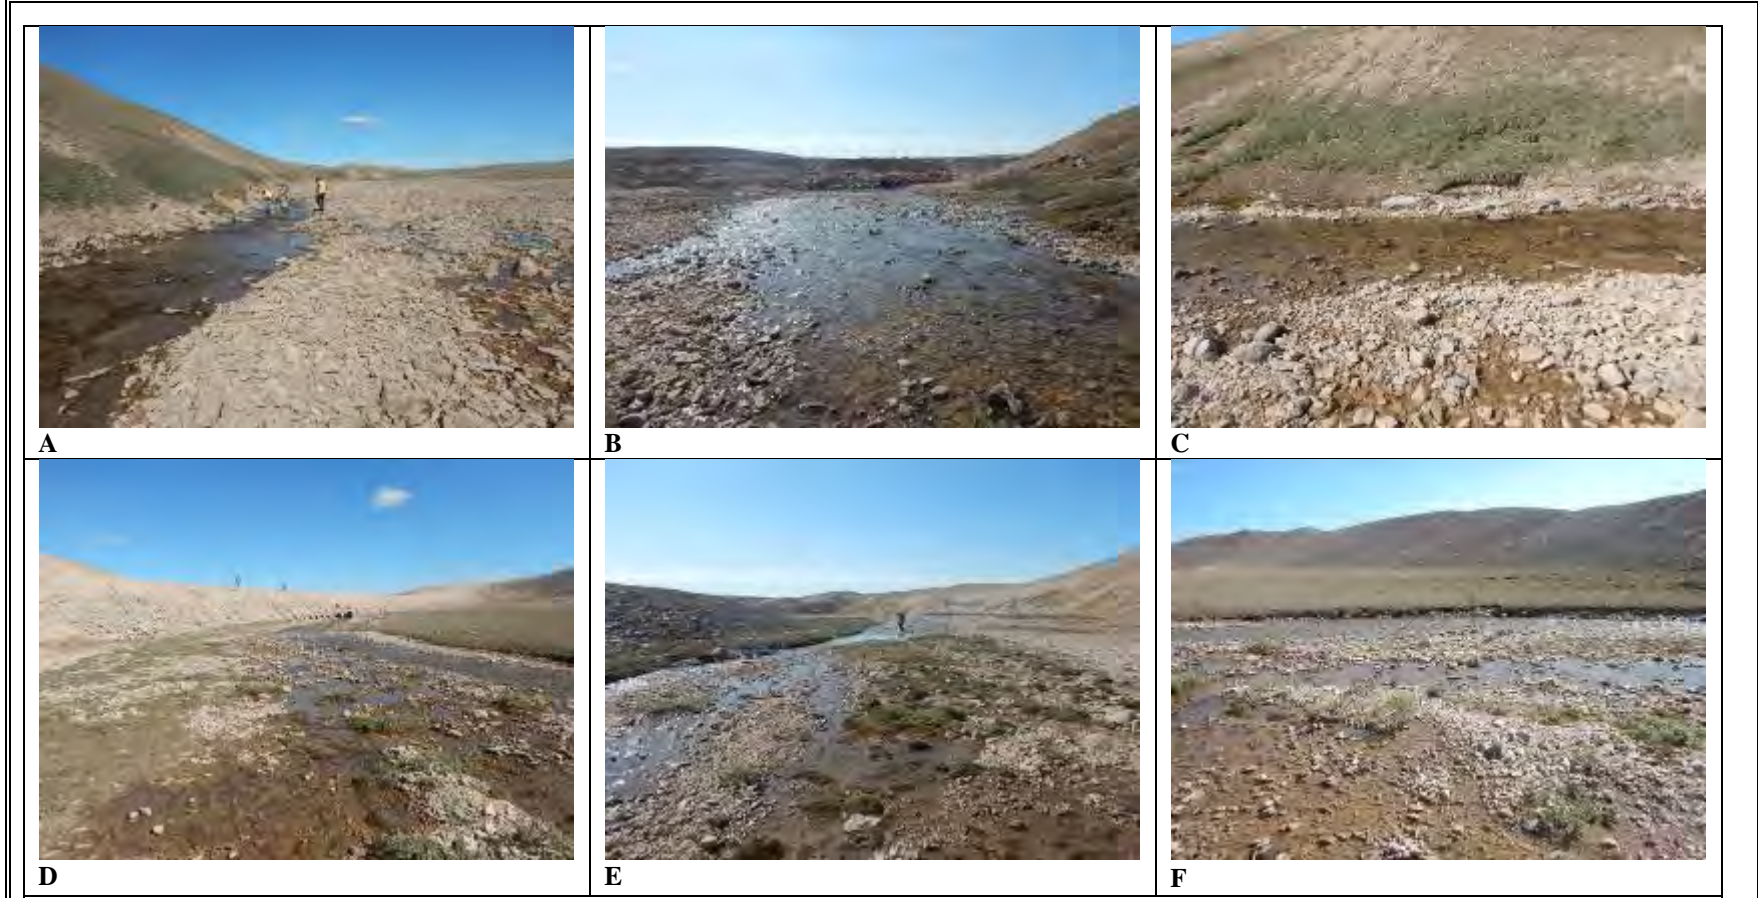
**Tote Road Site CV-049**

**Summary:** Site provides abundant summer rearing habitat for juvenile Arctic Char. There were no fish passage issues identified in spring 2019.

**Photos 1.** Photographs upstream of the Tote Road crossing CV-049: (A) looking upstream; (B) looking downstream; (C) looking across; and photographs downstream of the Tote Road: (D) looking upstream; (E) looking downstream; and (F) looking across.

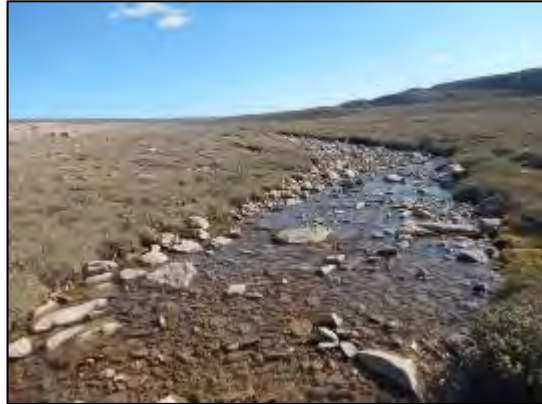
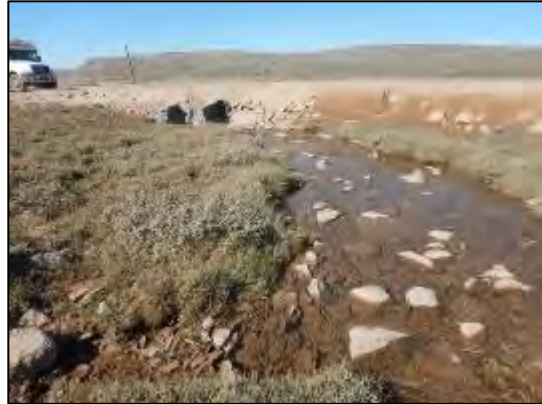
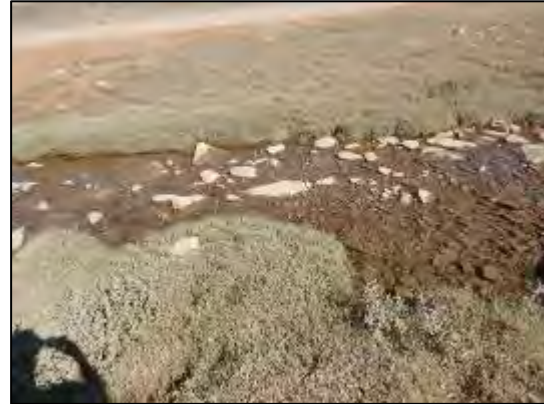
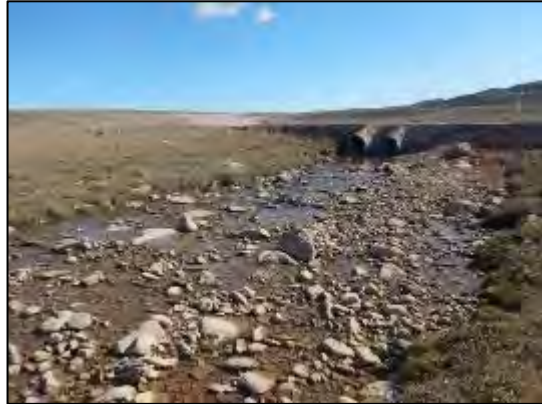
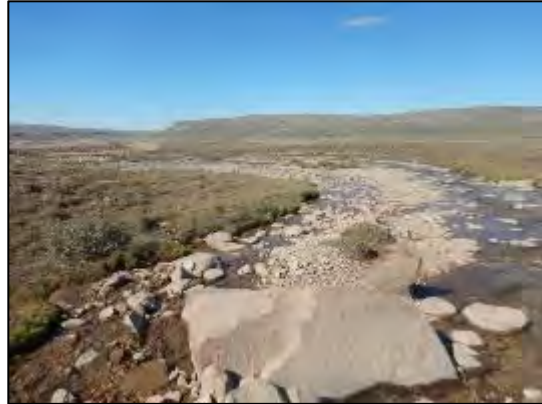
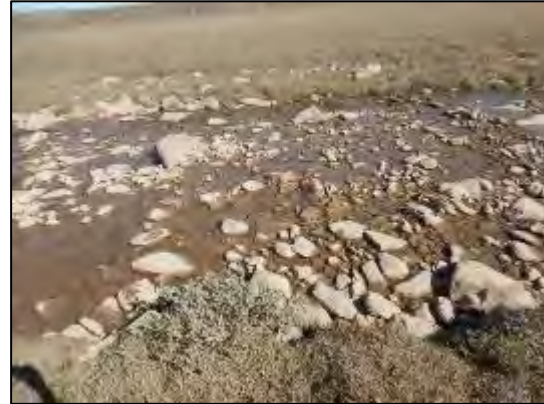
**Summary:** Stream provides aquatic habitat at the Tote Road crossing, but a persistent natural downstream subsurface flow barrier near its confluence with CV-049 prevents access from downstream overwintering lakes.

**Photos 1.** Photographs upstream of the Tote Road crossing CV-048: (A) looking upstream; (B) looking downstream; (C) looking across; and photographs downstream of the Tote Road: (D) looking upstream; (E) looking downstream; and (F) looking across.

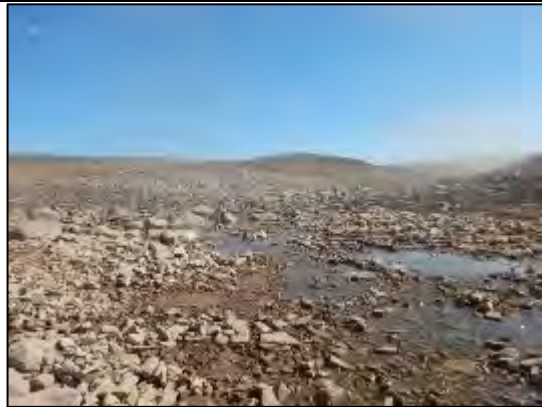
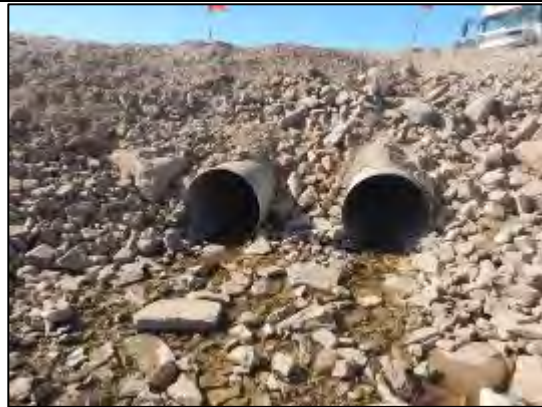
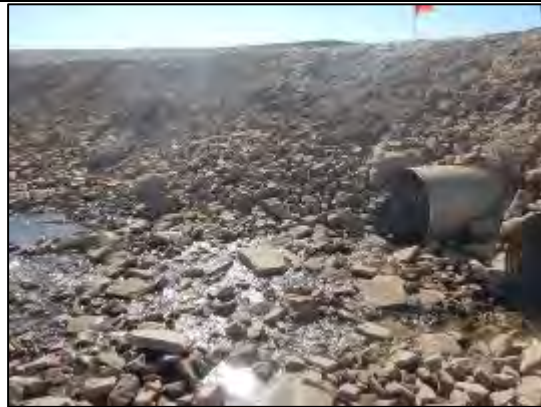
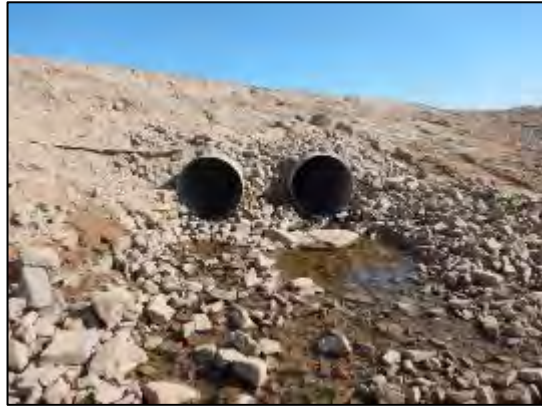
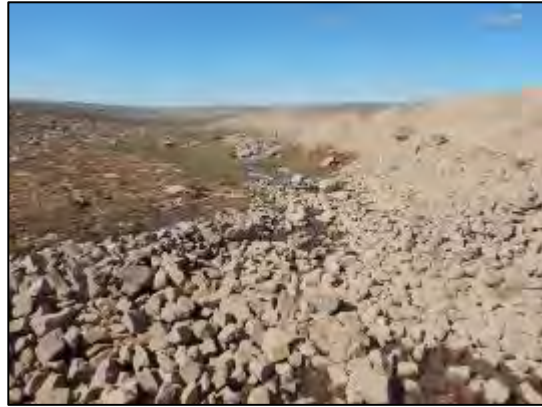
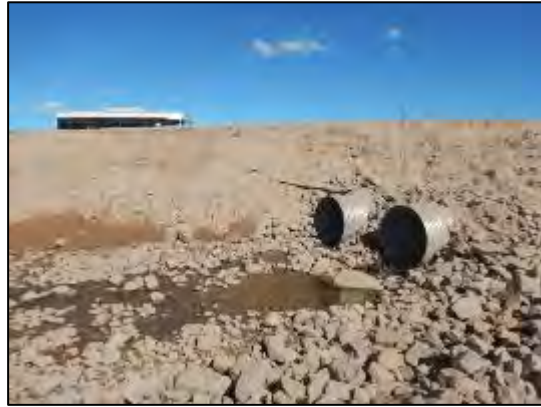
**Summary:** Stream provides aquatic habitat at the Tote Road crossing, but a persistent natural downstream subsurface flow barrier near its confluence with CV-049 prevents access from downstream overwintering lakes.

**Photos 1.** Photographs upstream of the Tote Road crossing CV-046: (A) looking upstream; (B) looking downstream; (C) looking across; and photographs downstream of the Tote Road: (D) looking upstream; (E) looking downstream; and (F) looking across.

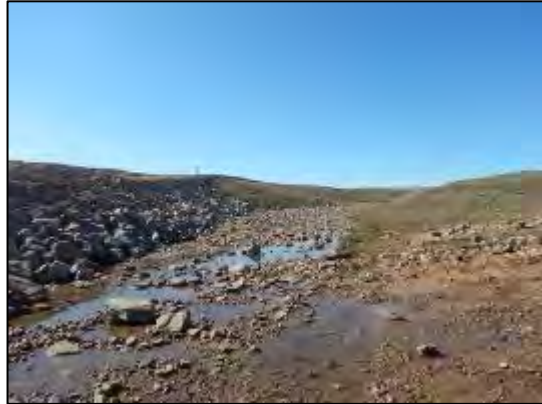
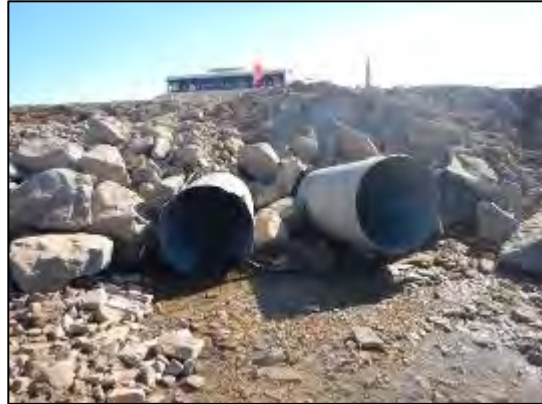
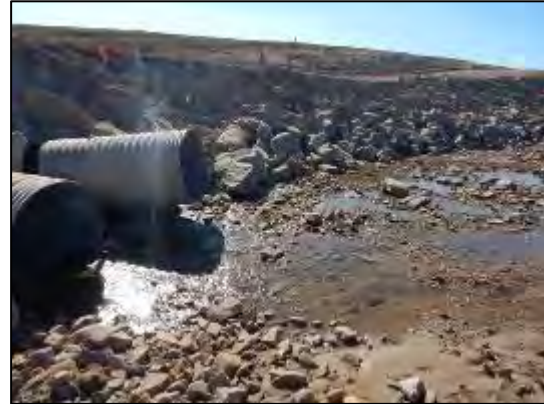
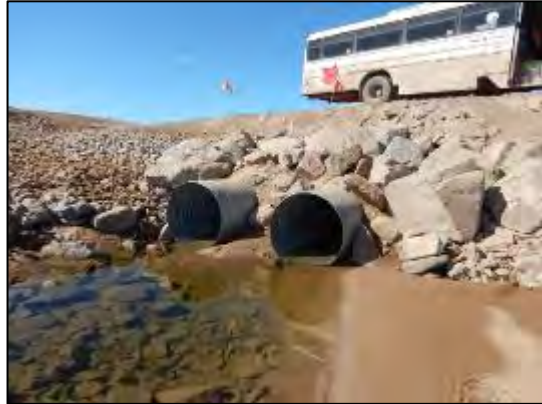
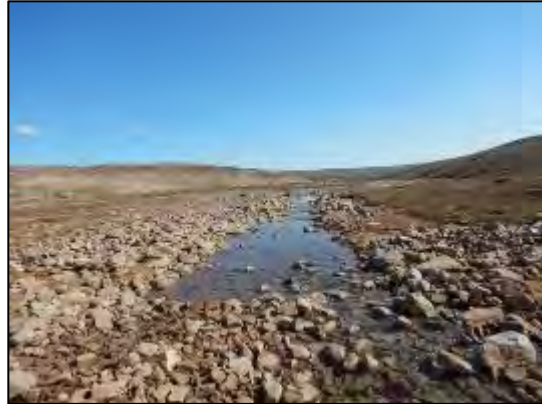
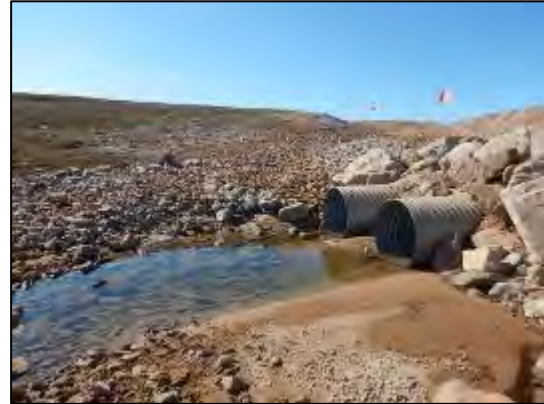
**Summary:** There is consistent surface flow at the crossing, but natural annual subsurface flows several hundred meters downstream, combined with large distance to overwintering habitat prevent fish access to the crossing.

**Photos 1.** Photographs upstream of the Tote Road crossing CV-040: (A) looking upstream; (B) looking downstream; (C) looking across; and photographs downstream of the Tote Road: (D) looking upstream; (E) looking downstream; and (F) looking across.

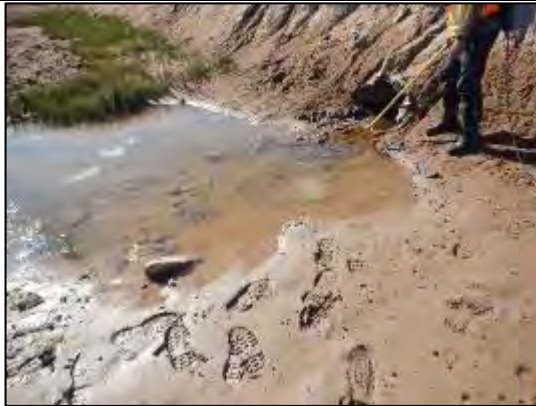
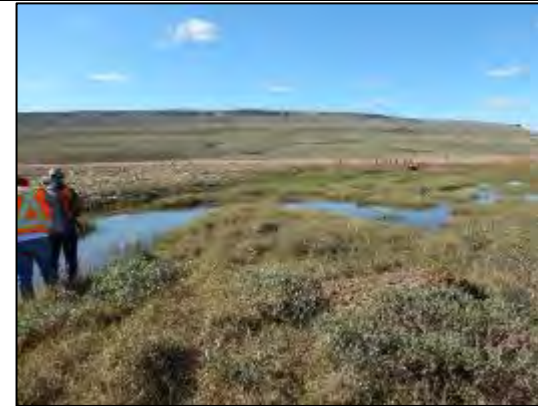
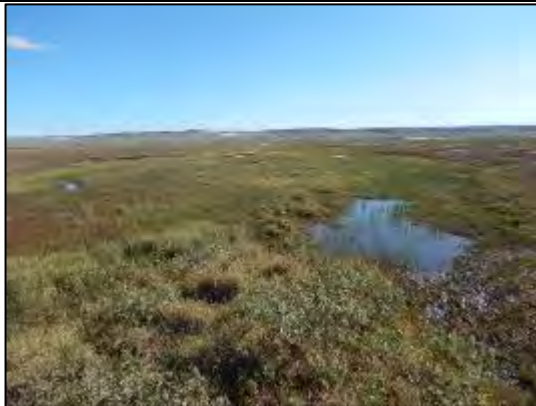
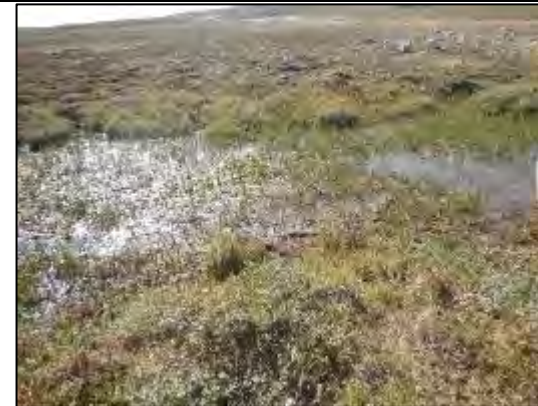
**Summary:** Arctic Char use of this stream is minimal due to consistently low water levels and lack of a clearly defined channel, but Ninespine Stickleback are typically abundant. There were no fish passage issues identified in spring 2019.

**Photos 1.** Photographs downstream of the Tote Road crossing CV-030: (A) showing the culvert; (B) looking upstream; (C) looking downstream; and (D) looking across.

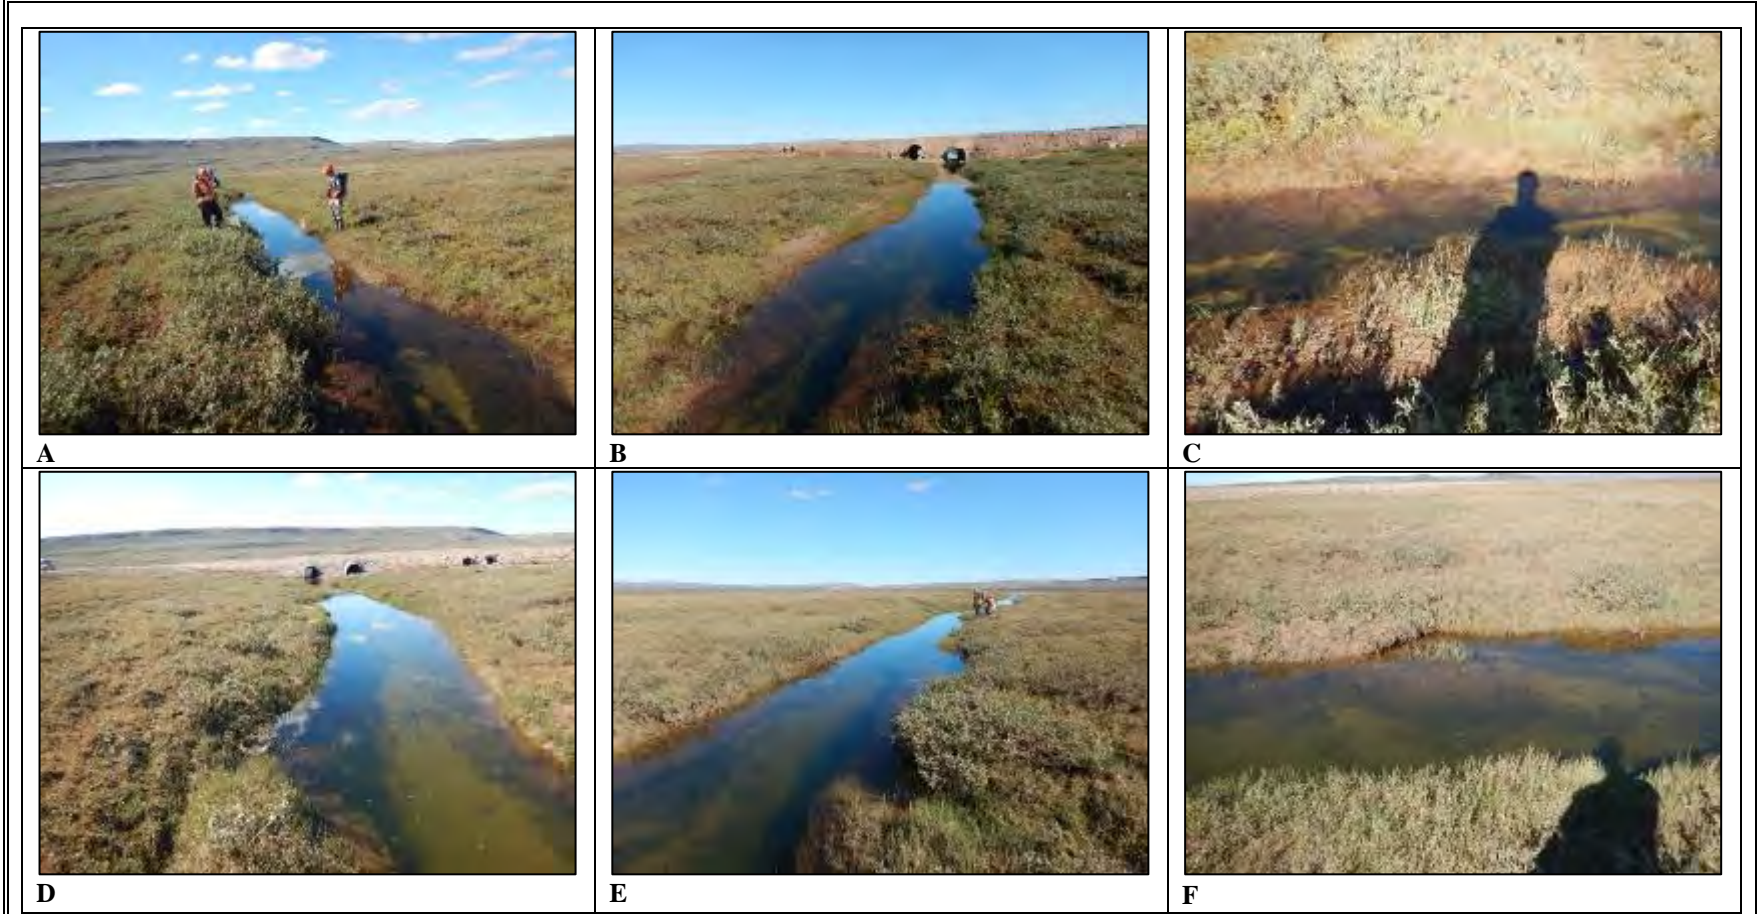
**Summary:** Consistently provides abundant, good quality rearing habitat for both species. There were no fish passage issues identified in spring 2019.

**Photos 1.** Photographs upstream of the Tote Road crossing BG-32 (A) looking upstream; (B) looking downstream; (C) looking across; and photographs downstream of the Tote Road: (D) looking upstream; (E) looking downstream; and (F) looking across.
