**BAFFINLAND IRON MINES CORPORATION  
MARY RIVER PROJECT**

**FISH HABITAT MONITORING  
2019 ANNUAL REPORT  
EARLY REVENUE PHASE - TOTE ROAD UPGRADES**

2019-12-31	0

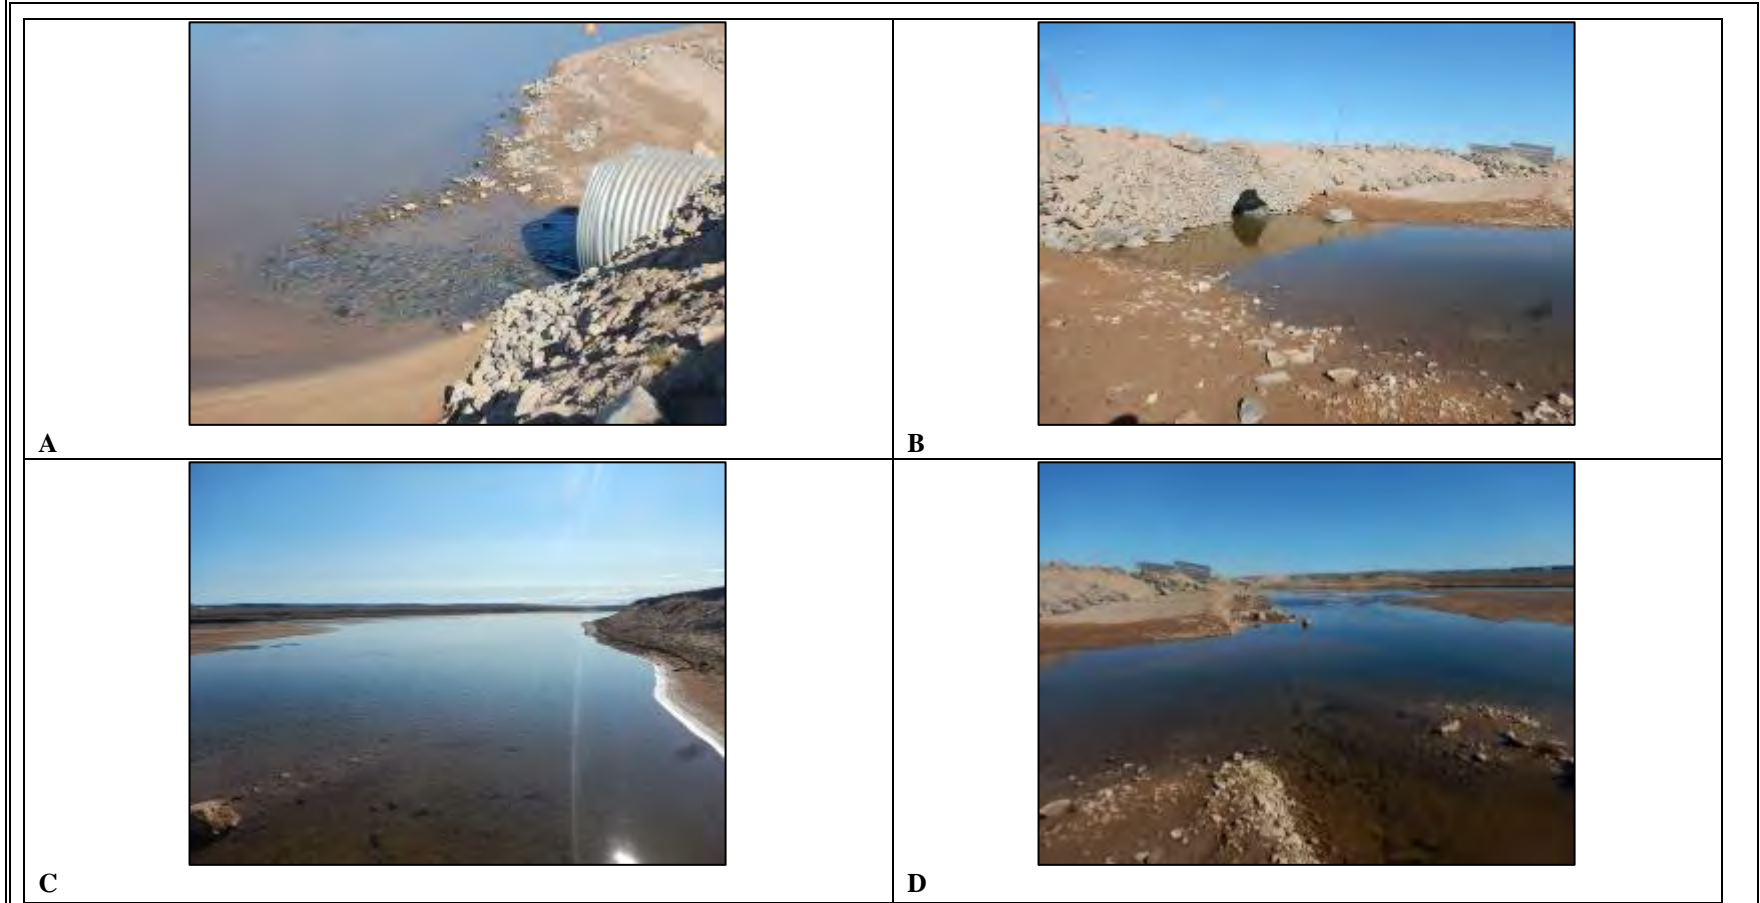
**Summary:** A bridge and culvert crossing with abundant habitat for both species. No fish passage issues were identified for either the bridge or culvert crossings in spring 2019.

**Photos 1.** Photograph upstream of the Tote Road crossing CV-217: (A) showing the culvert; and photographs downstream of the Tote Road: (B) looking upstream; (C) looking downstream; and (D) looking across.

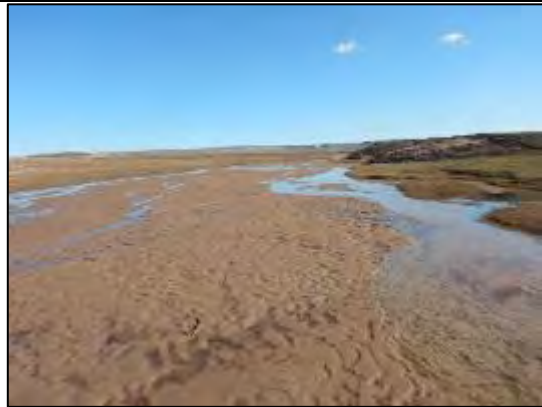
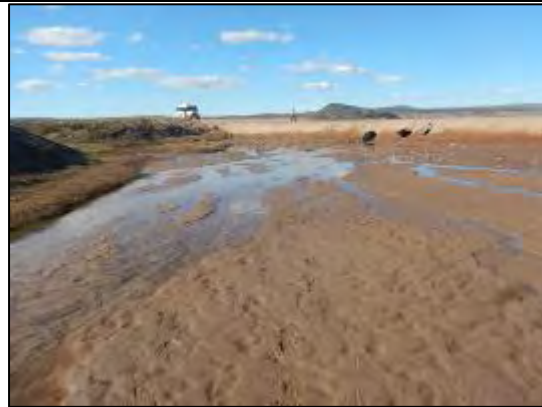
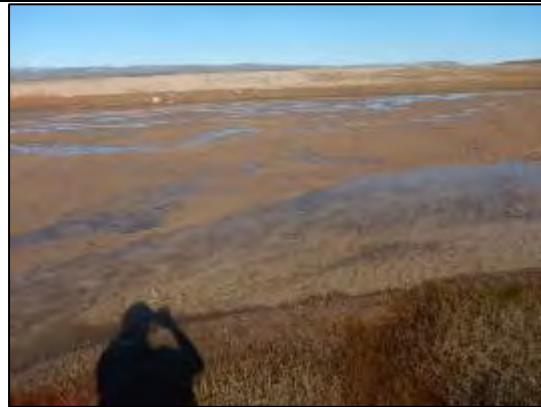
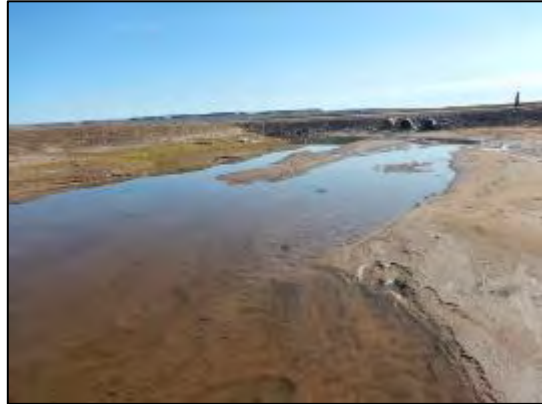
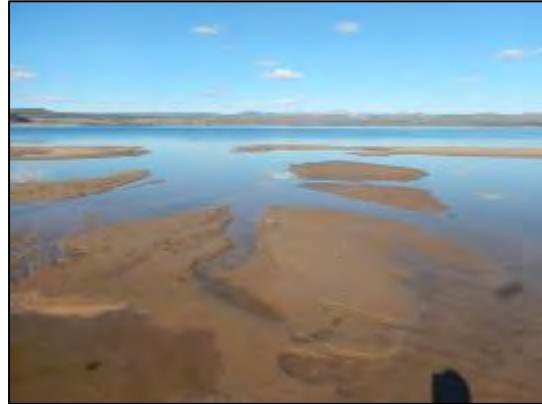
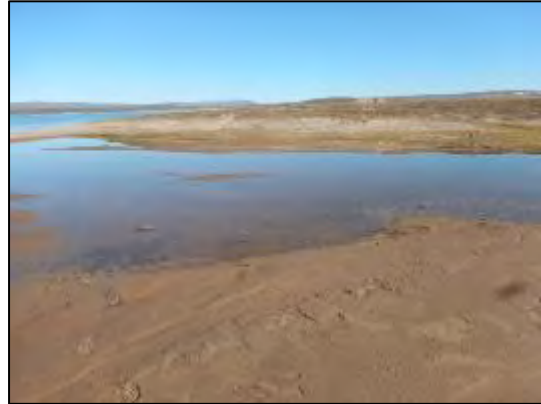
**Summary:** A small stream that provides habitat for Ninespine Stickleback and small juvenile Arctic Char (especially young-of-the-year from Muriel Lake). A slight perch was remediated in 2019.

**Photos 1.** Photographs upstream of the Tote Road crossing CV-216: (A) looking upstream; (B) looking downstream; (C) looking across; and photographs downstream of the Tote Road: (D) looking upstream; (E) looking downstream; and (F) looking across.

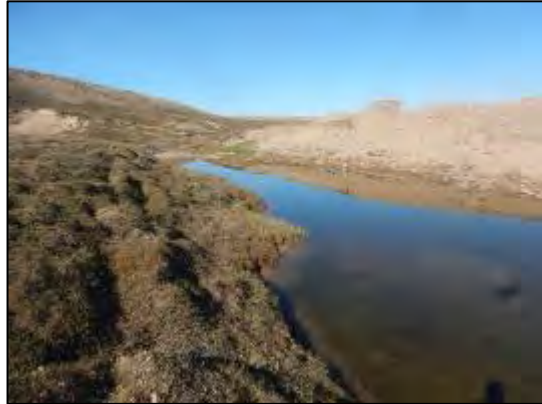
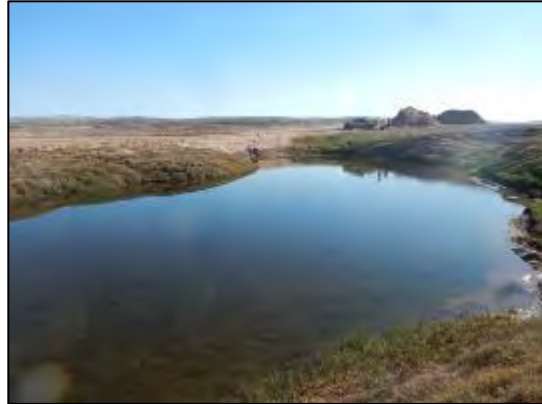
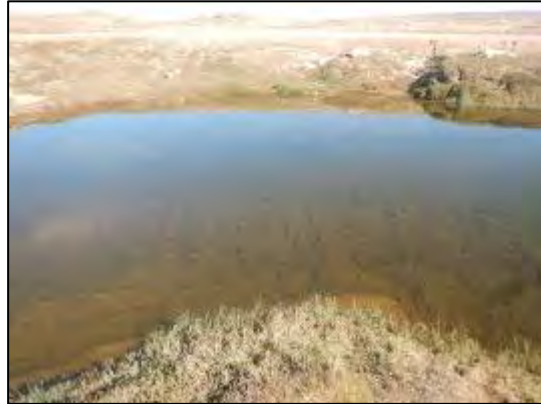
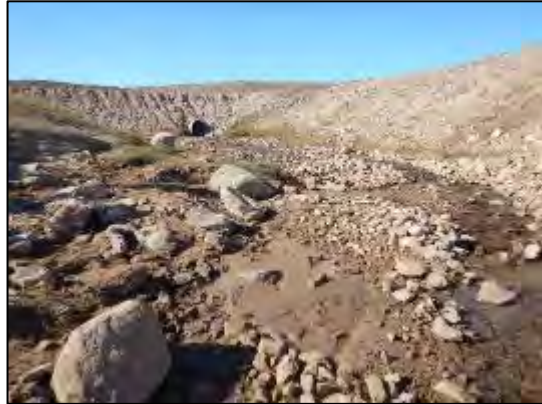
**Summary:** Stream provides abundant rearing habitat, particularly upstream of the road in a large pond. Access to the upstream pond was created with a rocky ramp as part of the Tote Road Compensation Plan. There were no fish passage issues identified in spring 2019.

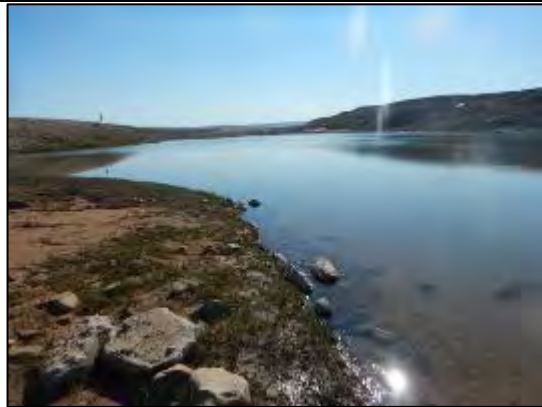
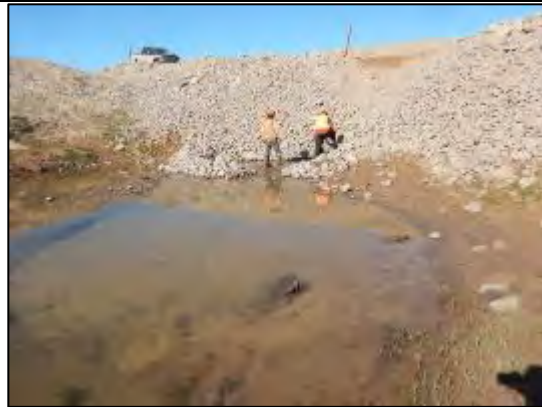
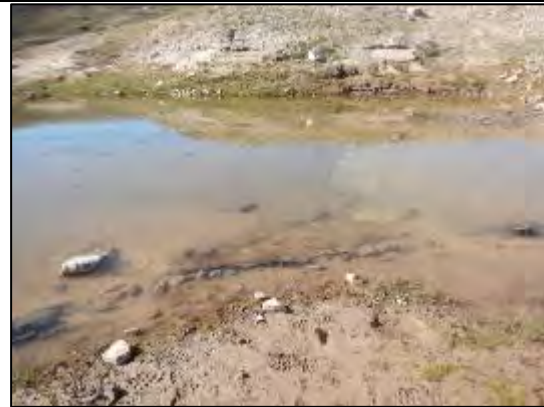
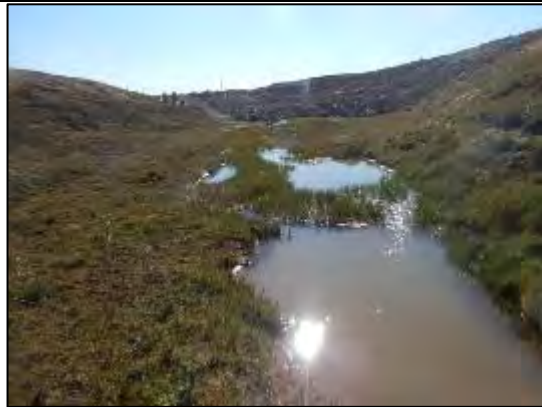
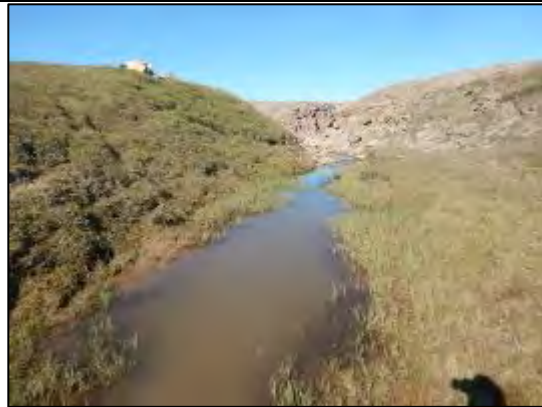
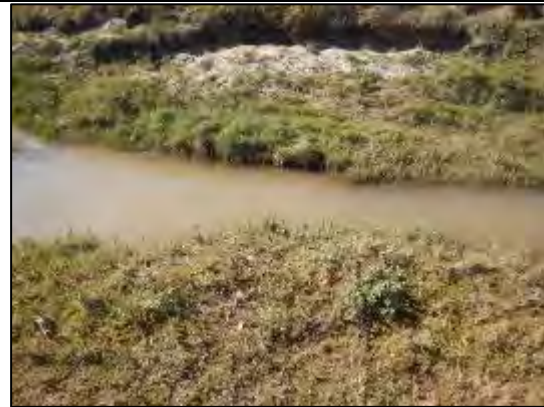
**Summary:** Stream provides abundant summer rearing habitat for both species. Road aggregate partially blocked the upstream end of the culvert in spring 2019. Blockage was removed and full access restored in fall 2019.

**Photos 1.** Photographs upstream of the Tote Road crossing BG-29: (A) looking upstream; (B) looking downstream; (C) looking across; and photographs downstream of the Tote Road: (D) looking upstream; (E) looking downstream; and (F) looking across.

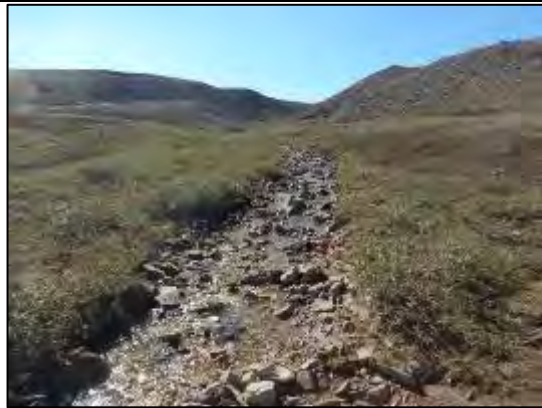
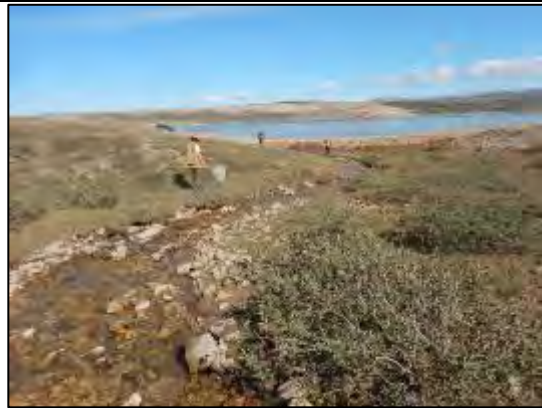
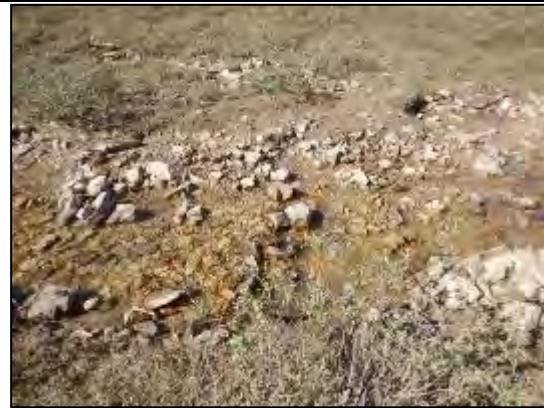
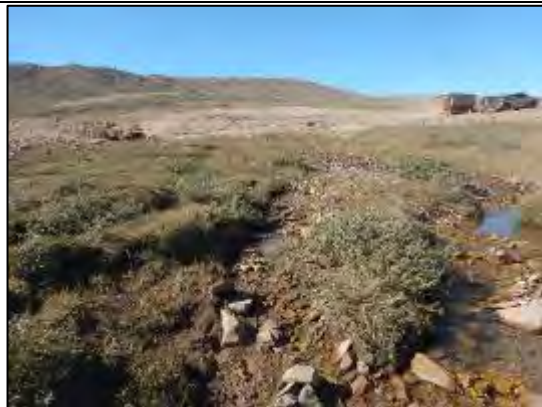
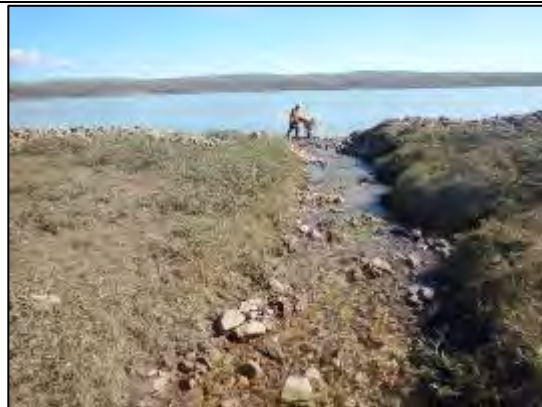
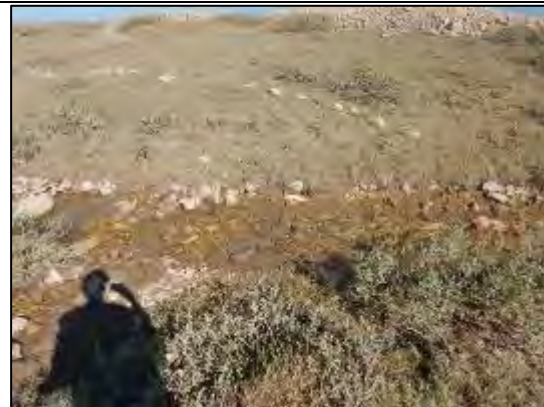
**Summary:** Site provides summer rearing habitat for juvenile Arctic Char. There were no fish passage issues identified in spring 2019.

**Photos 1.** Photographs upstream of the Tote Road crossing BG-27: (A) looking upstream; (B) looking downstream; (C) looking across; and photographs downstream of the Tote Road: (D) looking upstream; (E) looking downstream; and (F) looking across.

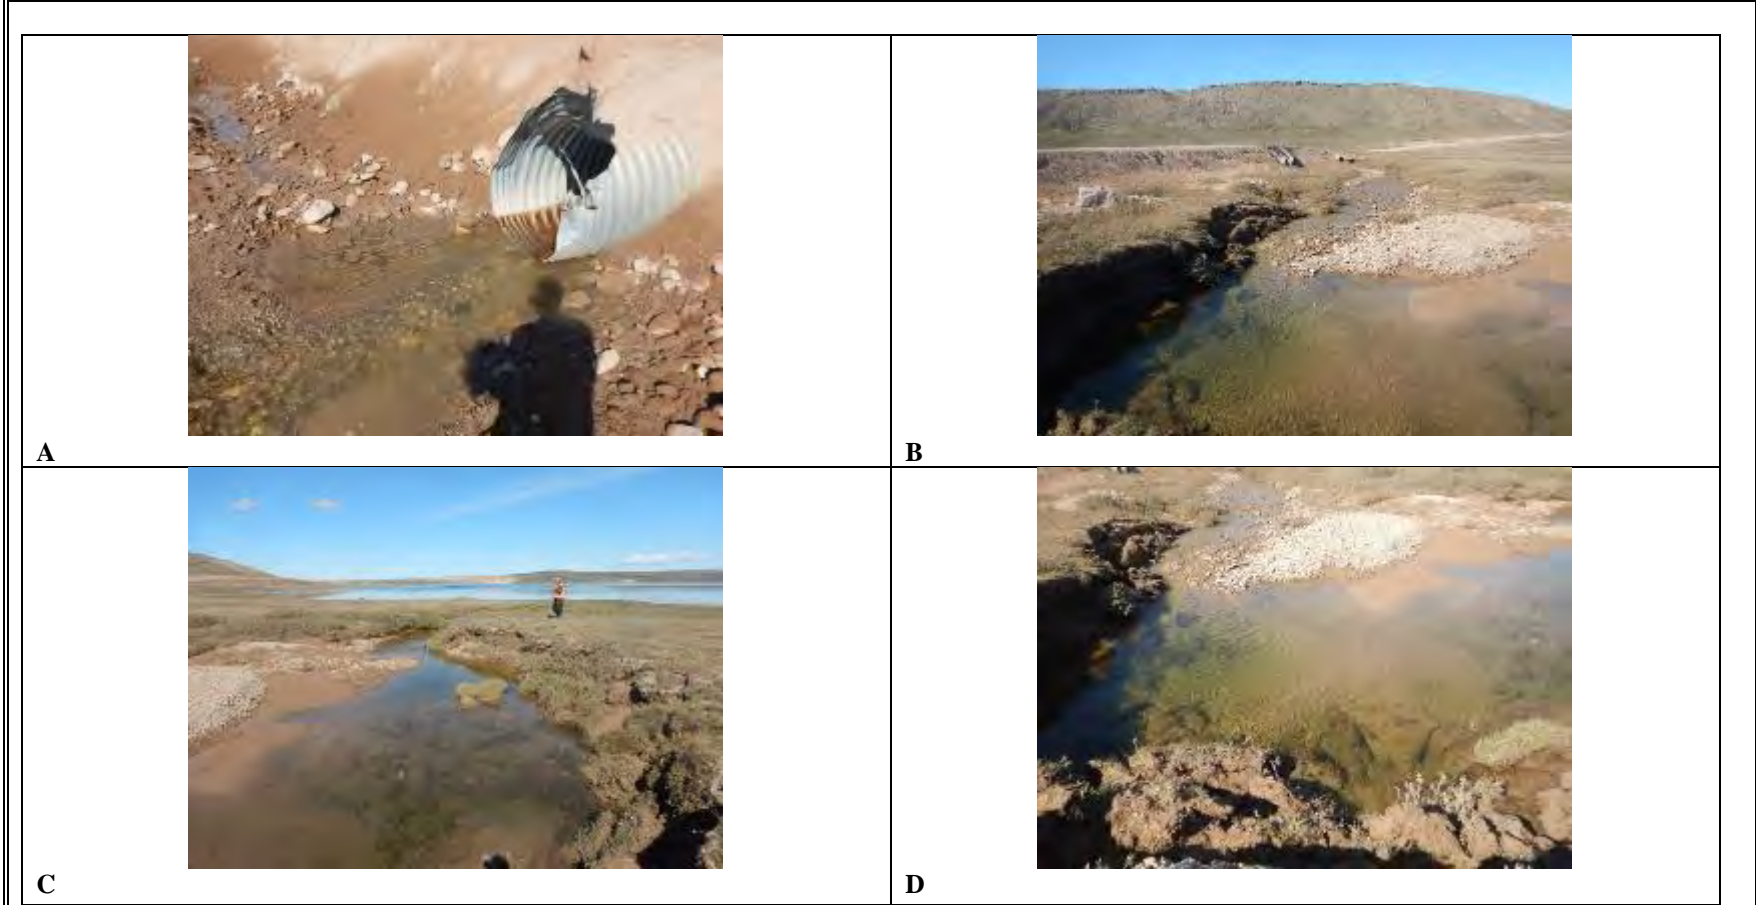
**Summary:** Site provides summer rearing habitat for juvenile Arctic Char. There were no fish passage issues identified in spring 2019.

**Photos 1.** Photographs upstream of the Tote Road crossing BG-24: (A) showing the culvert; and photographs downstream of the Tote Road: (B) looking upstream; (C) looking downstream; and (D) looking across.

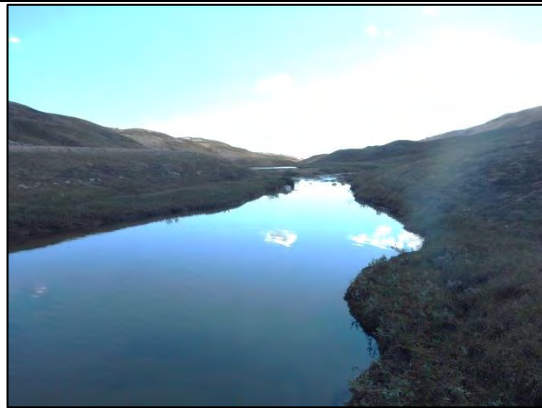
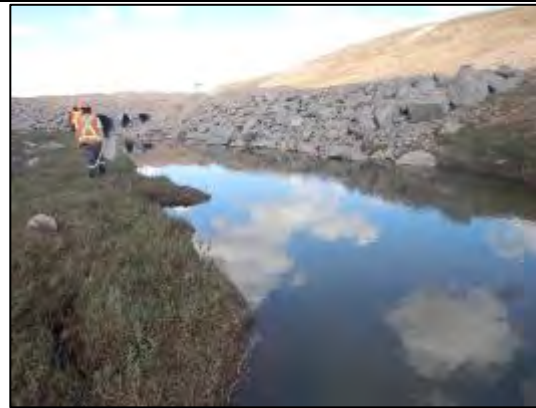
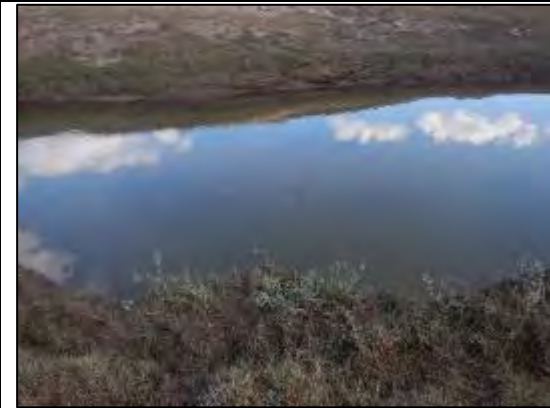
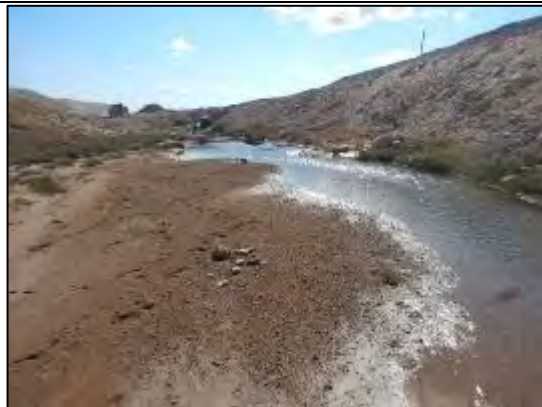
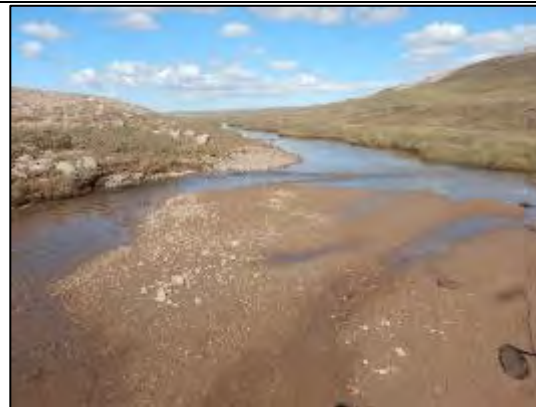
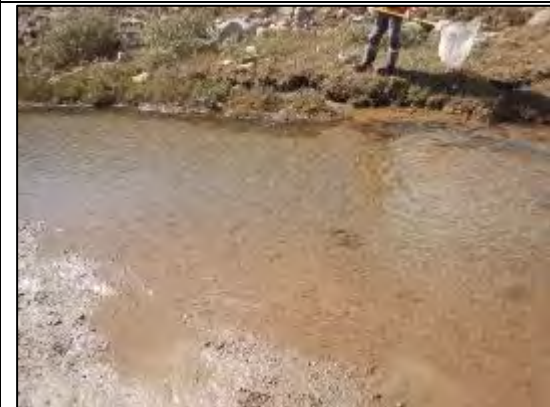
**Summary:** Site provides summer rearing habitat for both species. There were no fish passage issues identified in spring 2019.

**Photos 1.** Photographs upstream of the Tote Road crossing BG-17: (A) looking upstream; (B) looking downstream; (C) looking across; and photographs downstream of the Tote Road: (D) looking upstream; (E) looking downstream; and (F) looking across.

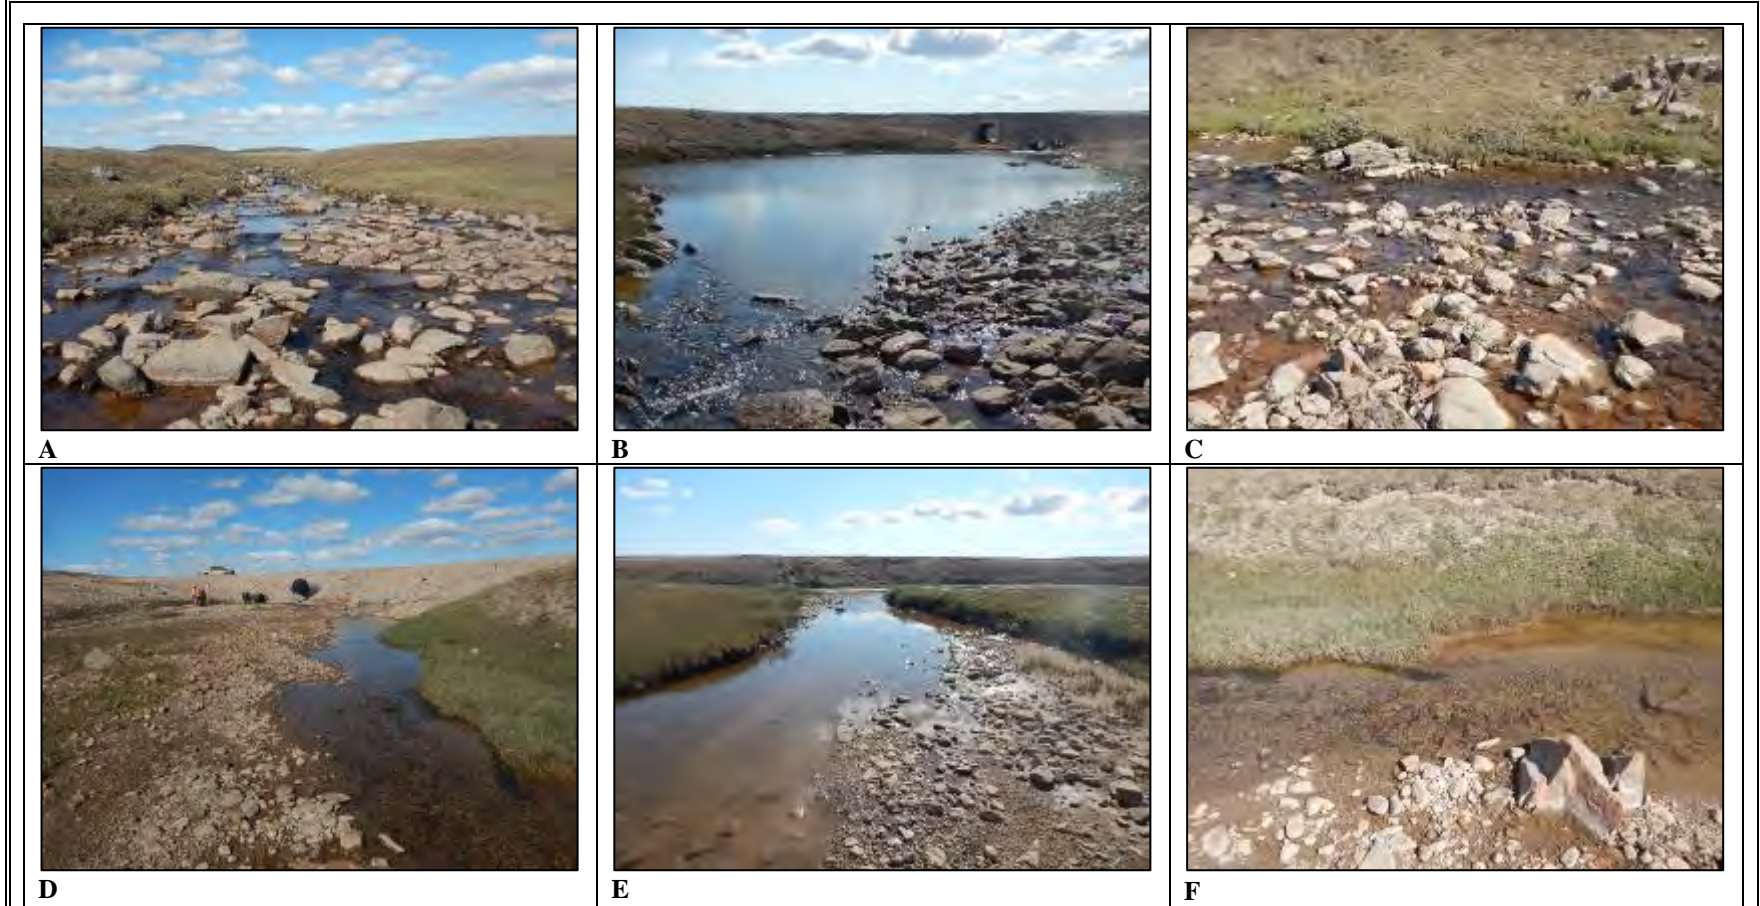
**Summary:** Site provides summer rearing habitat for both species. There were no fish passage issues identified in spring 2019.

**Photos 1.** Photographs upstream of the Tote Road crossing BG-04: (A) looking upstream; (B) looking downstream; (C) looking across; and photographs downstream of the Tote Road: (D) looking upstream; (E) looking downstream; and (F) looking across.

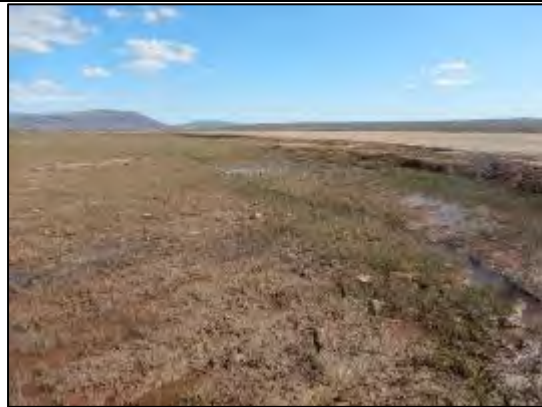
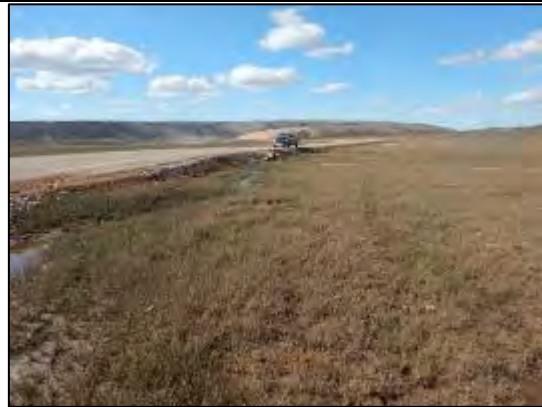
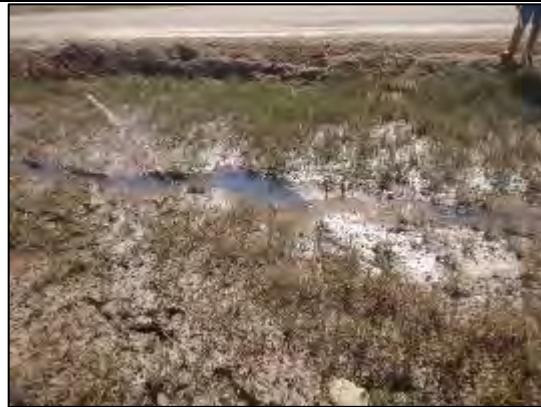
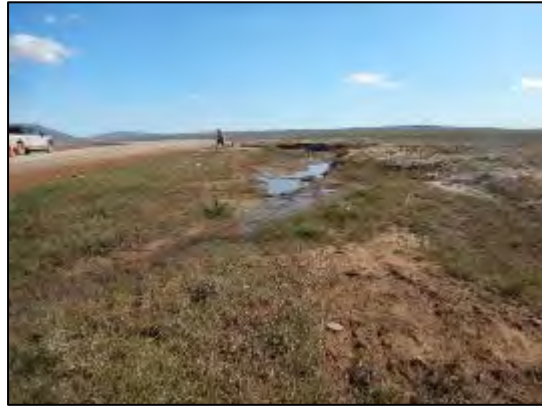
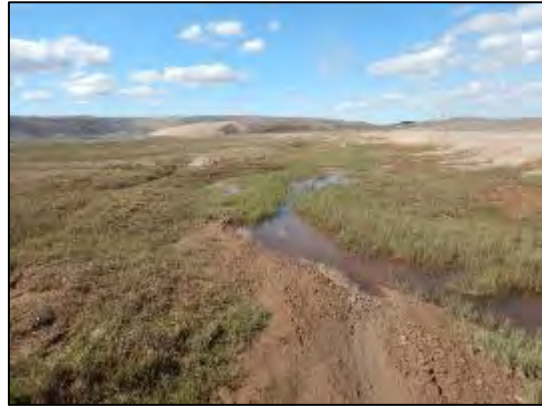
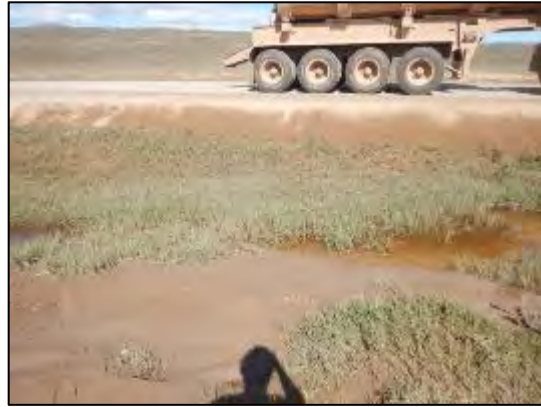
**Summary:** Fish were not present in spring 2019 due to naturally low water levels; however, this stream has typically provided summer rearing habitat for both species when surveyed. There were no fish passage issues identified in spring 2019.

**Photos 1.** Photographs upstream of the Tote Road crossing CV-001: (A) looking upstream; (B) looking downstream; (C) looking across; and photographs downstream of the Tote Road: (D) looking upstream; (E) looking downstream; and (F) looking across.

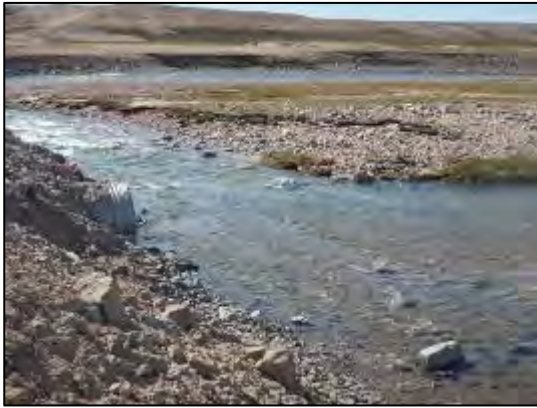
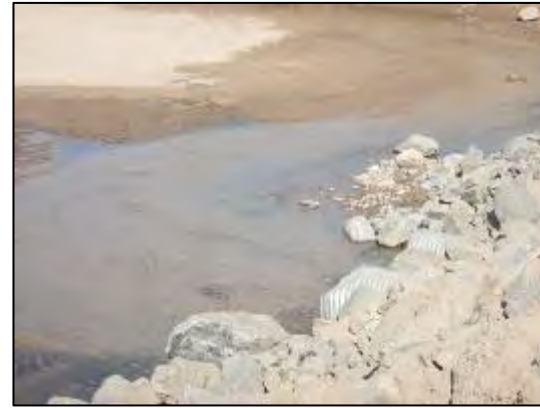
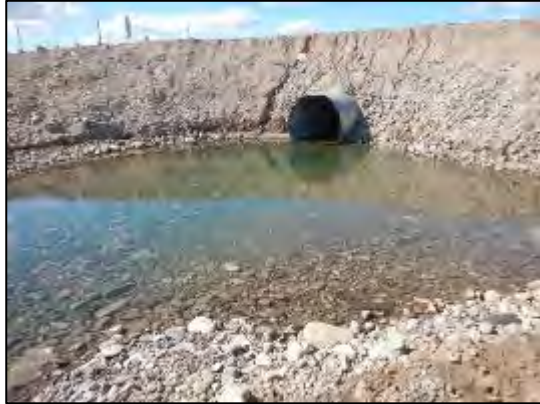
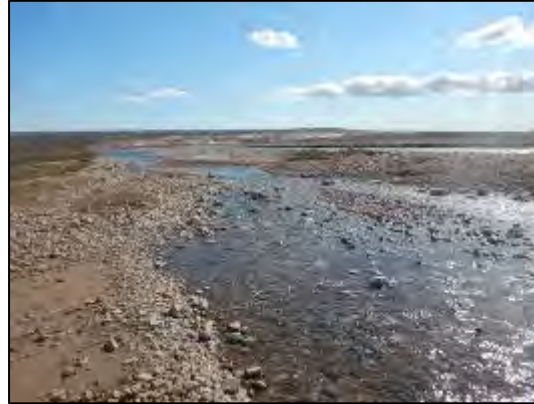
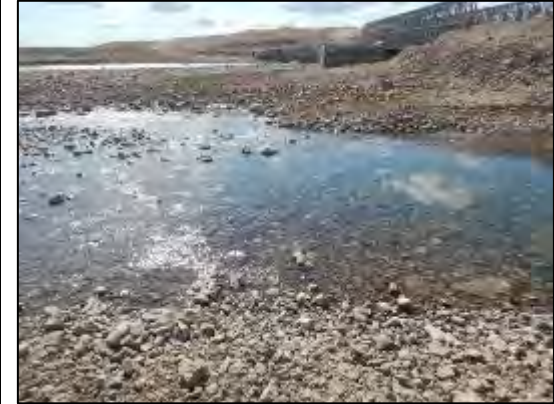
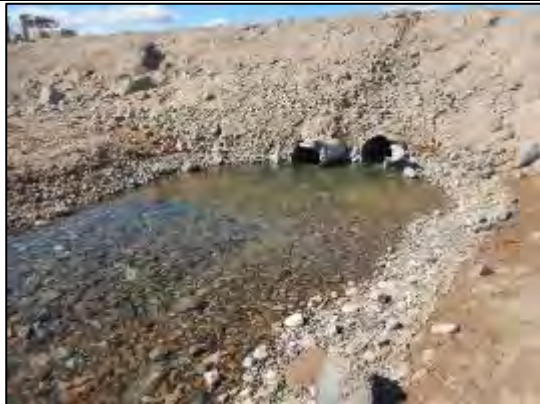
**Tote Road Site CV-223 (continued)**

**Summary:** This large river (Tom River) includes both bridge and culvert crossings. All channels provide abundant summer rearing habitat for Arctic Char. There were no fish passage issues identified in spring 2019.

**Photos 1.** Photographs upstream of the Tote Road crossing CV-223: left channel downstream of the Tote Road crossing CV-223: (C) looking upstream; (D) looking downstream; (E) looking across; and photographs of right channel downstream of the Tote Road: (F) looking upstream; (G) looking downstream; and (H) looking across.

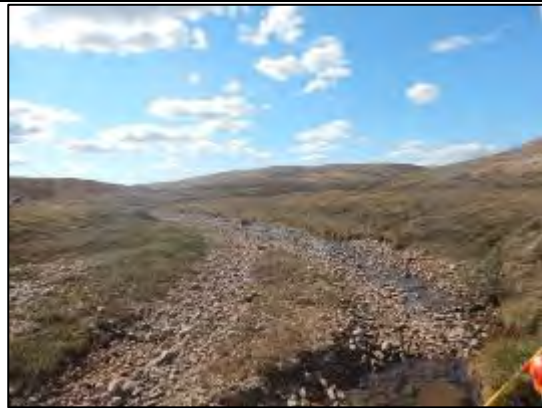
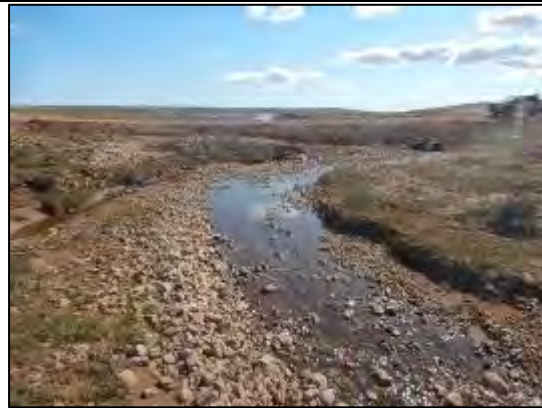
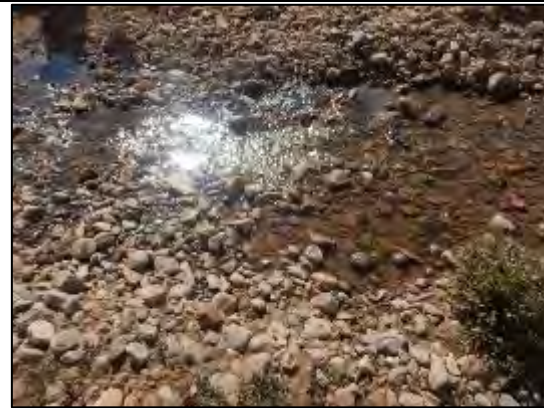
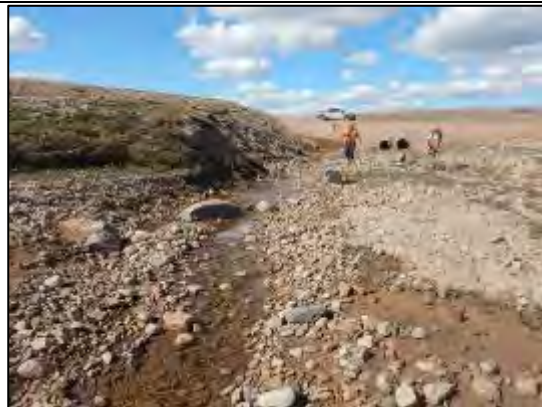
**Summary:** Site provides summer rearing habitat for both species. There were no fish passage issues identified in spring 2019.

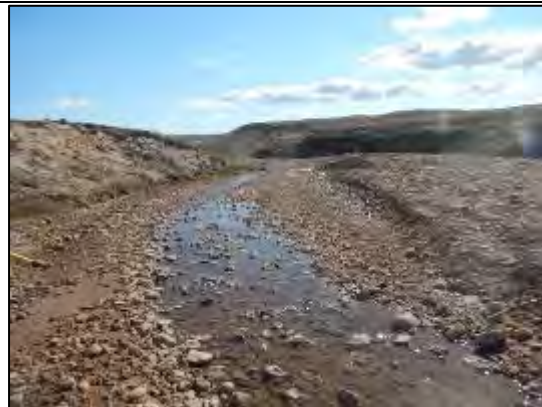
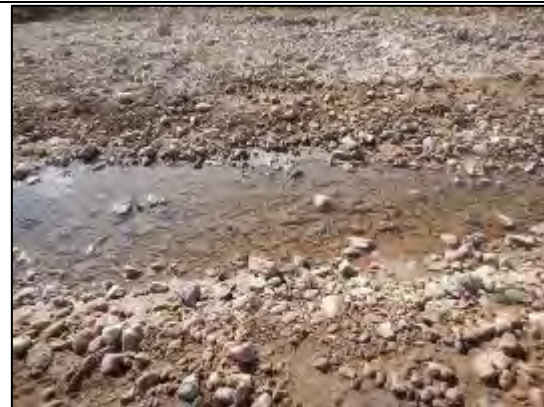
**Photos 1.** Photographs upstream of the Tote Road crossing CV-224: (A) looking upstream; (B) looking downstream; (C) looking across; and photographs downstream of the Tote Road: (D) looking upstream; (E) looking downstream; and (F) looking across.

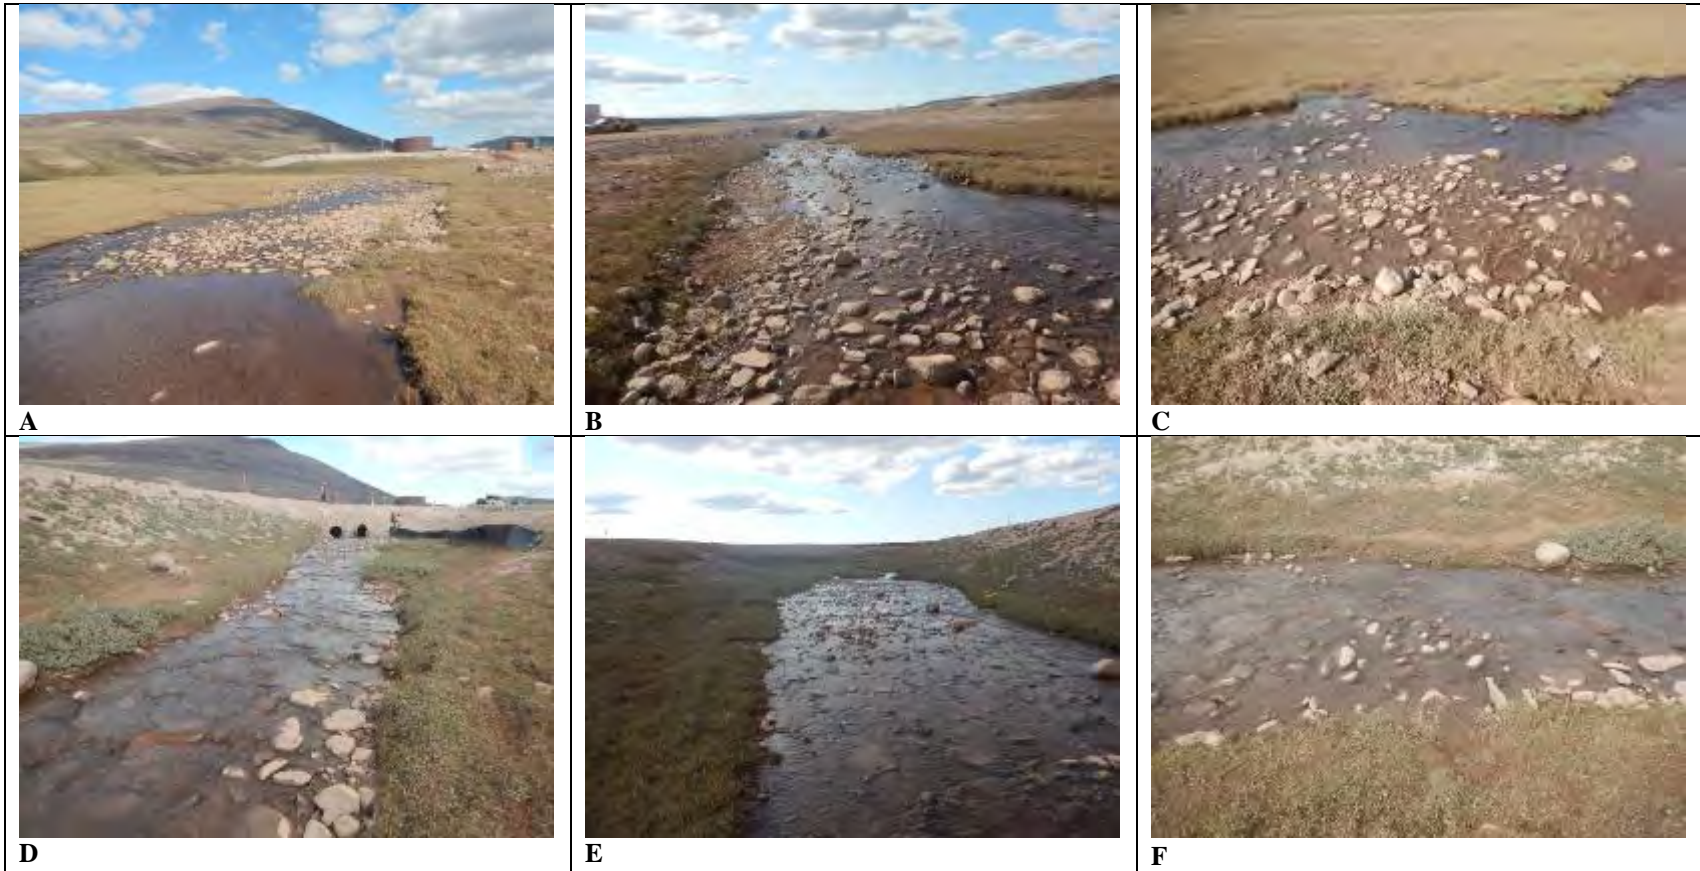
**Summary:** Site provides summer rearing habitat for both species. There were no fish passage issues identified in spring 2019.

**Photos 1.** Photographs upstream of the Tote Road crossing CV-186: (A) looking upstream; (B) looking downstream; (C) looking across; and photographs downstream of the Tote Road: (D) looking upstream; (E) looking downstream; and (F) looking across.

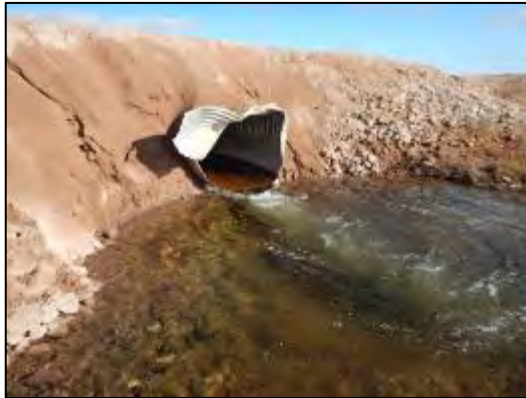
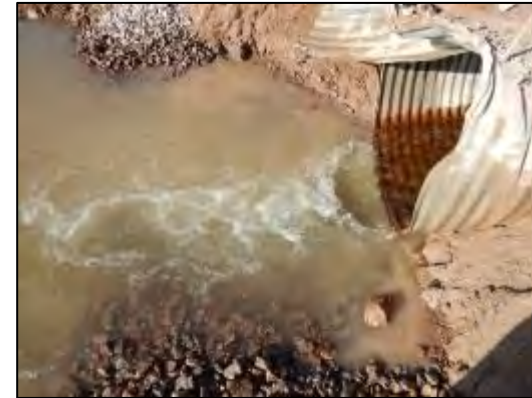
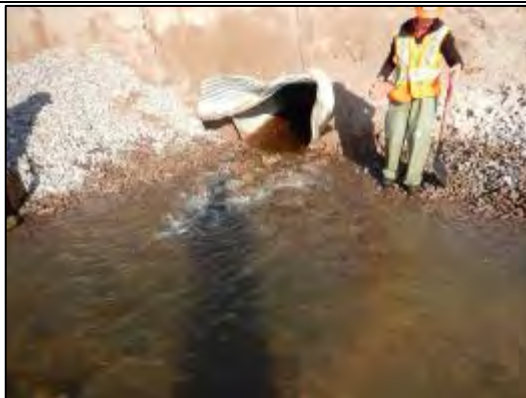
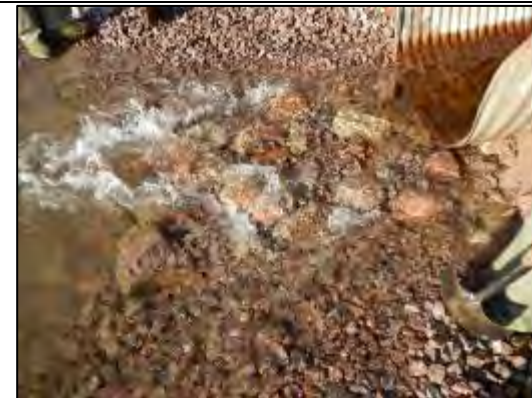
## 2019 Tote Road Stream Crossing Remediation – CV-129

**Photos 1:** Photographs of the downstream end of the perched culvert before remediation at CV-129: (A) showing of the slightly perched culvert; (B) showing the pool under the perched culvert; and photographs after remediation: (C) showing water flowing over constructed step-pool habitat; and D) showing a close-up of large rocks and cobble placed in the former pool to fill spaces, creating riffle habitat.

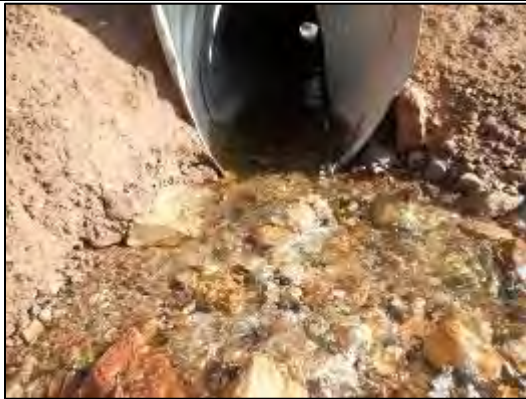
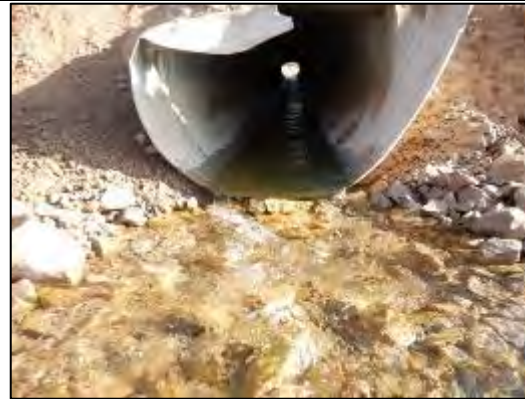
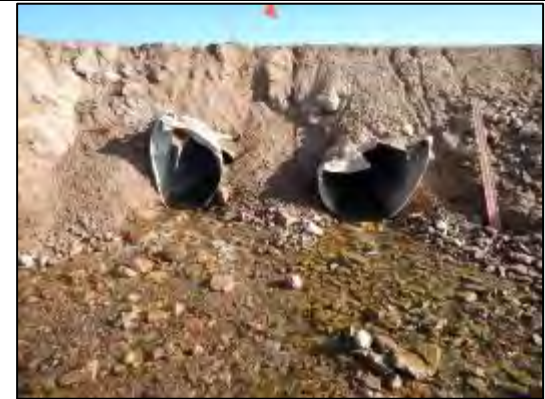
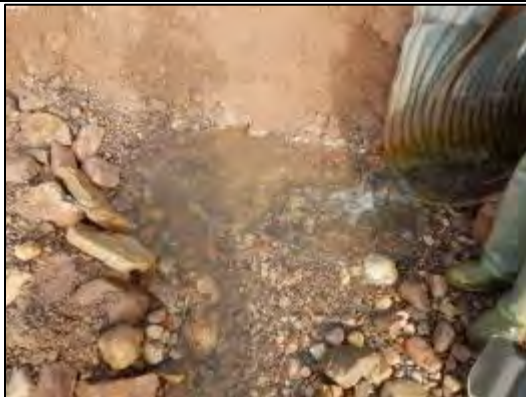
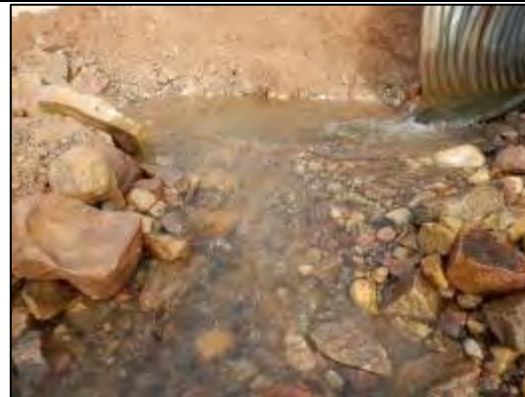
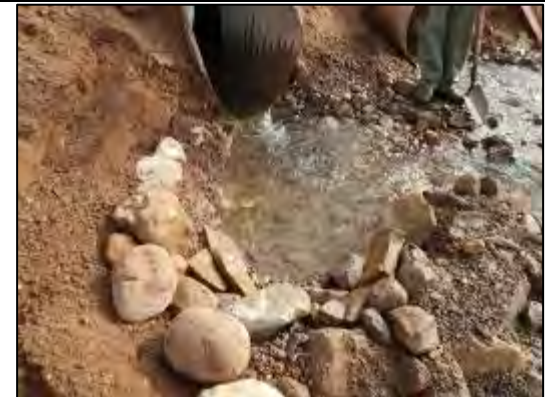
## 2019 Tote Road Stream Crossing Remediation – CV-114

**Photos 2:** Photographs of the downstream end the perched culvert before remediation at CV-114: (A) showing the slightly perched left culvert; (B) showing the slightly perched right culvert; (C) showing both perched culverts; and photographs after remediation (D) showing the first pool constructed by placing rocks in semi-ring formation to create a slight backwater effect; (E) showing riffle access to culvert pool; and (F) showing slightly increased water level at downstream end of the culverts with slight perch remaining.

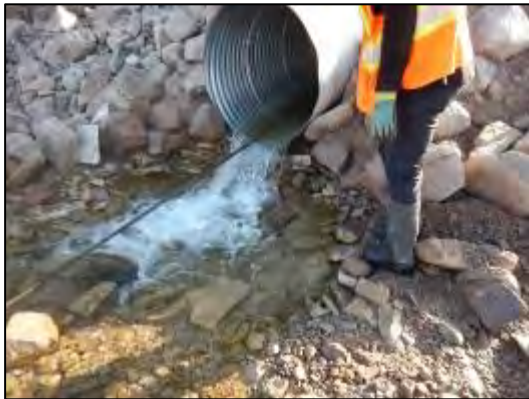
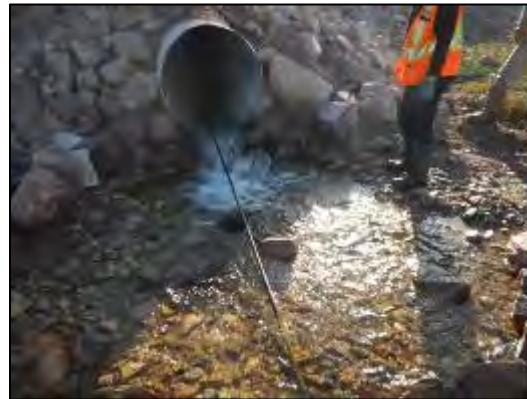
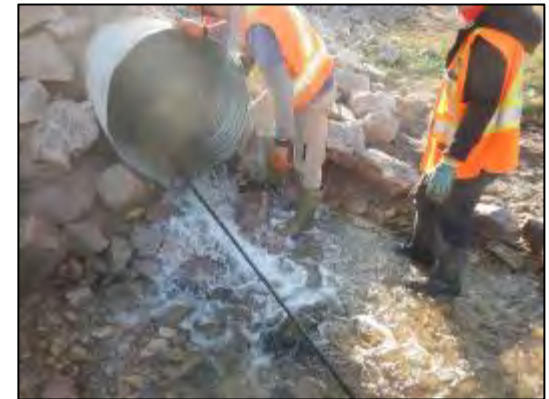
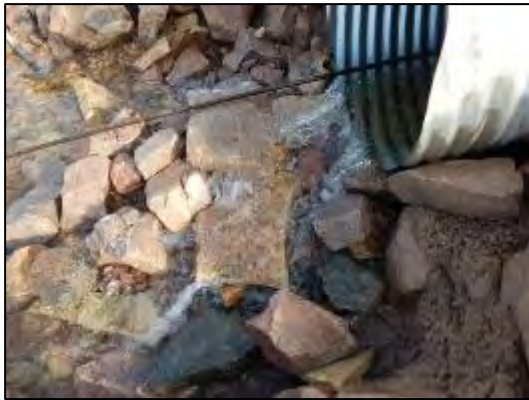
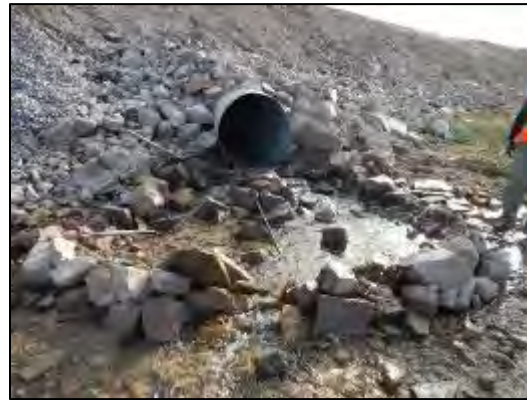
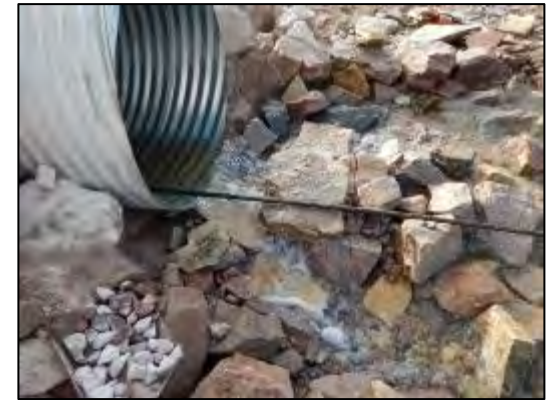
## 2019 Tote Road Stream Crossing Remediation – CV-111

**Photos 3:** Photographs of the downstream end the perched culvert before remediation at CV-111: (A) and (B) showing highly perched culvert; (C) showing the pool partway built and photographs after remediation (D) showing the pool and rock ramp constructed immediately below the culvert to create a backwater effect and lessen the perch; (E) showing the system of rock steps constructed to assist with accessibility; and (F) showing two constructed channels with a small perch remaining.

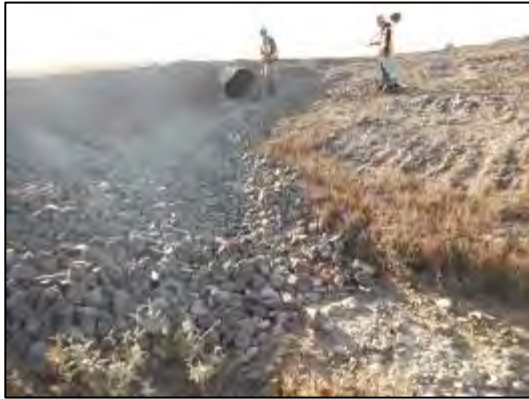
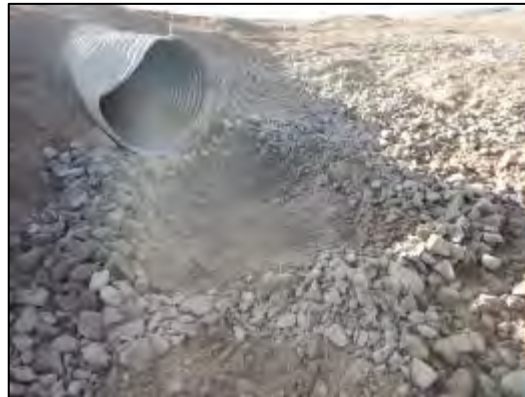
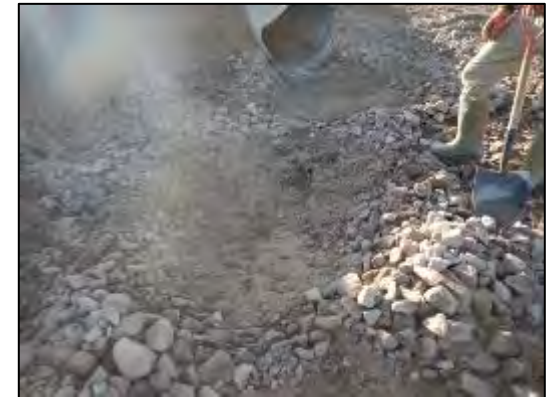
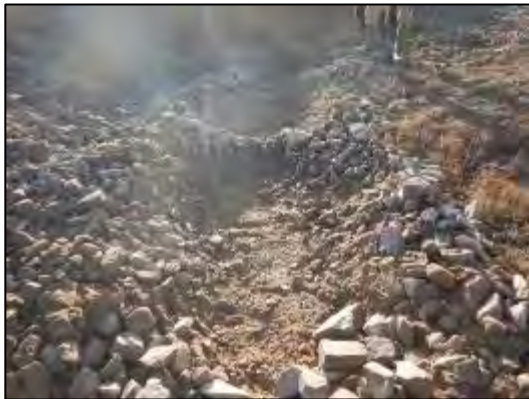
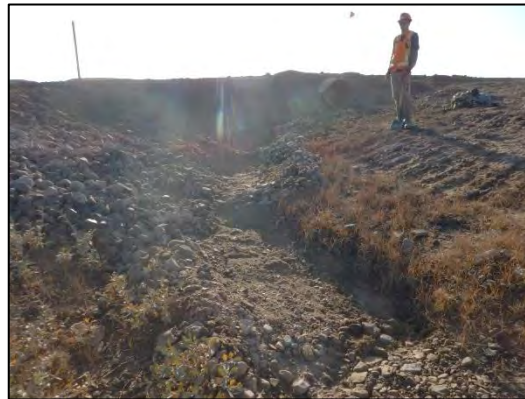
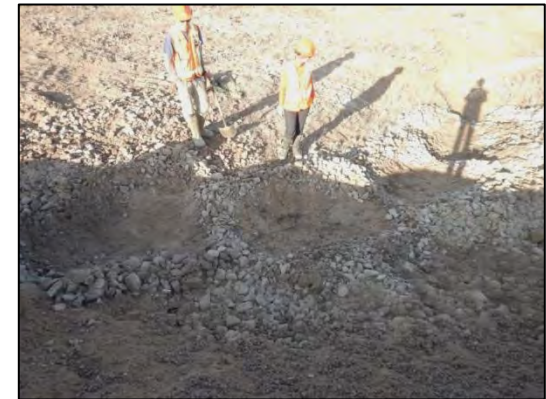
## 2019 Tote Road Stream Crossing Remediation – CV-106

**Photos 4:** Photographs of the downstream end the perched culvert before remediation at CV-106: (A) showing the dry channel with ineffective fish ramp that cannot maintain surface flow when water is present and photographs after remediation (B) Pool constructed immediately below the culvert at CV-106; (C-F) System of step-pools constructed below the culvert with cobble and gravel to help eliminate sub-flow problems.
