**BAFFINLAND IRON MINES CORPORATION  
MARY RIVER PROJECT**

**FISH HABITAT MONITORING  
2019 ANNUAL REPORT  
EARLY REVENUE PHASE - TOTE ROAD UPGRADES**

2019-12-31	0

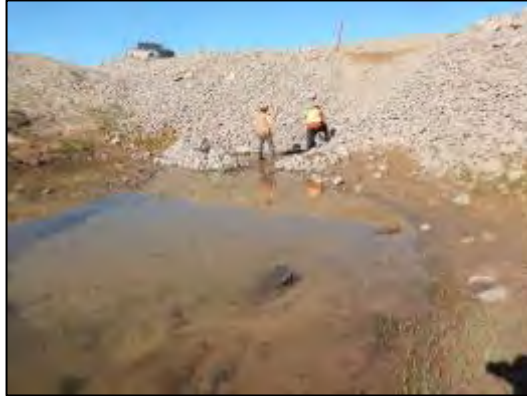
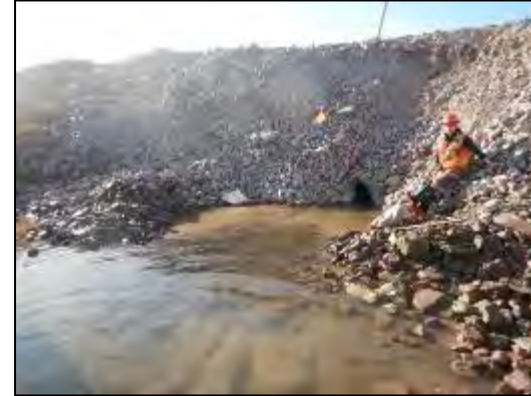
## 2019 Tote Road Stream Crossing Remediation – BG-29

**Photos 5:** Photographs of the upstream end of the perched culvert partway through remediation at BG-29: (A) showing the remaining berm blocking the culvert and photographs after remediation, and (B) showing the rocky material was removed to expose the culvert and improve fish access.

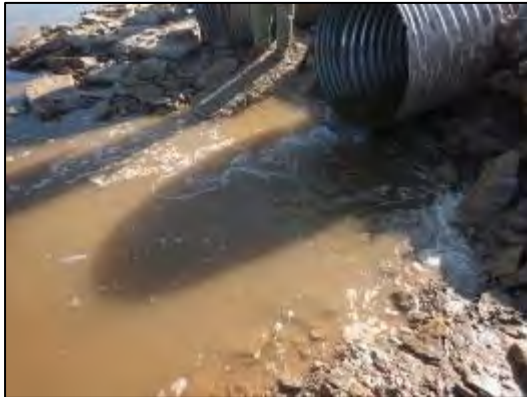
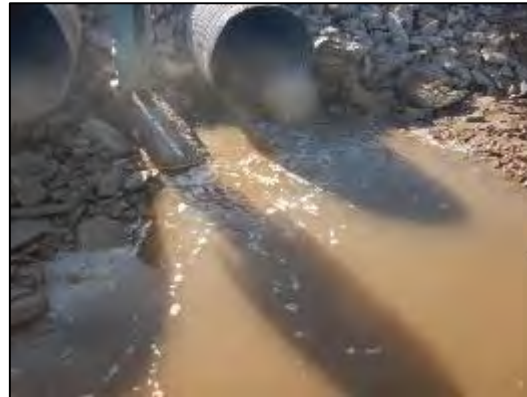
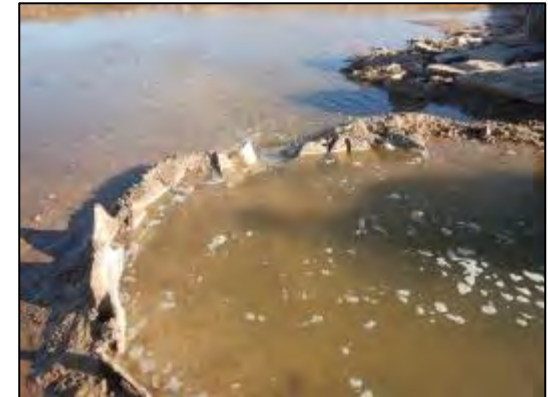
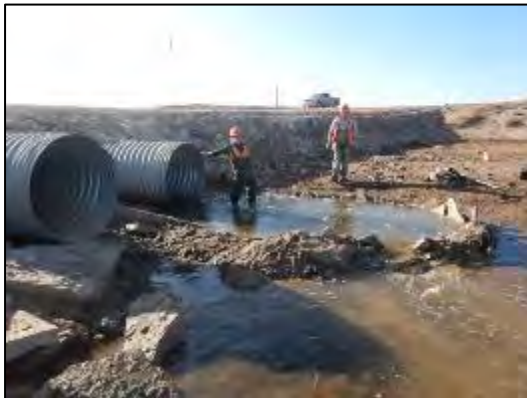
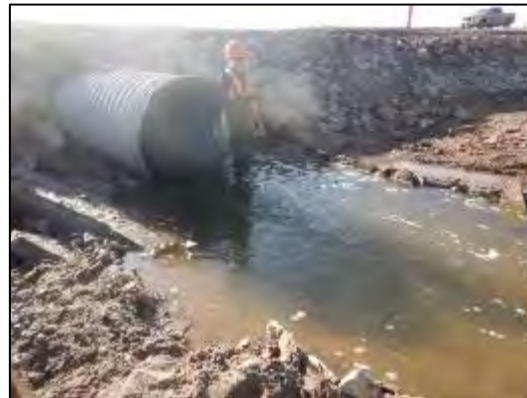
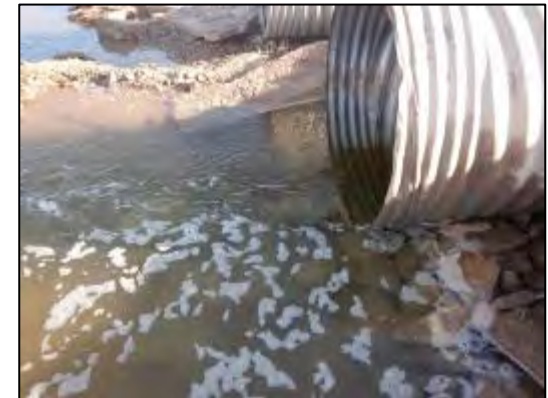
## 2019 Tote Road Stream Crossing Remediation – CV-216

**Photos 6:** Photographs of the downstream end the perched culvert before remediation at CV-216: (A) and (B) showing a slightly perched right culvert and dry perched left culvert; and photographs after remediation: (C) and (D) showing the boundary of the constructed pool around the right culvert, creating a backwater effect with passage through the center of the boundary; (E) showing the backwater effect created by the constructed boundary successfully removing the perch; and (F) showing rocky substrate added under the right culvert to fill empty space.

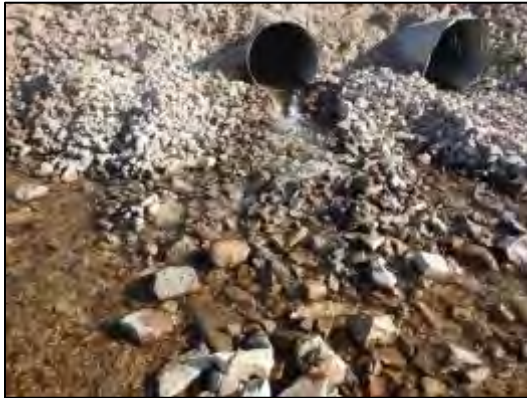
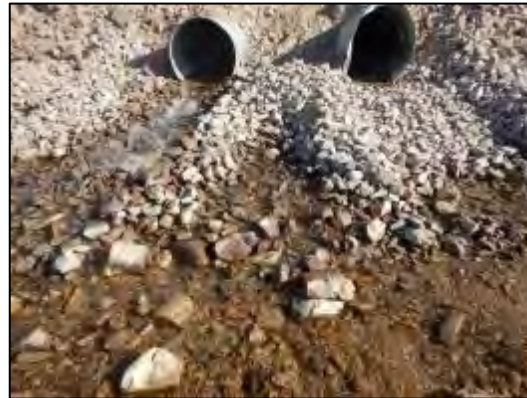
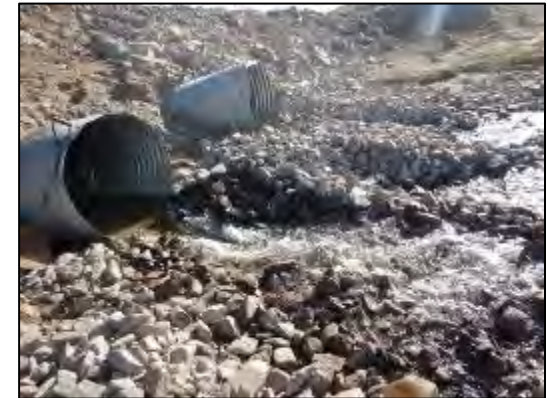
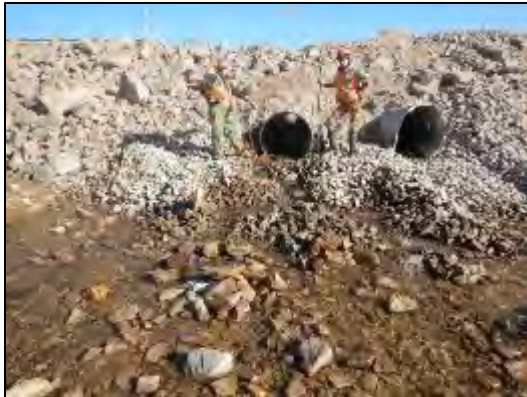
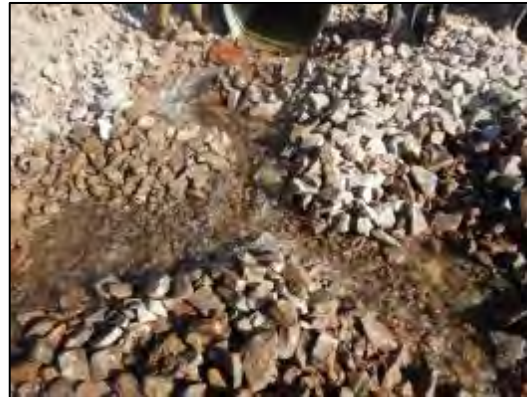
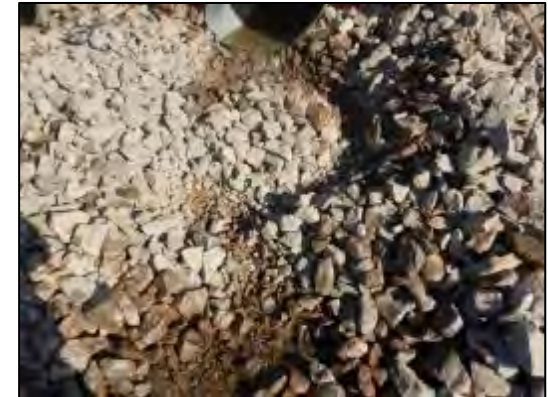
## 2019 Tote Road Stream Crossing Remediation – BG-50

**Photos 7:** Photographs of the downstream end the perched culvert before remediation at BG-50: (A-C) showing ineffective fish ramp at left culvert and dry right culvert with flow under the rocks; and photographs after remediation: (D) and (E) showing system of step pools and channels constructed to connect left culvert to stream below, improving fish access; and (F) showing a similar rocky ramp on right culvert, but insufficient water levels to determine effectiveness.
