RE: Submission of 2019 Geotechnical Inspection Report No. 1 (July 2019)

Annual Geotechnical Inspections – 2019 Report 1. Mary River Iron Mine Complex – Nunavut

Annual Geotechnical Inspections – 2019 Report 2. Mary River Iron Mine – Nunavut

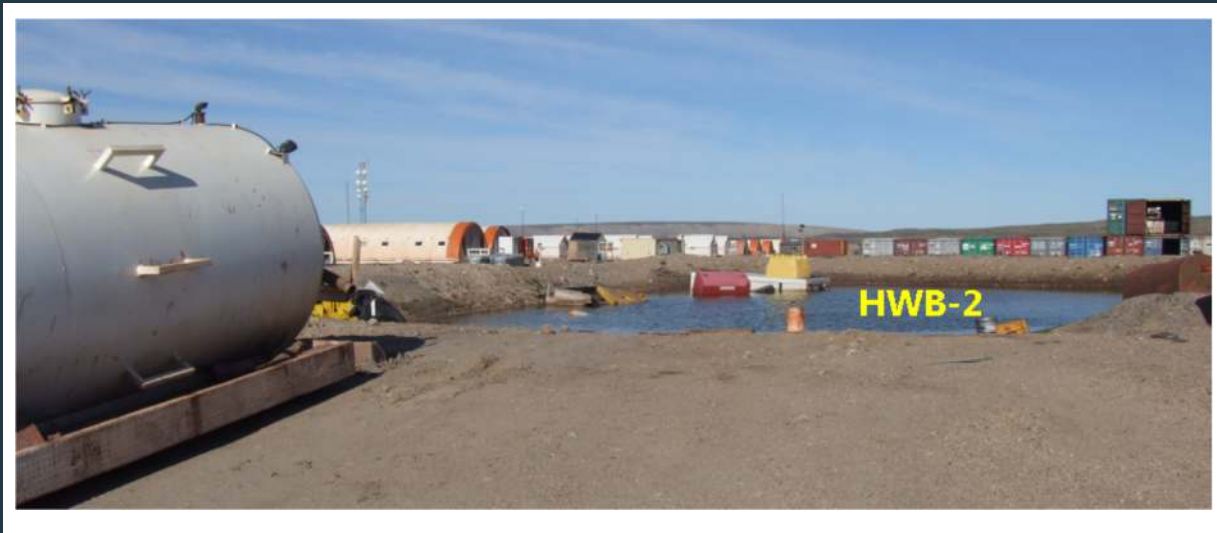
As shown in Figure 12, the perimeter berm appears to be stable. The presence of water visible within the pond demonstrates that the liner is intact. No visible seepage from the pond was noted around the berm, and the pond operates as intended.

Figure 12: View of HWB-2

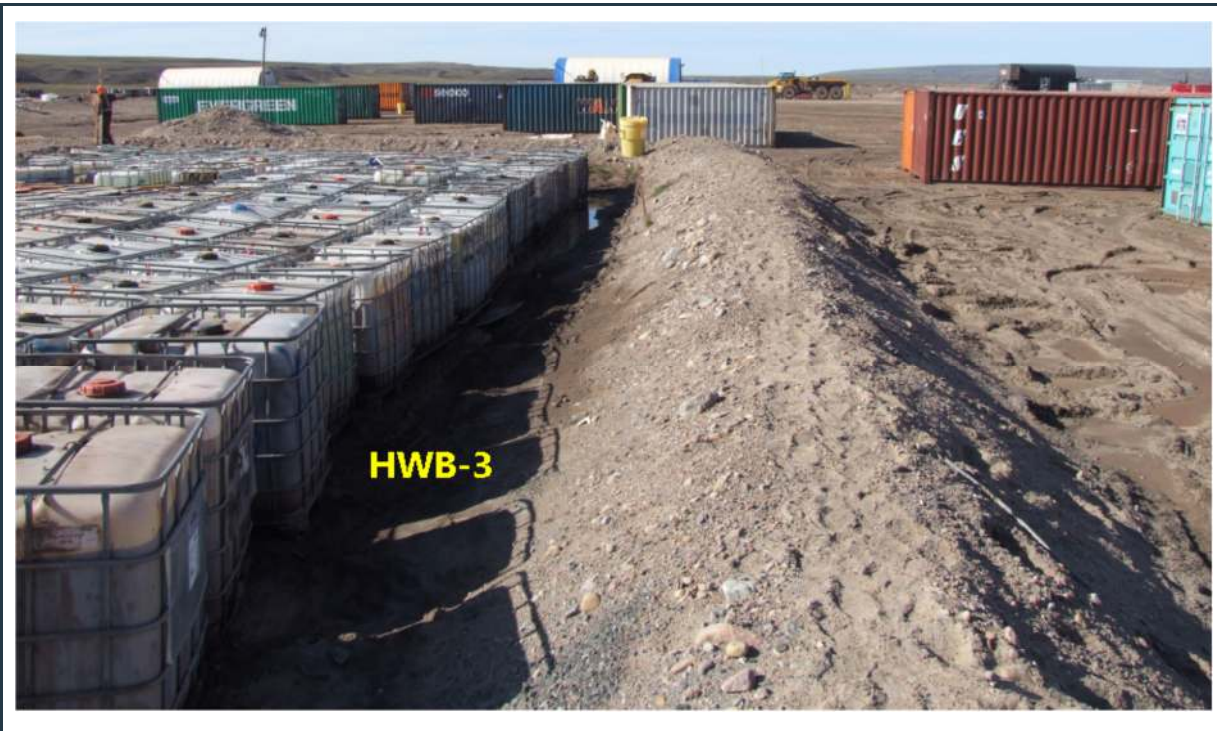
These cells are located side-by-side and were called in previous reports as “Fuel Containment” cells. As shown in Figures 13 and 14, there are predominantly contaminated waste (HWB-3) and fuel barrels (HWB-4) stored in these two cells.

The photographs of the cells attest stable berm condition, and good liner performance (e.g., ponded water in Figure 14). However, it is also shown on the images that foot traffic had caused disturbance on the slopes of the berms and that should be avoided. Furthermore, access points into the cells should be limited and foot traffic on the berms, particularly on their slopes, should be minimized. Furthermore, damaged wood pallets (shown in Figure 14) with nails sticking out of them, should be stored in a designated area, in order to minimize the possibility of liner damage by the nails.

Figure 13: View of HWB-3

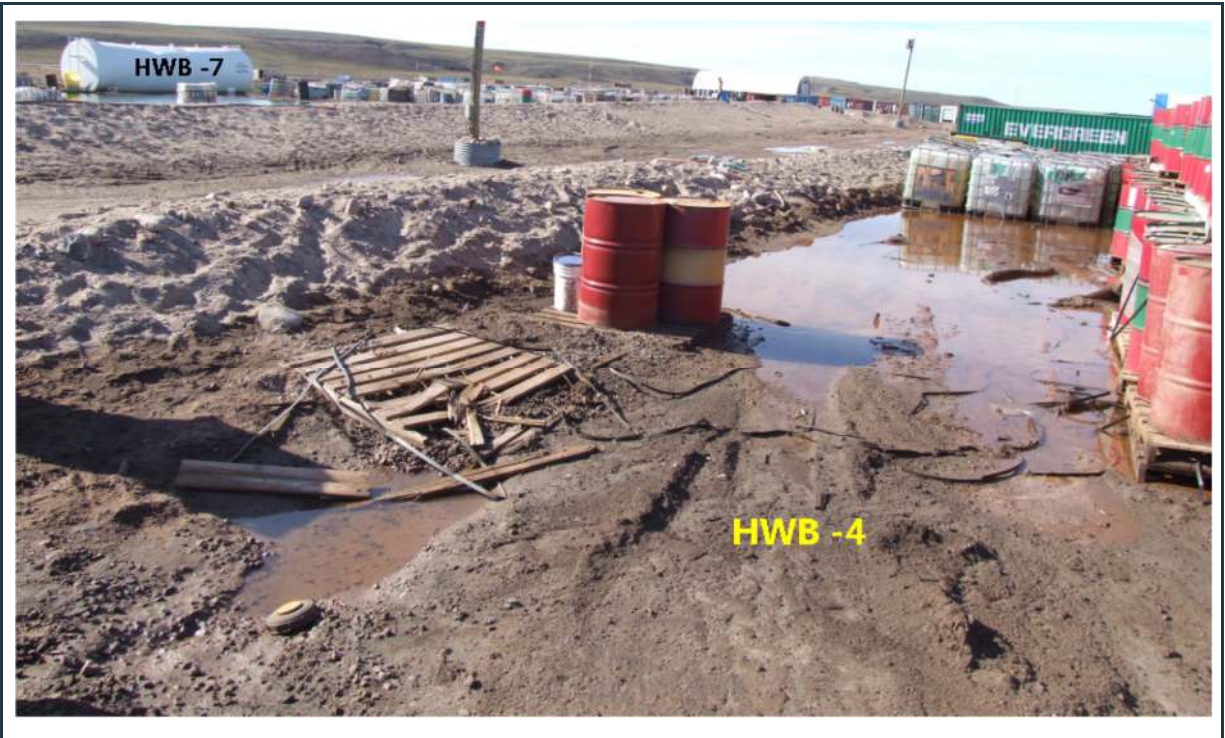
Figure 14: View of HWB-4

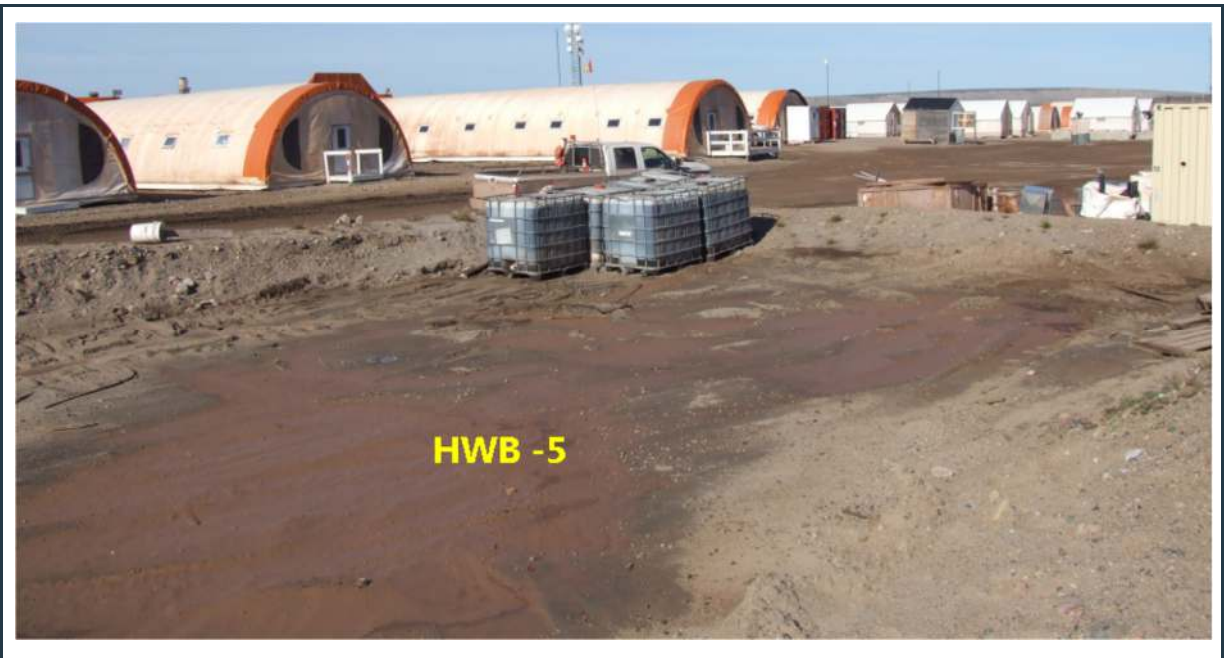
As shown in Figure 15, there are a few totes of lubricants currently stored in this cell. The berms around the cell appear to be stable and there is no visible liner damage. As recommended above, foot and truck traffic on the slopes and the crest of the berm should be prohibited with controlled / ramped access points (preferably one) provided for the skid-steers to dispose designated materials in the cell.

Figure 15: View of HWB-5

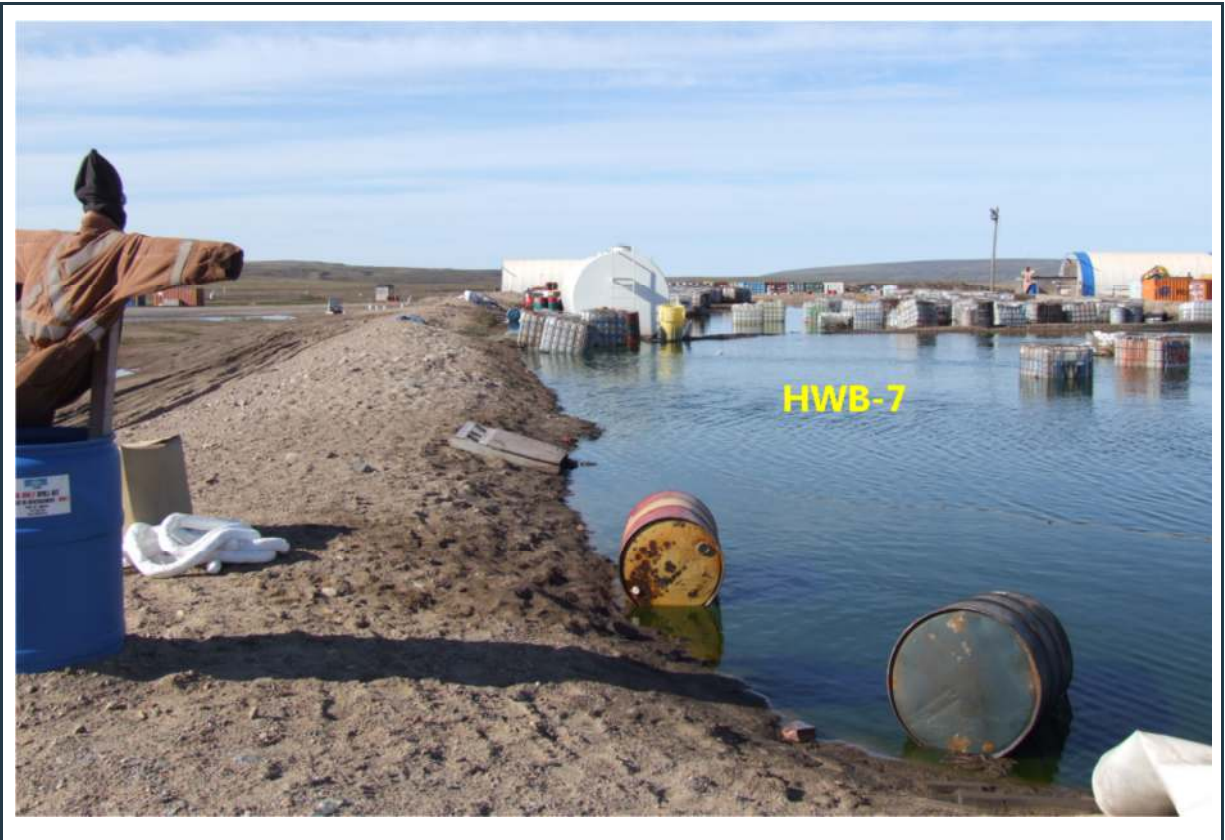
Based on information from historic reports, the HWB-7 cell was a bulk fuel storage facility in the past. Currently it is used to store fuel barrels, lubricant totes and a large fuel tank, as shown in Figures 18 and 19. The perimeter berm around three sides of the cell appears to be stable and the visible water within the cell supports adequate liner performance. There is a ramp along the fourth side of the cell (with appropriately high elevation at its highest end) to provide truck access into the cell.

Figure 18: View of HWB-7

Figure 19: View of HWB-7

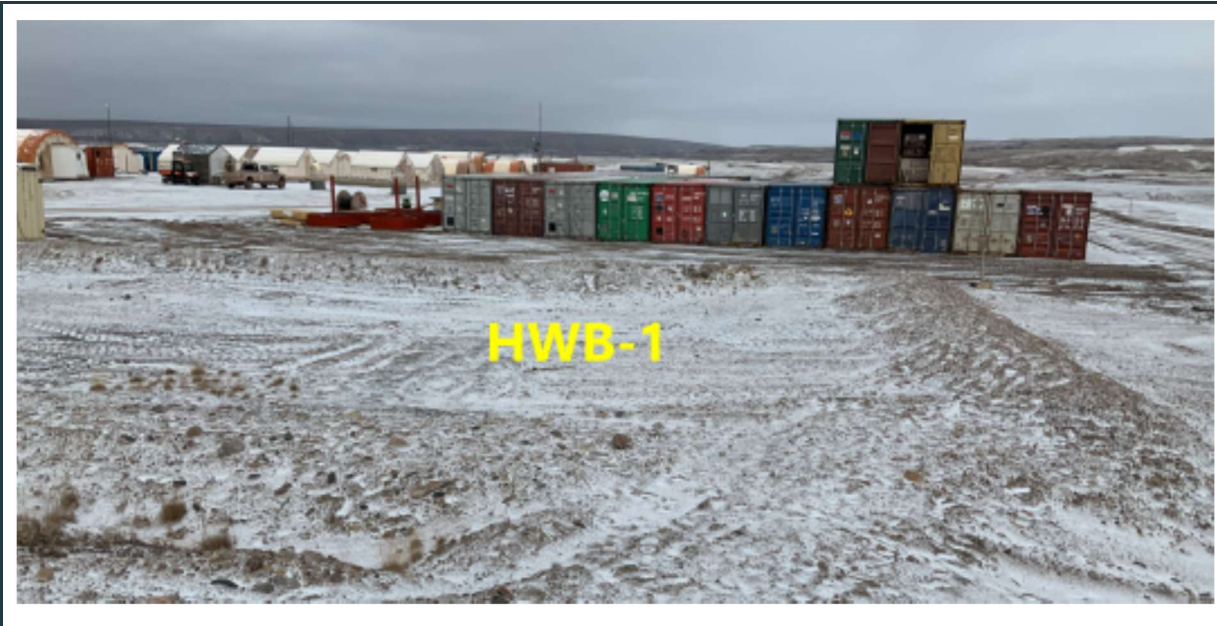
a) HWB-1

This cell is currently empty, with no water or ice visible within the cell (Figure 9). Based on information obtained during the June 27 to July 2, 2019 visit, it is understood that potential liner damage was suspected here, and consequently no material is stored in the cell.

Figure 9: View of HWB-1 – Currently this cell is empty.

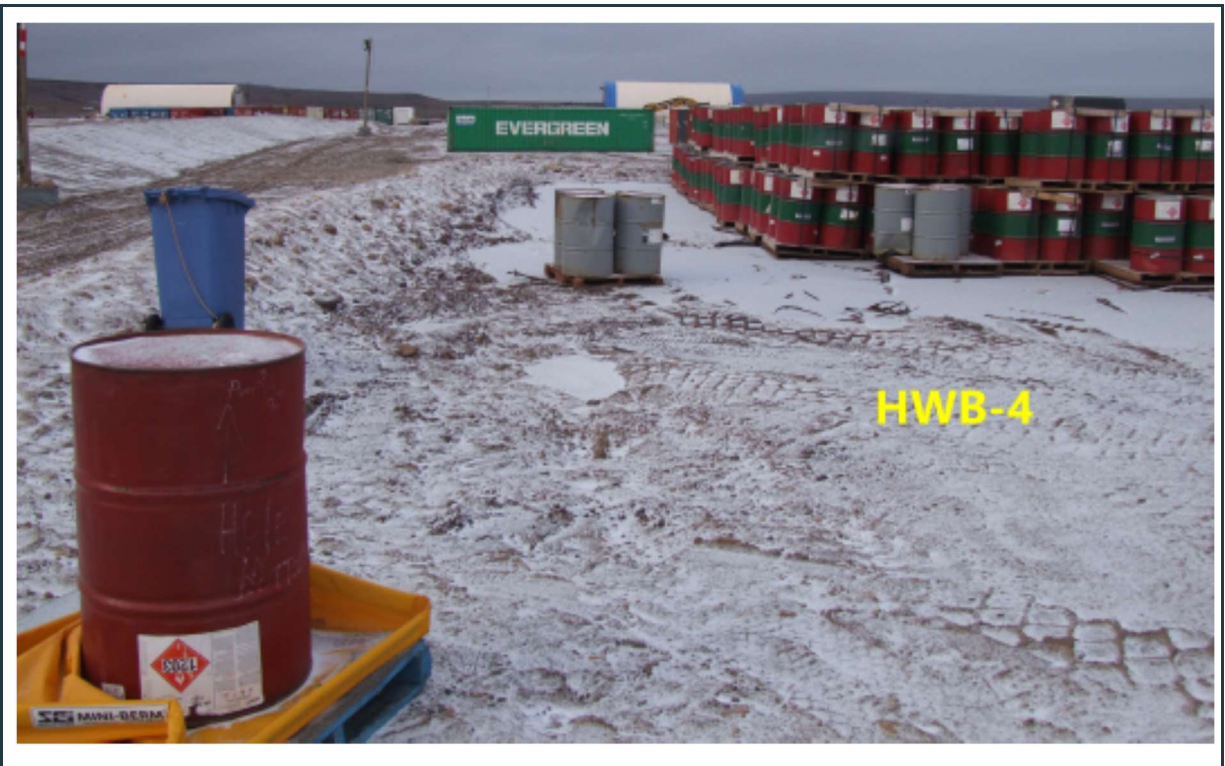
These cells are located side-by side and were called, in previous reports, "Fuel Containment" cells. As shown in Figures 11 and 12, there are only fuel barrels visible now in these two cells, stored on wooden pallets. The berms are stable and there is no visible liner damage in these cells. As recommended in the August 31, 2019 report, all damaged wood pallets and other debris have been removed from the cells to prevent potential damage to the liners.

Figure 12: View of HWB-4, with fuel barrels stored on wooden pallets.

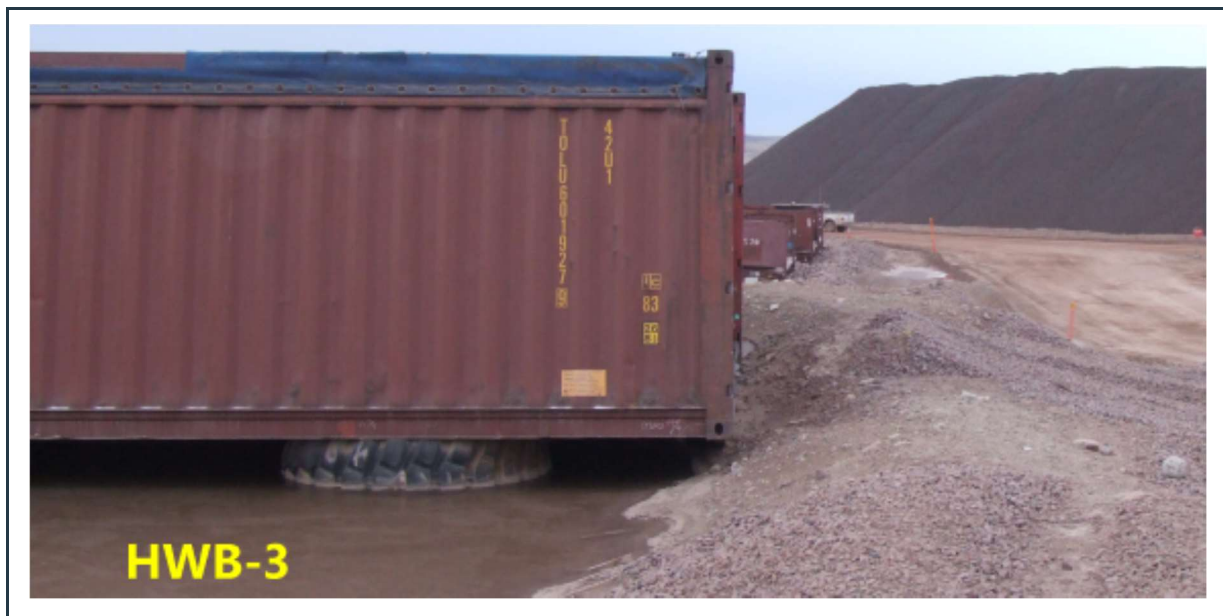
The HWB-3 and HWB-4 cells are located immediately next to each other (twin-cells) and contain shipping containers only, as shown in Figures 42 to 44. The berms appear to be in good condition with no visible signs of slope instability (e.g., movements or settlement). The liner was found to be exposed at a few locations on the crest and downstream slopes of the berms, as shown in Figures 43 and 44. It is recommended that all exposed liner areas be regraded and covered with a protective layer of granular fill (clean sand and gravel), to ensure proper liner performance in the long run.

Figure 42: View of the HWB-3 cell, containing frozen water and shipping containers.

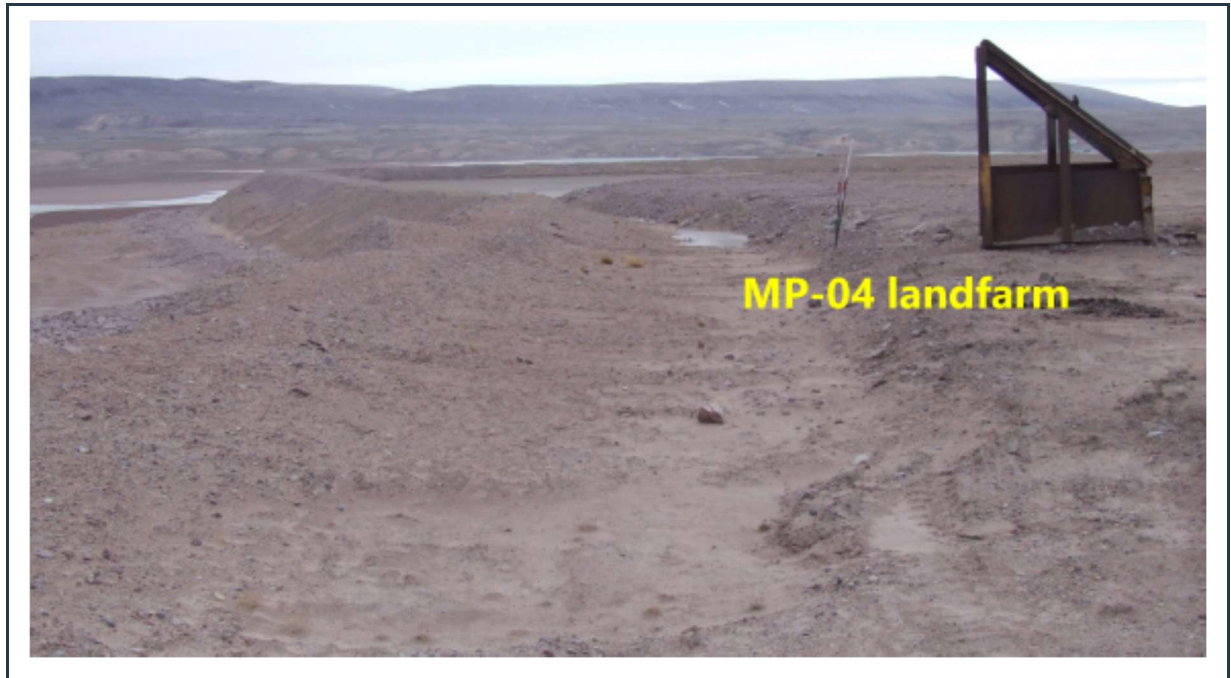
The MP-04 and MP-04A cells are located south of the port complex at higher elevation, adjacent to the rock quarry. MP-04 is a large landfarm cell that predominantly stores contaminated soils, as shown in Figure 47. The berm structure around the cell did not exhibit any signs of instability or evidence of seepage. However, the liner was found to be exposed (e.g. lacking protection of soil cover) on the downstream slope sections of the berm. This was particularly prominent along the north berm. It is recommended that the respective exposed liner areas (see Figure 48) be provided with protective gravel layer (e.g. wind uplift prevention).

Figure 47: View of stable berms around the MP-04 landfarm.

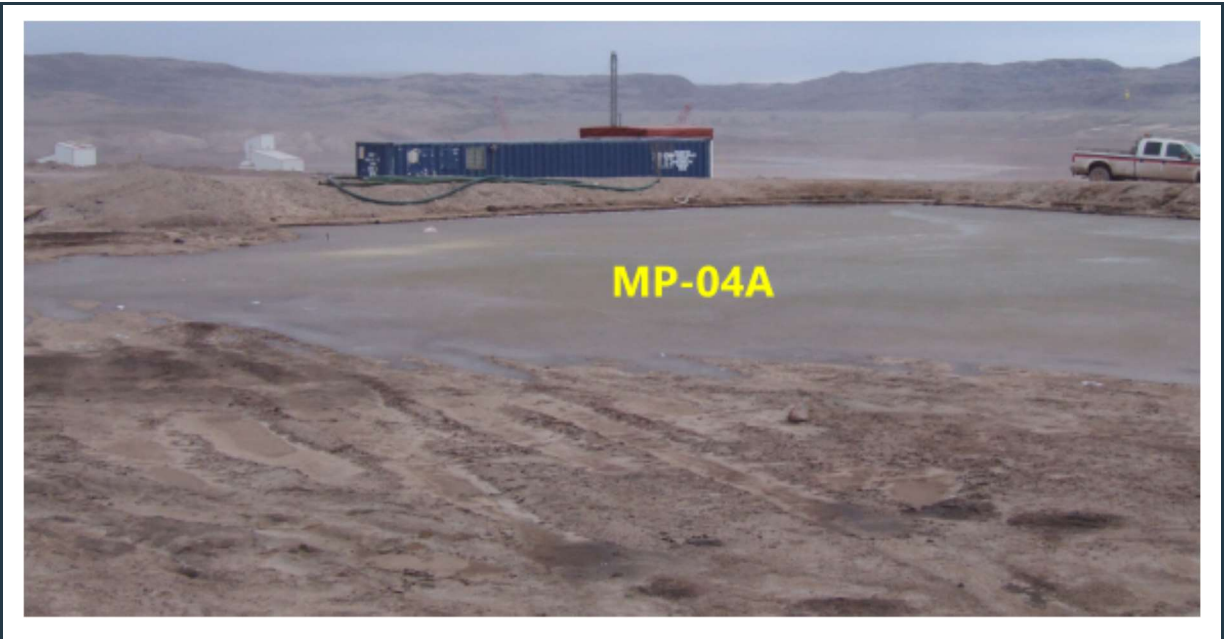
MP-04A is a smaller cell used generally for the disposal of contaminated snow impacted by hydrocarbons. This pond was constructed immediately adjacent to the MP-04 landfarm cell, shown in Figure 49. There were no visible signs of instability or evidence of seepage pertaining to the earthen containment. The

Figure 49: Stable berms and frozen water at the MP-04A contaminated snow dump.
